Effect of spherical dents on microstructure evolution and rolling contact fatigue of wheel/rail materials

X.J. Zhao^{1,2}, J.Guo¹, Q.Y. Liu¹, E. Butini², L. Marini², E. Meli², A. Rindi², W.J. Wang^{1,*}

Abstract: Surface dents may occur on both rail head and wheel tread and have a deep influence on their microstructures. This investigation aims at exploring the microstructure evolution and RCF of wheel/rail materials with spherical dents. The experimental results, obtained through a suitable instrumented roller-rig, highlight the different microstructure evolutions not only between rail and wheel, but also between front and rear areas of dent. Electron backscattered diffraction data shows that the grains around dent on wheel have higher strain, misorientation and quantity of large angle grain boundaries than those on rail roller, leading to a weaker RCF resistance in wheel rollers. Meanwhile, cracks tend to propagate in front area of dent on rail and rear area of dent on wheel.

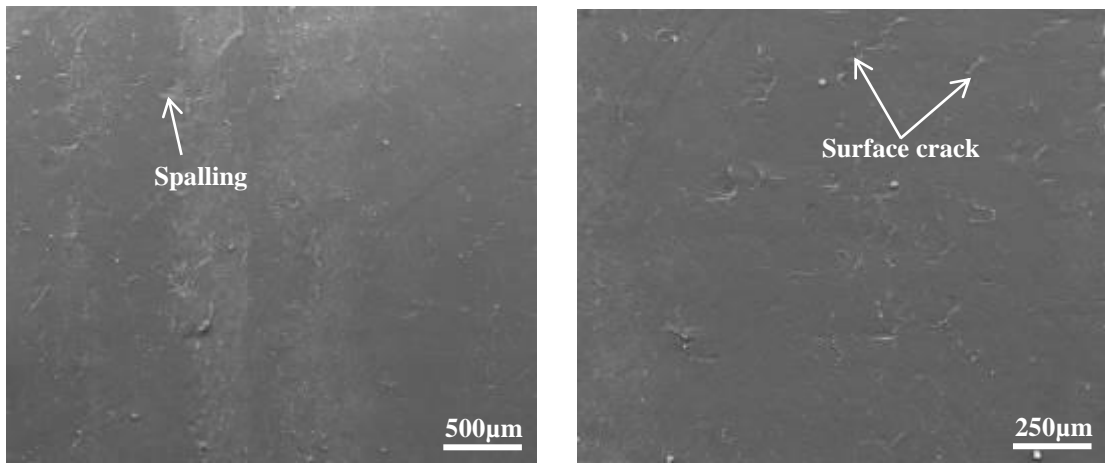
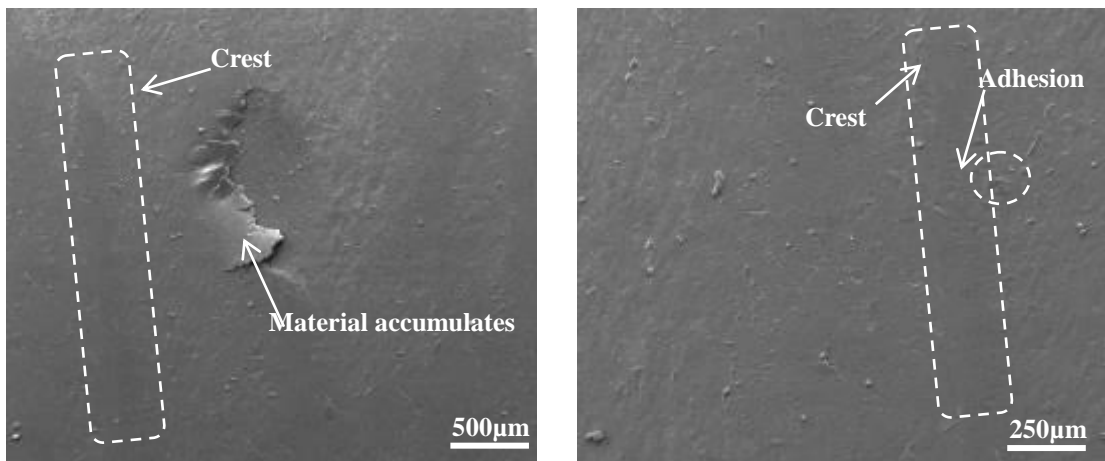
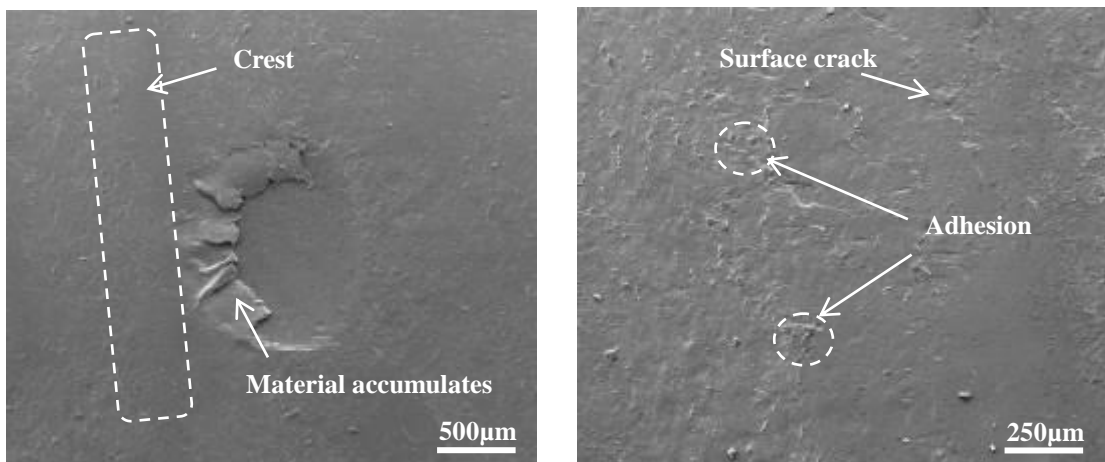
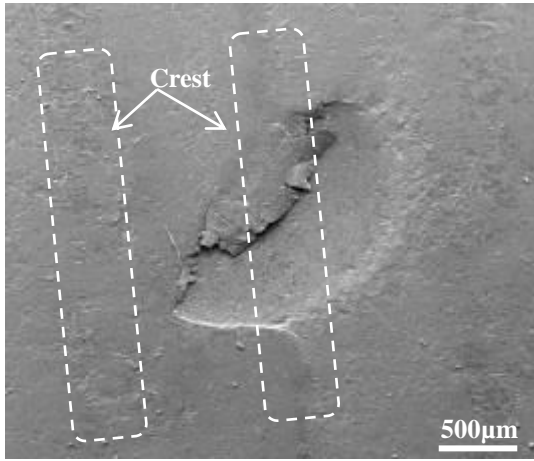
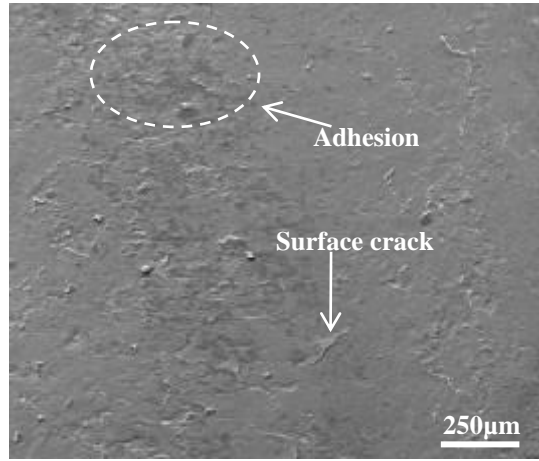
Fig.4

SEM micrographs of surface damage on rail rollers are shown in Fig.4. It is obvious that the material accumulates on one side of the dents. Compared to the rail roller without dents,

the crest appears on the surface of defected rail rollers. Besides, with the size of dent increasing, the crest becomes more visible as well as the adhesion spots on it (Figs.4b-d). As for the surface cracks, it seems to alleviate when the small dents emerge on the rail roller (Figs.4a, b). However, the surface cracks aggravate with the size dents enlarging (Figs.4c, d).

Fig.4: SEM micrographs of surface damage of rail rollers, (a) RN; (b) RS; (c) RM; (d) RL.

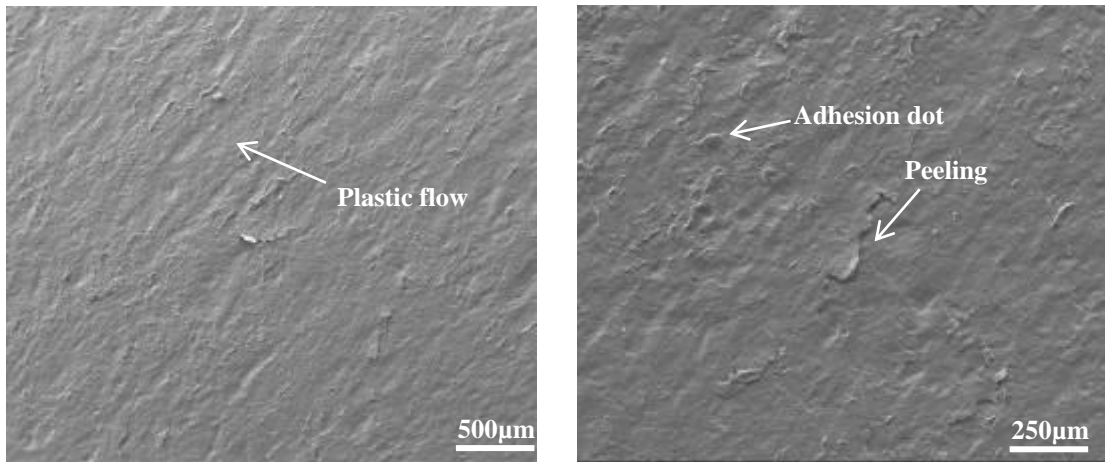
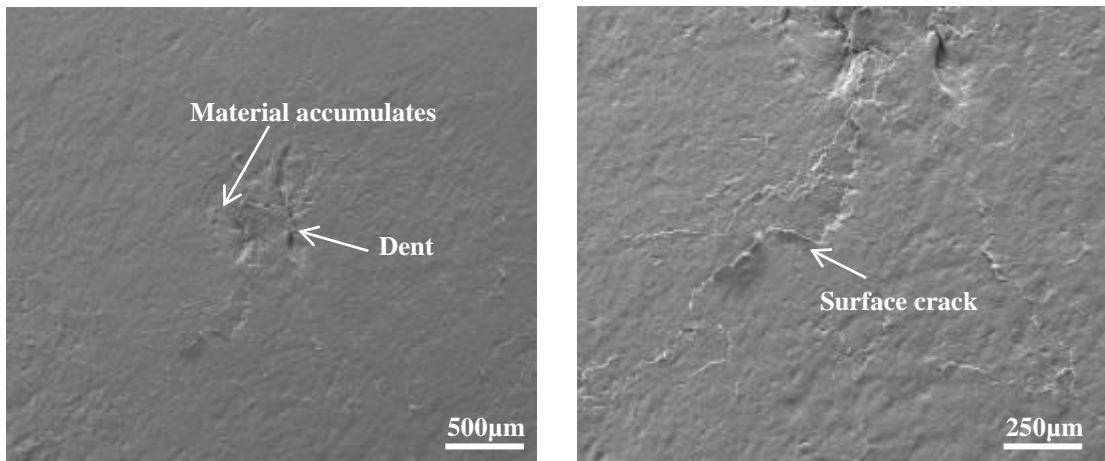
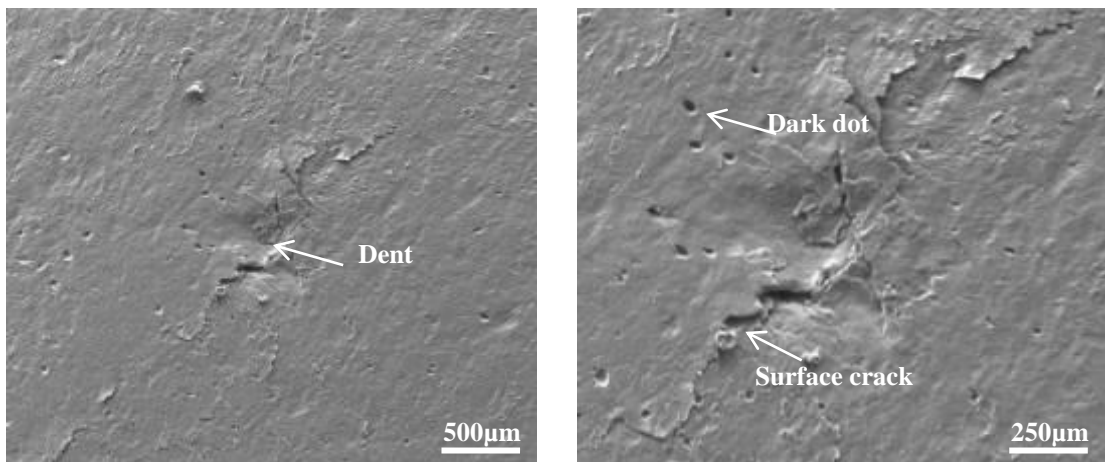
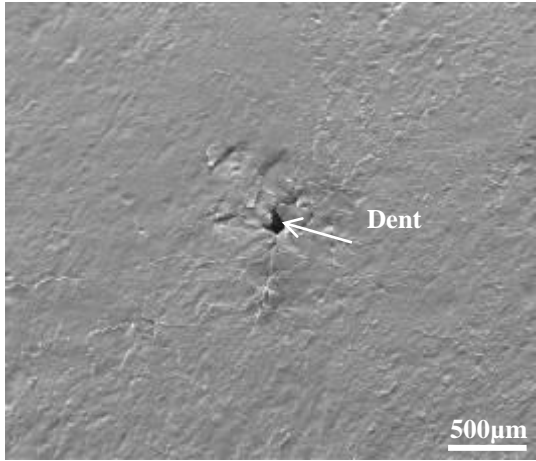
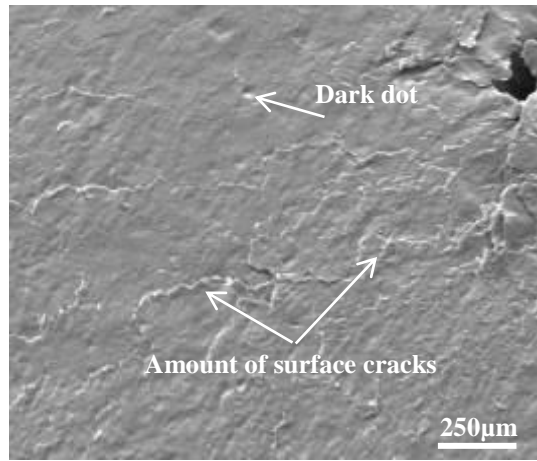
The surface damage behavior changes on wheel rollers, as Fig.5 shows. The dents tend to be covered by accumulated material from different directions. There are seldom adhesion spots on the wheel roller, which may be due to the fact that wheel material has a lower hardness than rail material. Moreover, only plastic flow and small peelings appear on RN rollers while, on the defected rollers, the surface cracks dominate. In particular, some dark dots gathered around the dent (Fig.5c) are present; these dark dots might be the dislocation pile-up group. Because of the residual stress caused by the dent, dislocations begin to glide or climb and finally piled up at surface [22].

Fig.5: SEM micrographs of surface damage of wheel rollers, (a) WN; (b) WS; (c) WM; (d) WL.

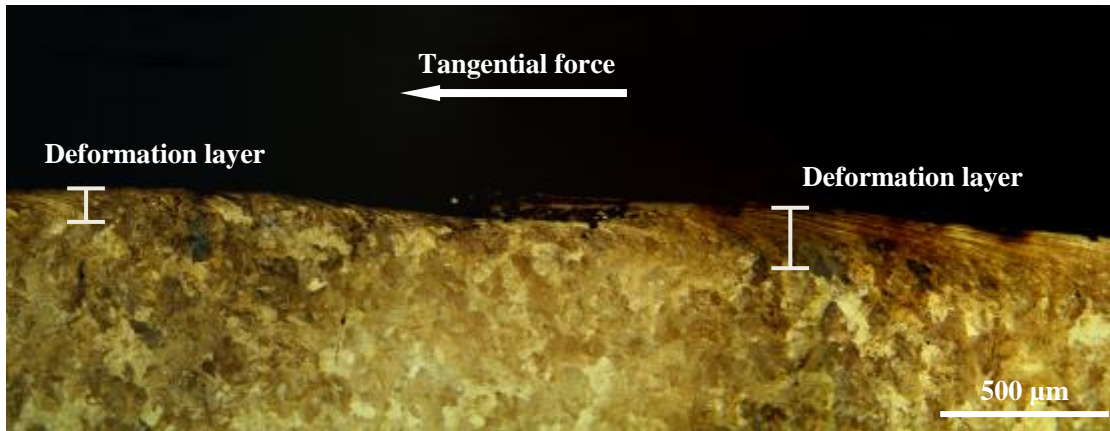
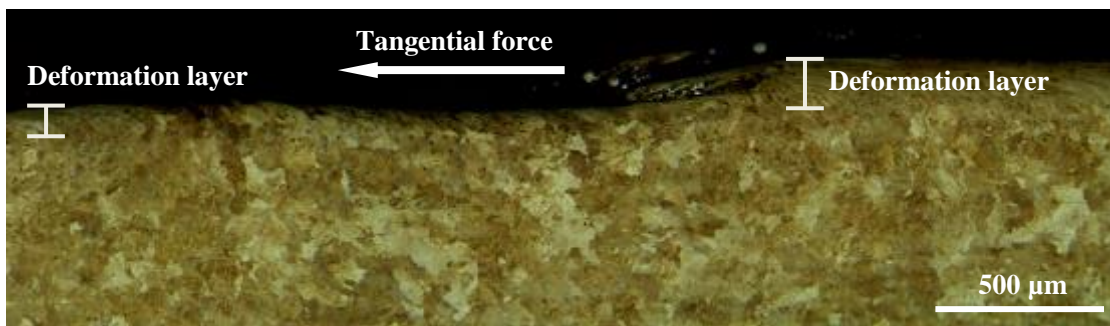
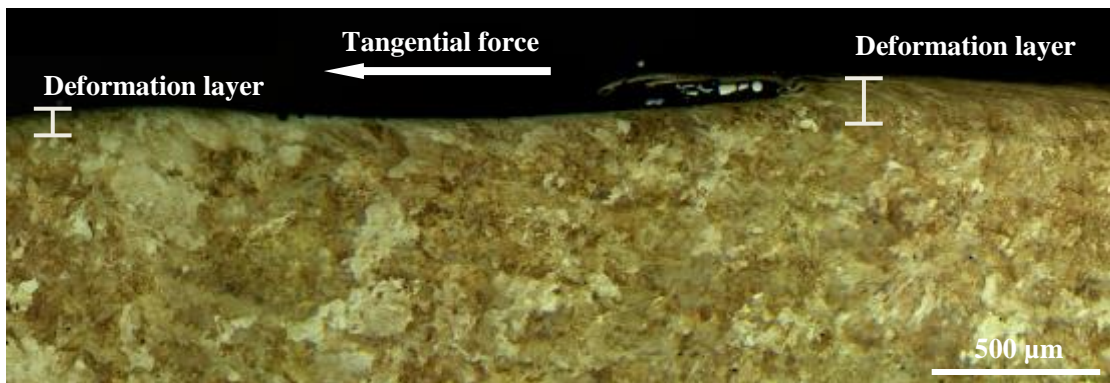
Fig.6 shows a different plastic deformation extent of rail material around dent. Along the direction of tangential force, the sample profile can be divided into two areas by dent: front area and rear area. **The depth of deformation in the front area is larger than that in the rear area.** Due to the reverse of rolling direction, the deformation characteristics of wheel roller vary (Fig.7). Within certain scale near the dent, the front and rear areas have opposite direction of plastic deformation. It is noteworthy that the deformation depth on front area gradually declines and the deformed line finally changes into an opposite direction. As Fig.7 shows, the length of transition zone declines from 1054 to 713 μm as the dent increases from small to large.

Fig.6: OM micrographs of plastic deformation of rail rollers, (a) RS; (b) RM; (c) RL.

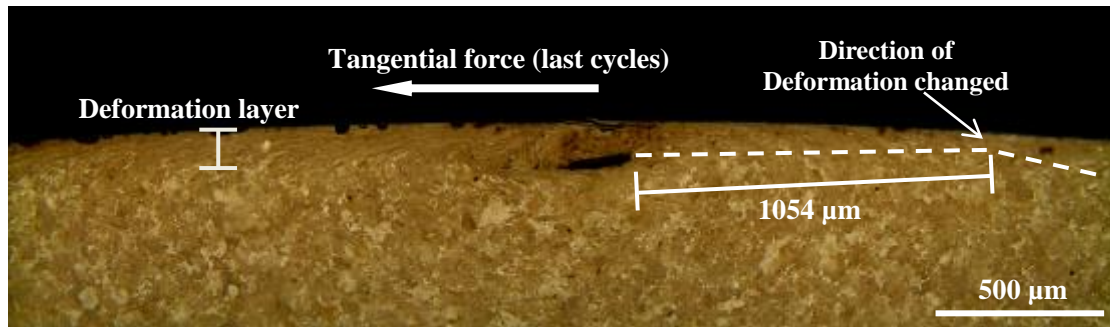
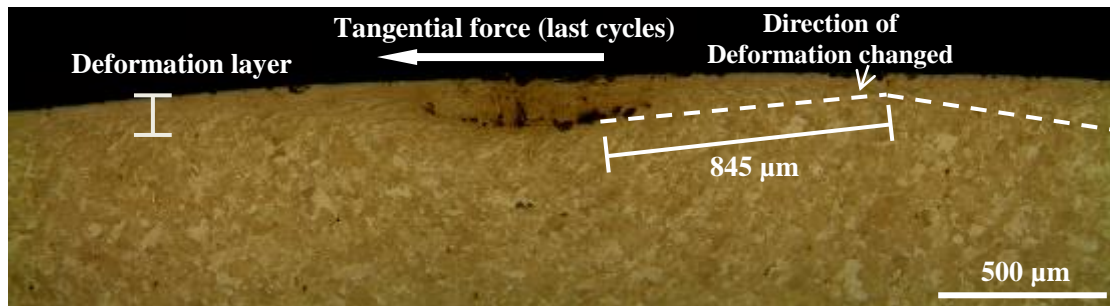
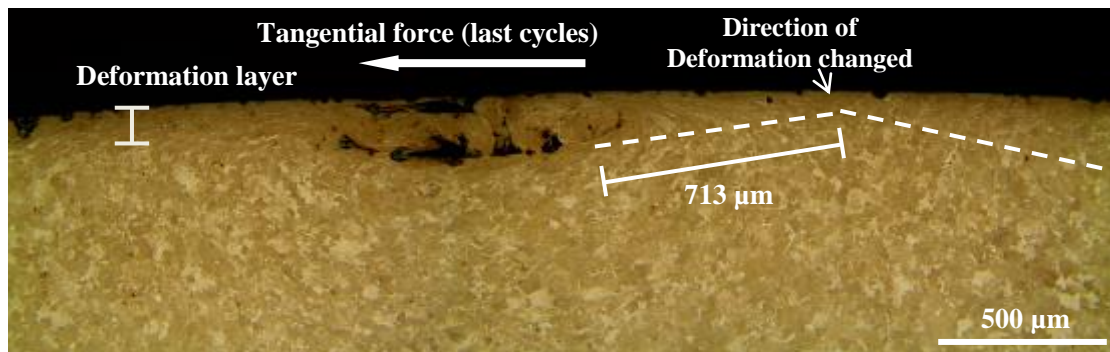
Fig.7

Fig.7: OM micrographs of plastic deformation of wheel rollers, (a) WS; (b) WM; (c) WL.

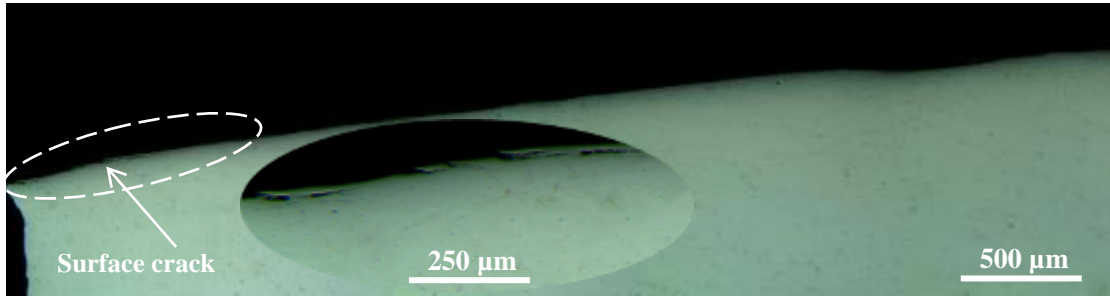
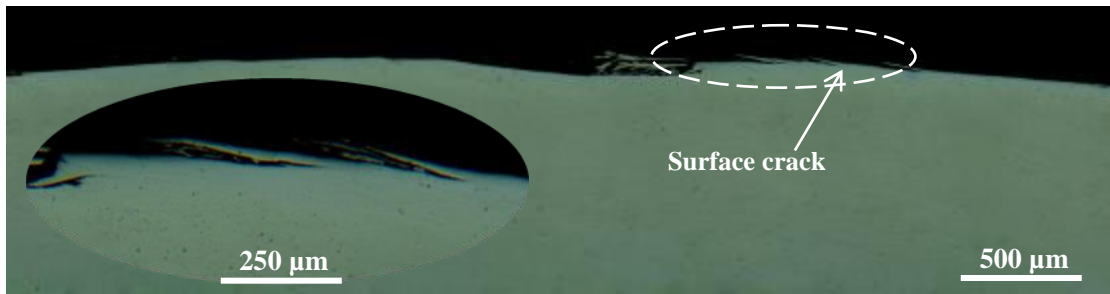
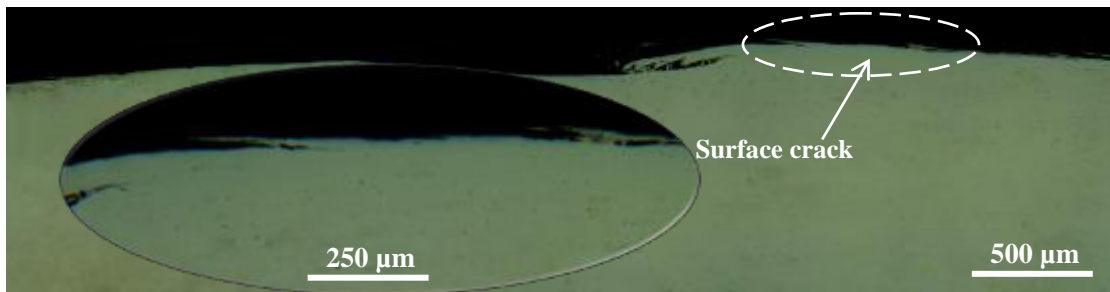
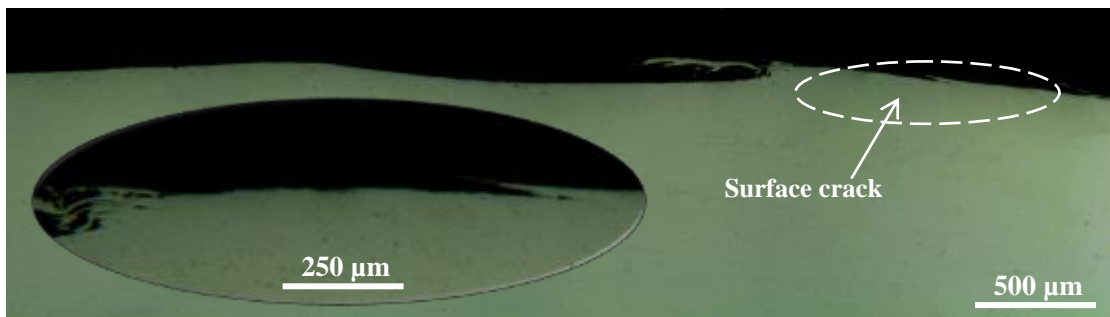
Fig.8 shows the fatigue cracks on the section of rail rollers. The statistics about these cracks on rail rollers are listed in Table.3. As it shows, due to the different depth of plastic deformation near the dent, cracks seem easier to initiate in front area than in rear area. More importantly, the length of the crack in front area is 1.12 times that in rear area (RS roller), then this ratio further increases up to 1.78 times with size of dent rising (RL roller).

Fig.8: OM micrographs of fatigue cracks on the section of rail rollers, (a) RN; (b) RS; (c) RM; (d) RL.

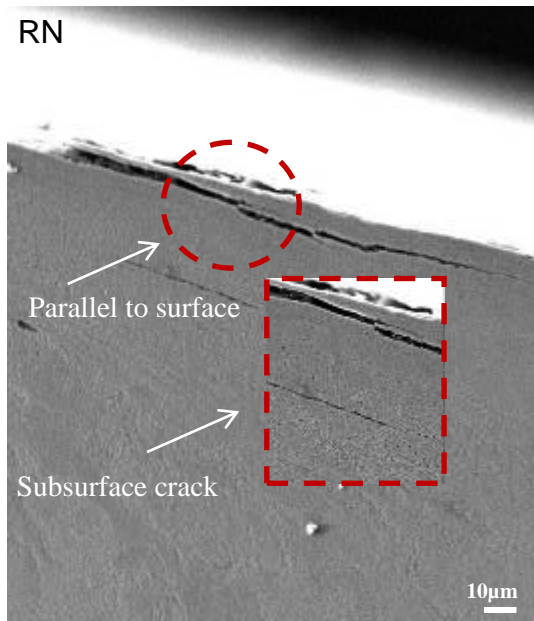
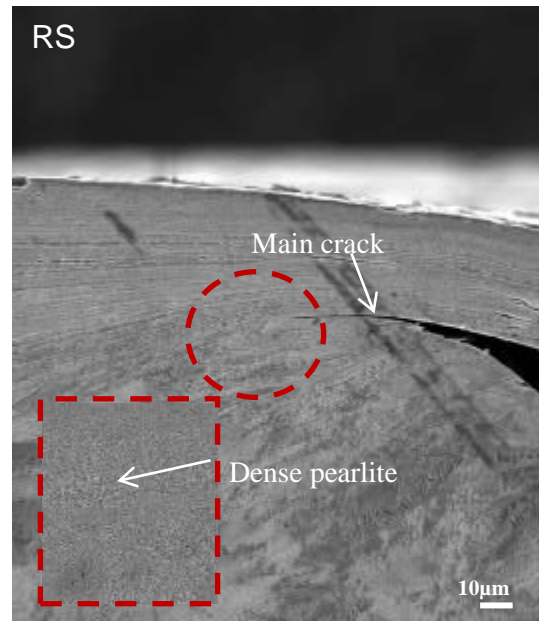
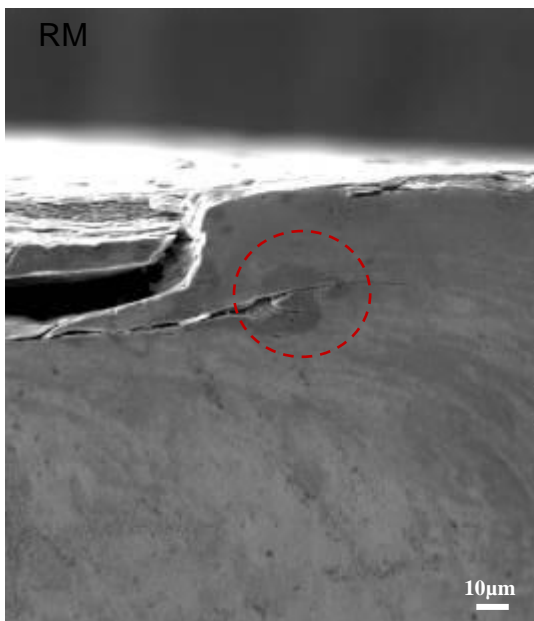
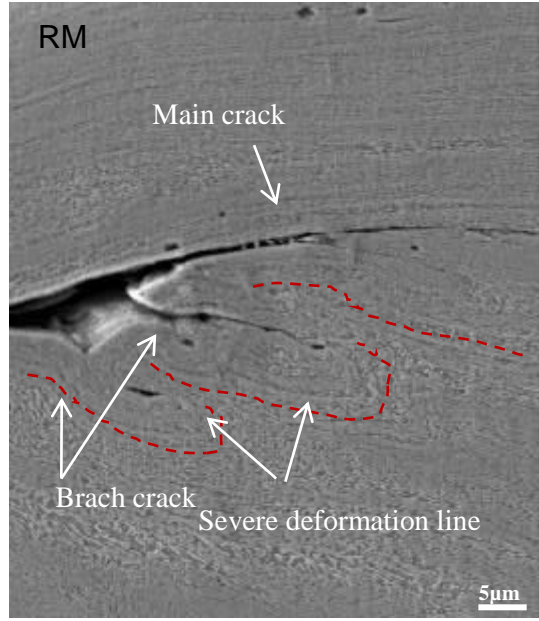
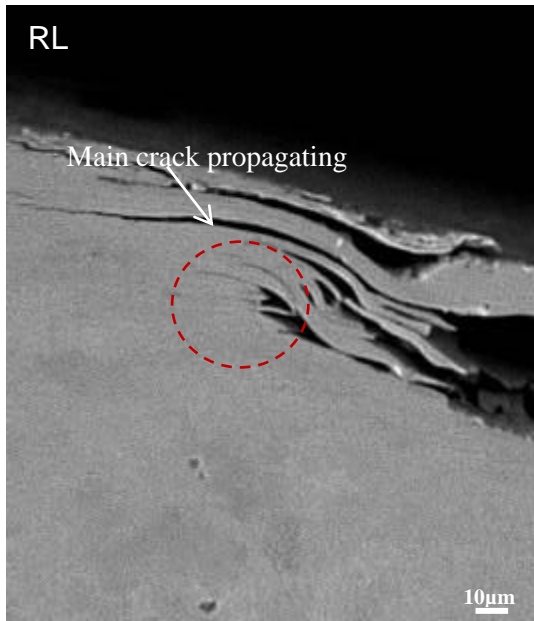
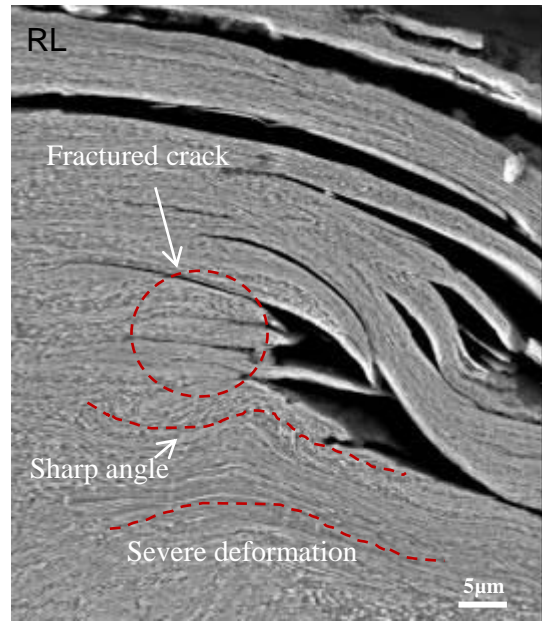
Fig.9

In order to reveal the relationship between deformation and tiny cracks, SEM micrographs with high magnification was applied on front and rear areas of dent. Compared to regular deformed line in Fig. 9a, the deformed line is distorted in the edge of dent. This may attribute to the cyclic impact when the dent entering wheel/rail interface. A small cyclic impact may densify the pearlite (Fig.9b) or could be an inducement for vertical crack initiation (Fig.9c). However, the crack would fracture due to the fact that the deformed line is distorted at a sharp angle by the increasing cyclic impact.

Fig.9: SEM micrographs of fatigue cracks on the section of rail rollers, (a) RN; (b) RS; (c) RM; (d) RL

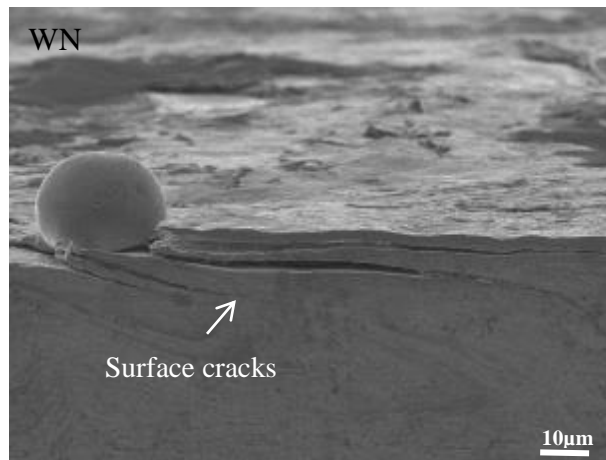
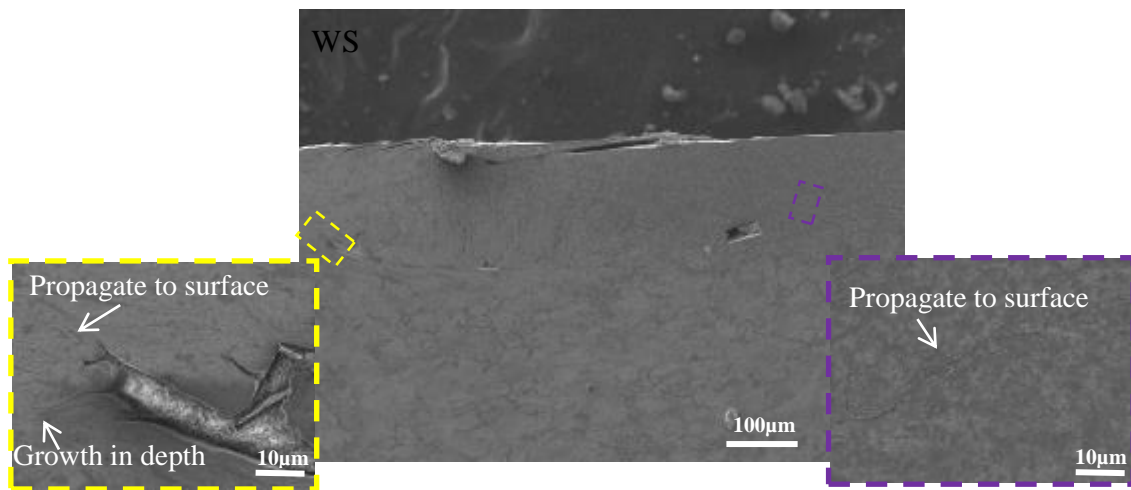
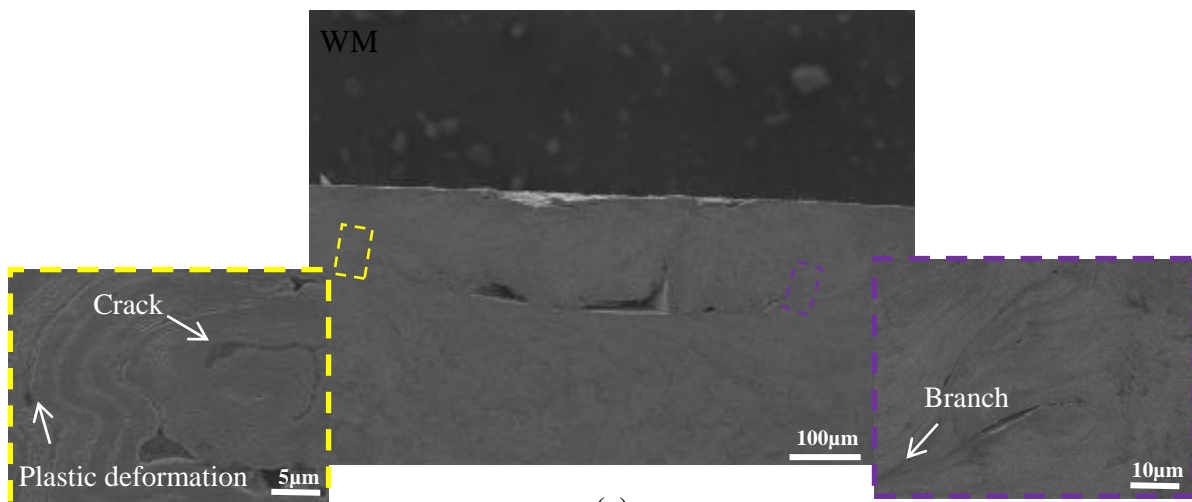
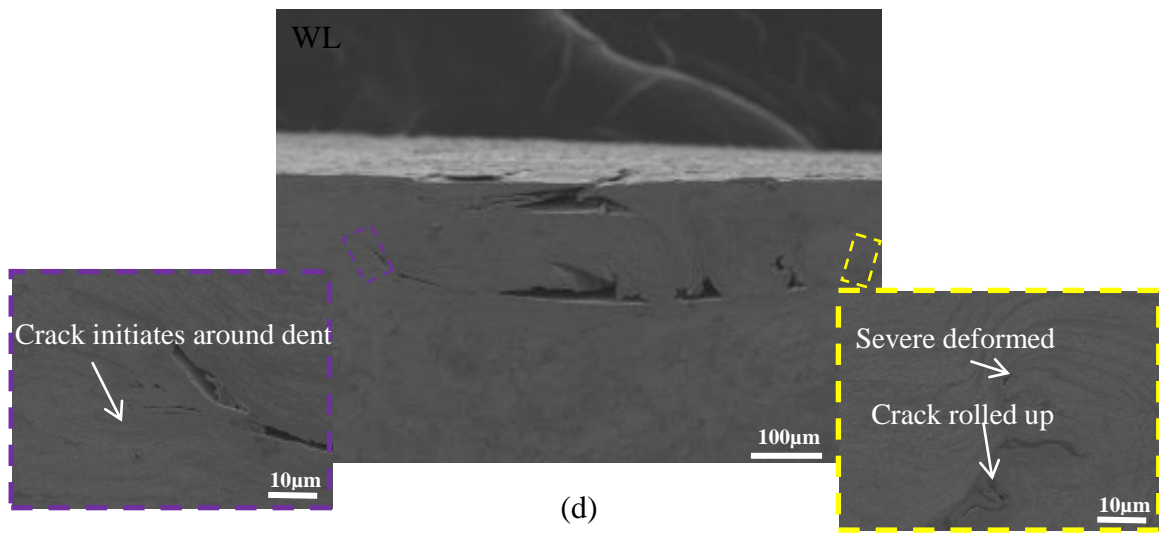
Since the tangential force on wheel roller reverses frequently, the deformation line and the crack propagation behavior changes at each period. In yellow square of Fig.10 (standing for “front area”), the deformed line rolls up the pearlite (Fig.10c) or even the cracks (Fig.10d), making the cracks propagating at unpredictable angles. In the blue square (standing for “rear area”), cracks initiate and grow in length. It can be concluded from Fig.10 that cracks in rear area is longer than that in front area. Table 4 compares the types of crack around dent in wheel and rail materials. The crack growth in depth can be detected in all the defected wheel samples while it can be only found in RM roller. Meanwhile, the branch cracks often emerge on the wheel rollers. Therefore, it can be inferred that the subsurface damage on defected wheel roller is as severe as that on rail roller.

Fig.10: SEM micrographs of fatigue cracks on the section of wheel rollers, (a) WN; (b) WS; (c) WM; (d) WL

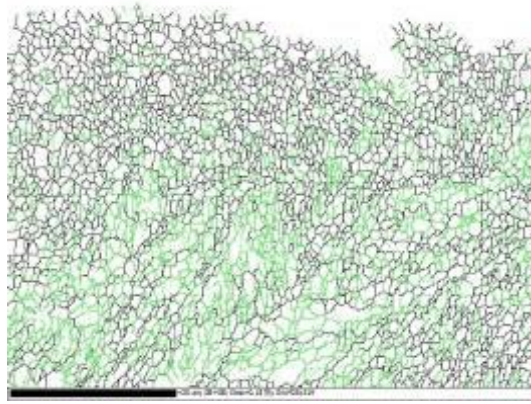
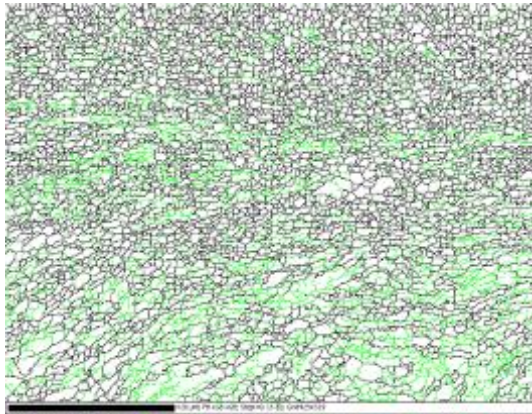
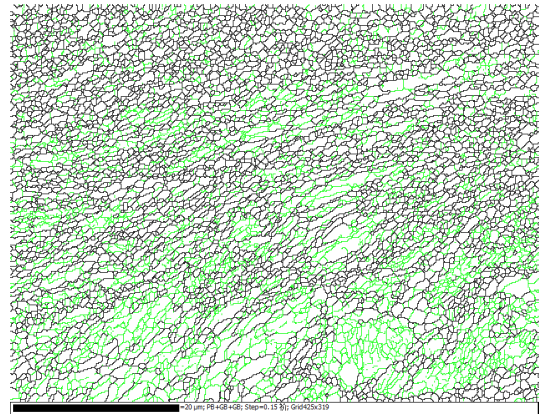
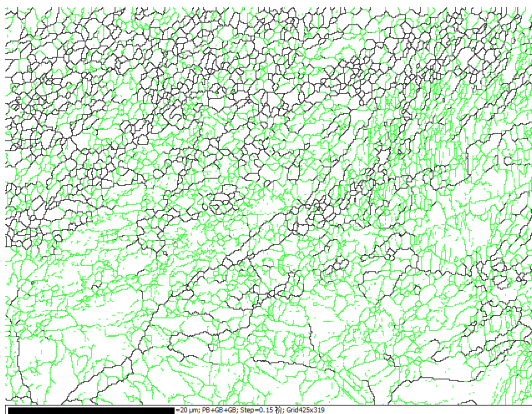
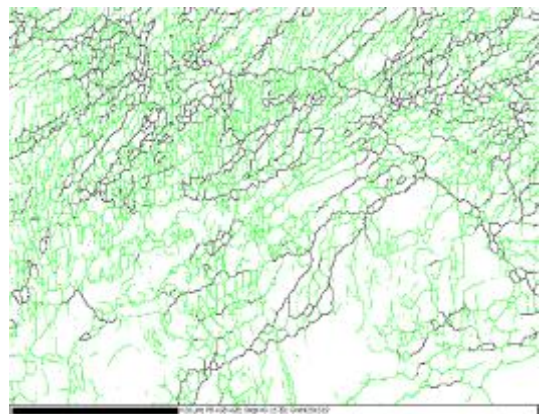
The EBSD method is focused on the deformed grains on wheel and rail rollers with dent. Therefore, the test areas are selected at about 50 μm below the surface. Fig.11 reveals the distinct differences of grain angle between rail and wheel rollers. The black line sketches the grains boundary with large angle (more than 15 degree) while the green line stands for the grains boundary with small angle (from 2 up to 15 degree). It is obvious from Fig.11a that grains with large angle gather near the surface and become less frequent inside the body. However, the grains with large angle boundary dominate on defected wheel roller as Figs.11b-c show. On the contrary, the situation changes on the defected rail roller, especially in the rear of the dent. In this case, the majority of grains are characterized by small boundary angle. It can be attribute to the fact that the slight deformation in the rear area assures less energy to disorder the grains.

Fig.11: EBSD micrographs of grain boundary on wheel/rail rollers, (a) WN; (b) WM (in the front of dent); (c) WM (in the rear of dent); (d) RM (in the front of dent); (e) RM (in the rear of dent)

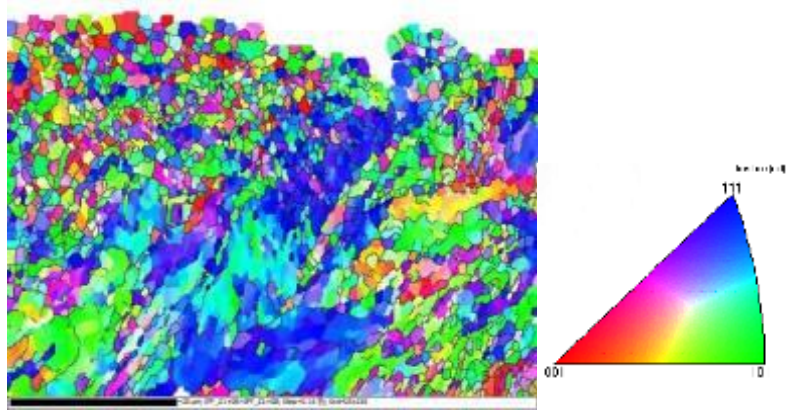
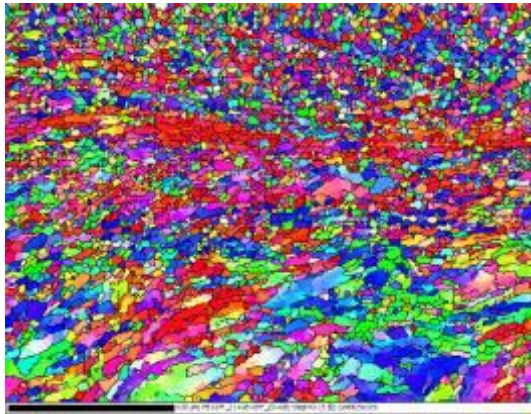
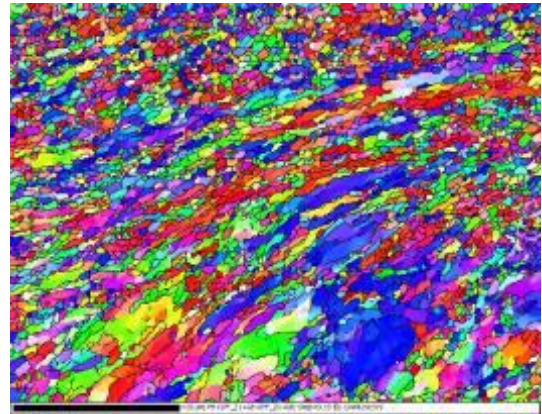
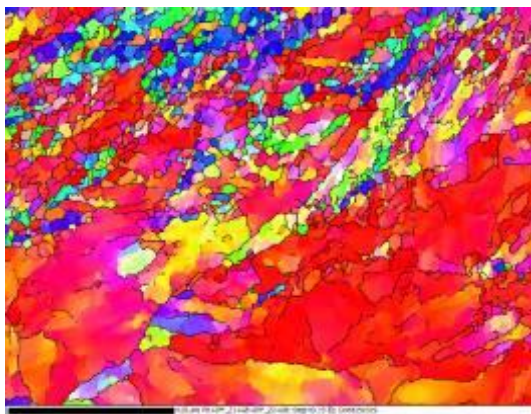
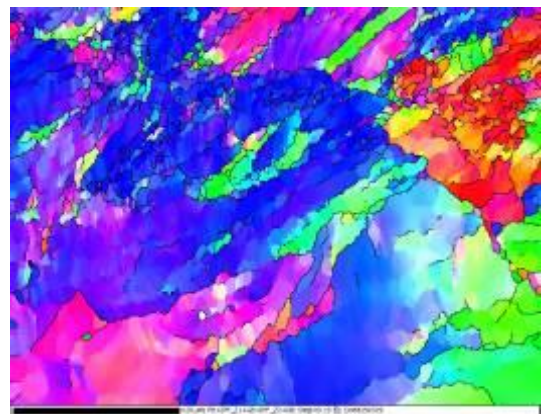
Fig.12

The inversed pole figure (IPF) shows the crystal orientation of each grain on rail and wheel rollers. The similar color presents a same orientation trend for grains. The gains orientation in wheel roller shows a clear anisotropy phenomenon (Fig.12b). Only a few fiber textures with small misorientation can be found in the rear of dent (Fig.12c). Conversely, the grains in rail roller share an almost similar crystal orientation, especially in rear of dent (Fig.12e).

Fig.12: Inverse pole figure (IPF) of wheel/rail rollers, (a) WN; (b) WM (in the front of dent); (c) WM (in the rear of dent); (d) RM (in the front of dent); (e) RM (in the rear of dent)

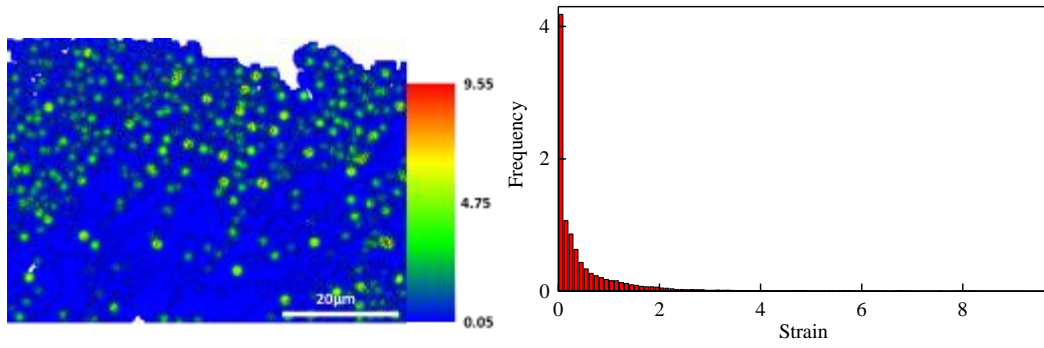
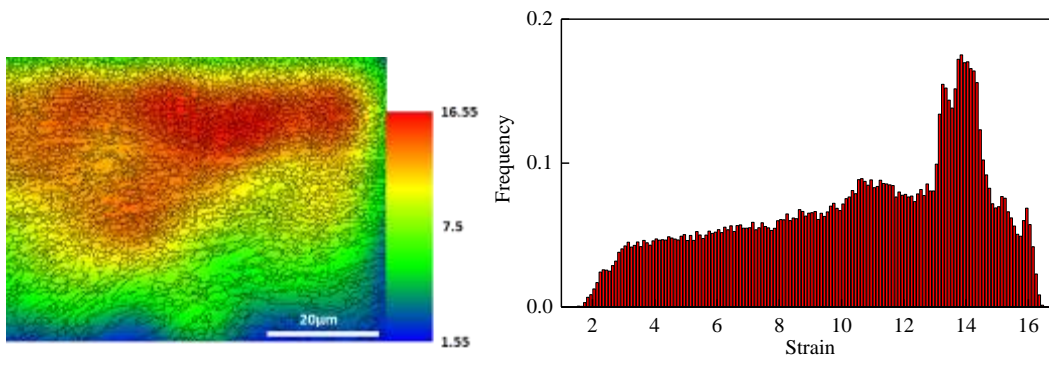
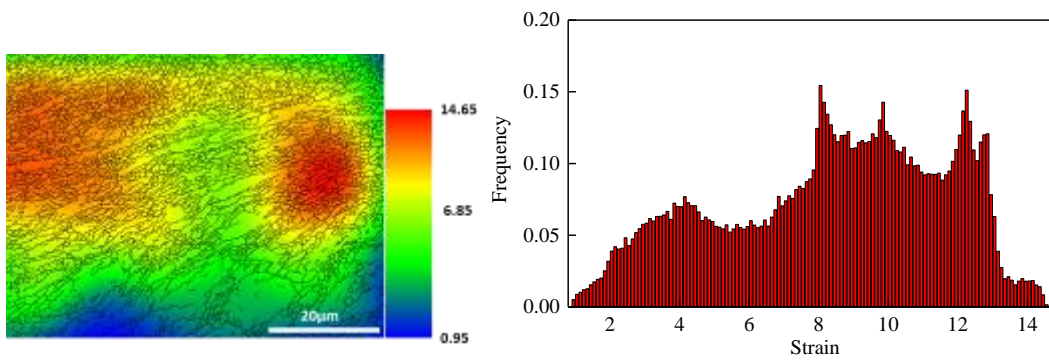
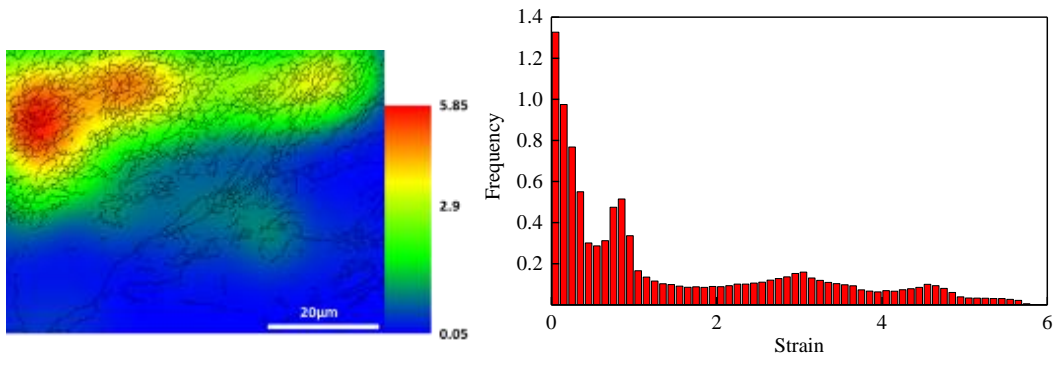
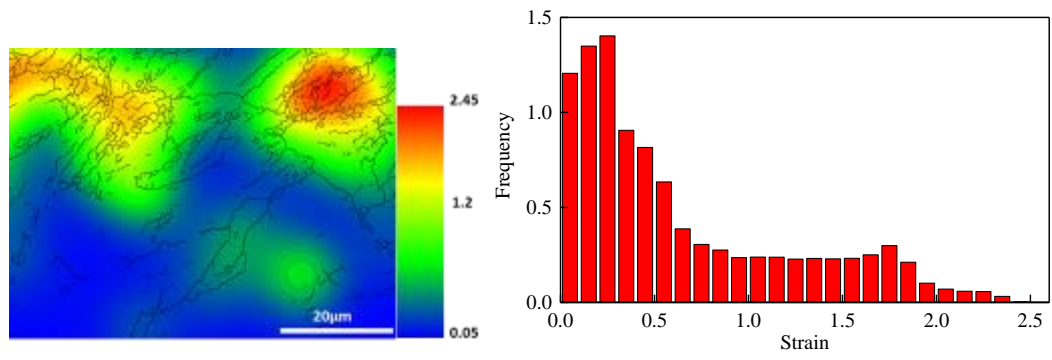
Fig.13

The strain distribution on wheel and rail roller after testing is shown in Fig.13. On WN rollers, the high strain areas are concentrated near the surface at the maximum value of 9.55. When a dent appears on wheel roller, the strain increases immediately up to 16.55. On the contrary, the strain on rail roller shows an extremely low value at 5.85 and it decreases rapidly

towards the inside of the body. Finally, it has to be noticed that the average strain in rear area seems lower than that in front area, both in wheel and rail rollers.

Fig.13: Strain contouring of wheel/rail rollers, (a) WN; (b) WM (in the front of dent); (c) WM (in the rear of dent); (d) RM (in the front of dent); (e) RM (in the rear of dent)

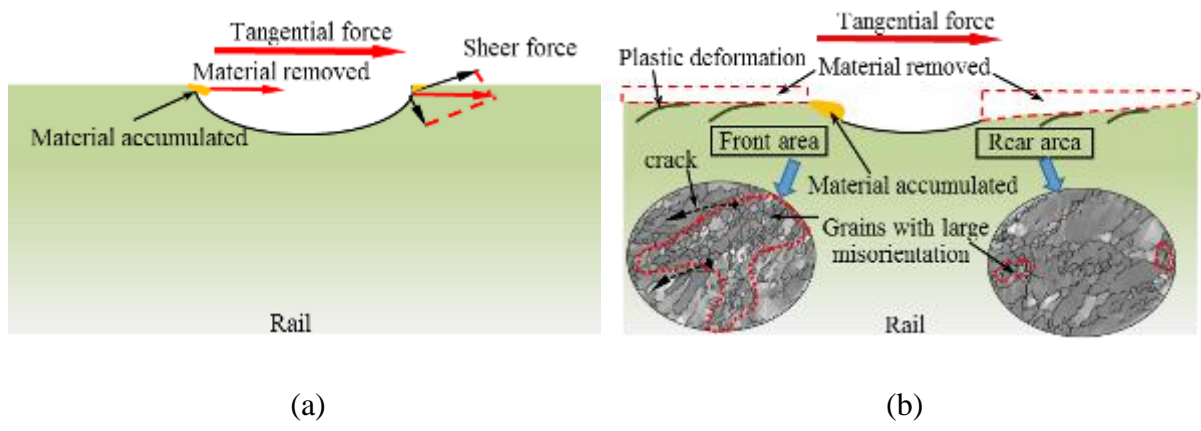
Fig.14

a large misorientation facilitates the onset of small cracks [26]. The grain in the front area of dent has larger misorientation than that in rear area on rail roller (Fig. 14(b)). Thus, the cracks in front area on rail roller is more severe than that in rear area (as Table 3 shows).

Fig.14: Crack growth mechanism around the rail dent, (a) in early cycles; (b) in final cycles.

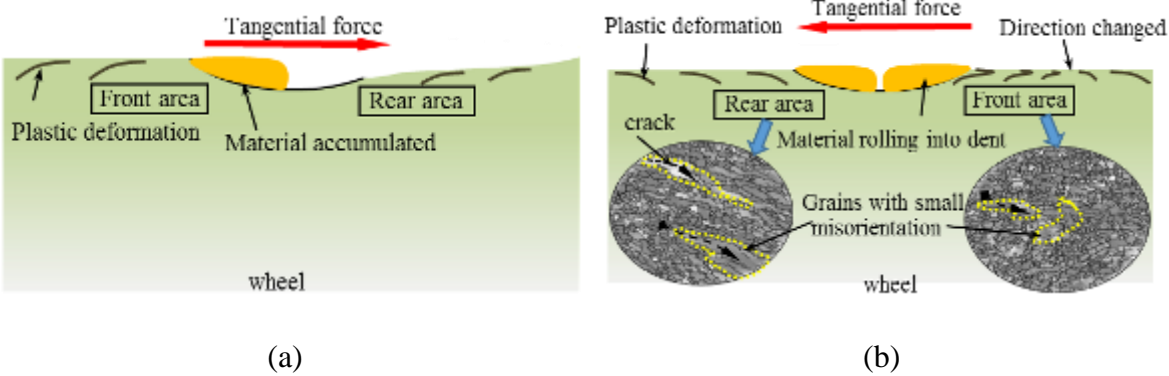
Fig. 15

Because of the inversion of tangential force on wheel roller, the “front area” in the previous period turns into “rear area” in the current period. As it is mentioned above, the rear area of the dent has a higher wear rate. In the primary cycles, the material accumulates in the front area of dent (Fig.15a). Subsequently, the plastic deformation is easily worn and forms a new plastic deformation layer with single flow direction as the “front area” changes into “rear area”. As a result, a fiber texture with small misorientation emerges in the rear of dent. As a previous paper mentions [26], tiny cracks tend to propagate in the area with small misorientation (Fig.15b). The other side of dent experiences the transformation from “rear area” into “front area”. Due to low wear rate in “front area”, the microstructure is affected by two plastic deformation lines with different flow directions. The previous plastic deformation is rolled up (Fig.6), the continuous fiber texture is destroyed (Fig.12b) and the microstructure is mainly anisotropic, which slows down the crack growth. This way, the crack in rear area of dent on wheel roller is longer than that in the front area (Fig.10).

Fig.15: Crack growth mechanism around the wheel dent, (a) early cycles; (b) the next cycles (direction of tangential force changed).
