Restoration of a sandstone facade: from the project to the monitoring

RESTORATION OF A SANDSTONE FACADE: FROM THE PROJECT TO THE MONITORING

This work describes the restoration of a facade of an historical building, constructed from typical local sandstone, characterized by different subsequent decay phenomena and subjected in the past to a conservation treatment. The sandstone was characterized, the quarry of provenance was identified, and the causes of the different decay phenomena were investigated. Potential commercial products for the restoration were tested first in the laboratory, then in situ selected products were applied and the effectiveness of treatment was subsequently monitored. Analytical methodologies such as x-ray diffraction (XRD), observation of thin sections under polarized microscope (OM), Fourier transform infrared spectroscopy (FT-IR), micro-Raman spectroscopy, and water absorption tests were employed in the laboratory, while nondestructive tests, performed with portable instrumentation such as colorimeter and sponge contact, were carried out in situ.

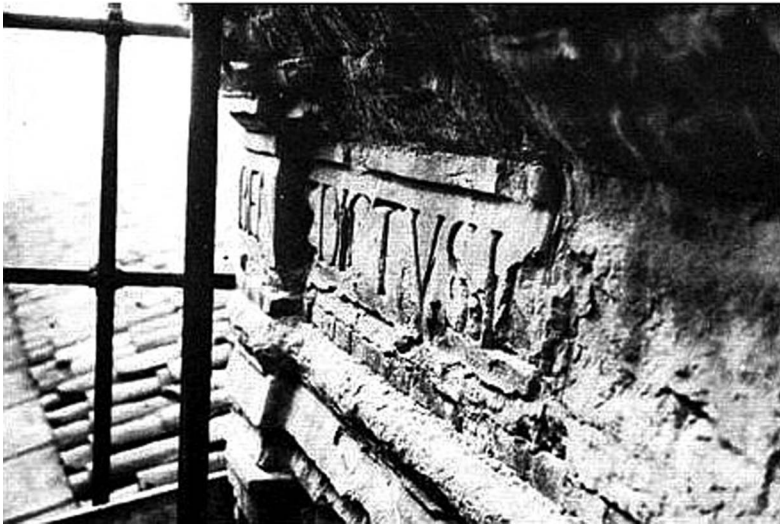
Figure 2. The state of conservation of a portion of facade in 1974.

Initially a conservation status map of the building was prepared. This map confirmed that the conservation carried out in 1974 did not stop ongoing decay from penetrating water into the material, causing a loss of consistency of the building stone while the facade's form became almost indiscernible.

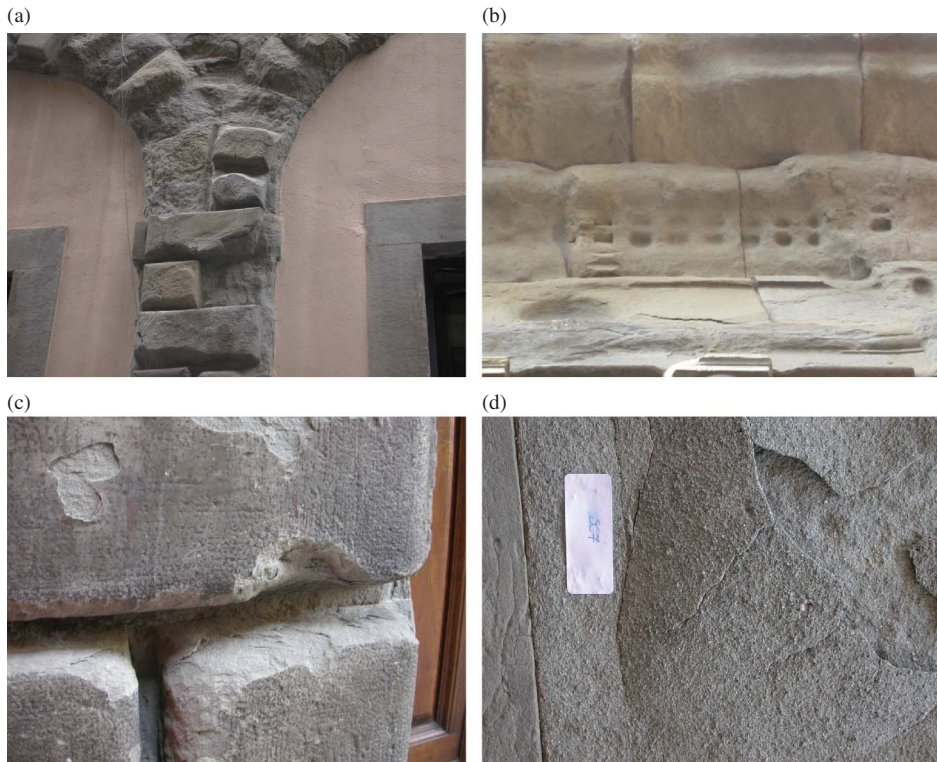
In the lower level of the facade black crusts were prevalent, especially in the area protected by percolating waters; under some crusts granular disintegration was also present. Exfoliation phenomena, detachment of portion of material and swelling were evident at the first floor level. A total loss of molding and of working traces was registered in some areas.

Other very dangerous decay phenomena were related to the presence of microcracking and to the detachment of the surfaces that can cause the fall of entire portions of blocks.

The frieze located above the second ledge became virtually unreadable, only some characters were clearly recognizable. At the top level decohesion, arenitization, and loss of material were recurrent phenomena, especially under the roof. At this level it was evident that in the 1974 intervention some columns have been replaced with new columns realized using similar sandstones, which remain in a good state of conservation.

Figure 3. Different decay phenomena at variable scales: erosion, scaling (a), decohesion and dissolution (b), flaking and scaling (c), swelling (d) (color figure available online).

The facade was then preconsolidated and the black crusts removed before treatment with selected commercial products. The preconsolidation was realized with ETS or injections of lime fluid mortar in the partially detached portions. The totally detached fragments were reattached with epoxy resins.

The black crusts were removed using a cellulose paste containing ammonium carbonate. In a second step, a biocide product was applied with a brush to remove the biological agents. The ancient plastering made of cement, iron springs and nails were removed, all the flows and micro-crackings were filled with a mortar composed of lime and stone powder. Some areas were selected to evaluate the conservation treatment on the basis of their accessibility after the removal of scaffolds.

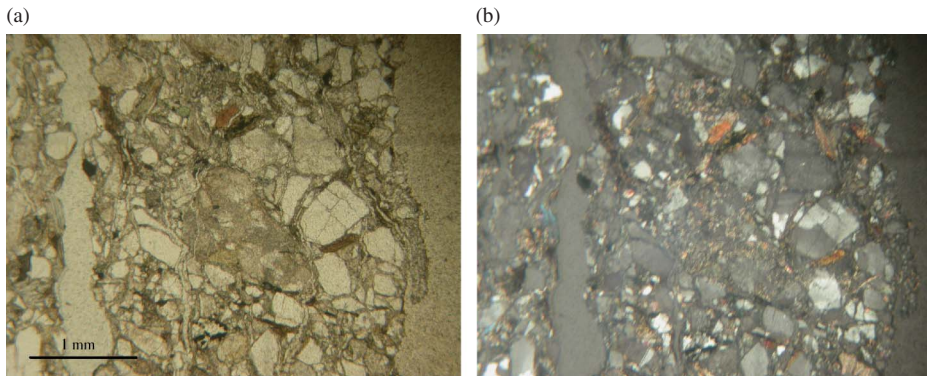
Optical microscope (OM) analyses allow the identification of the stone used for the facade as a sandstone constituted by a framework of fine grained quartz (mono and polycrystals), Kfeldspars, plagioclases, muscovite, biotite and metamorphic rock fragments. The matrix is predominantly clay, rarely calcite, and in the samples from the superficial portion ashlar is limited to a small amount. The plagioclase shows naturally alteration phenomena (sericitization). At microscopic level the incipient arenitization of the rock is evident, the clay matrix was almost all washed out (Figures 4a, 4b).

It is known that the decay of sandstones is specifically connected with the mineralogic, petrographic, and physical characteristics of material. The presence of water in the masonry determines the dissolution of calcium carbonate that subsequently, in the evaporation stage, reprecipitates on the surface, forming a less porous crust causing reduction of the permeability of the stone and affecting the detachment of material. Another cause of decay is linked to the presence of clay minerals in the matrix, causing the decohesion of material. The knowledge of the intrinsic characteristics of material and the extrinsic environmental conditions (presence of water, its circulation, its sources, presence of pollutants) is essential for planning a conservation intervention.

Figure 4. Thin section of a sample in which the detachment phenomenon is evident (polarized microscope: magnification 6,25X, $n // [a]$, $n \perp [b]$) (color figure available online).

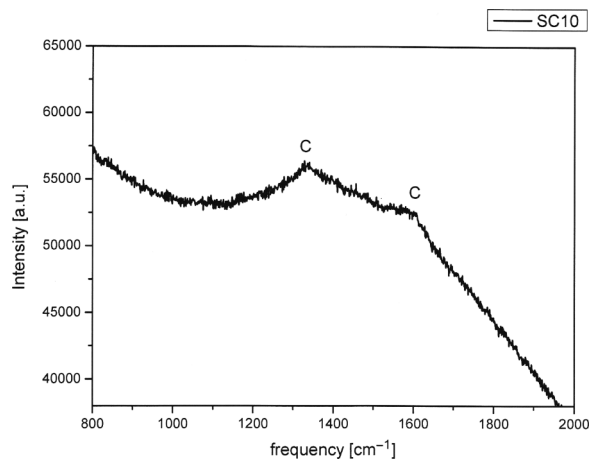
Figure 5. Micro-Raman spectra of a black crust (C= amorphous carbon).

The integrate FT-IR and micro-Raman analyses allow determination of the composition of powders and to exclude the presence of any treatment product, that over a span of 30 years disappeared at depth in the stone (Figures 5 and 6). The crusts were formed by gypsum and amorphous carbon. The physical tests performed with hydrostatic balance in the samples obtained from the fallen block, show a porosity accessible to water of 6.1% (± 0.8) and a water imbibitions coefficient (in weight) of 2.4% (± 0.3).

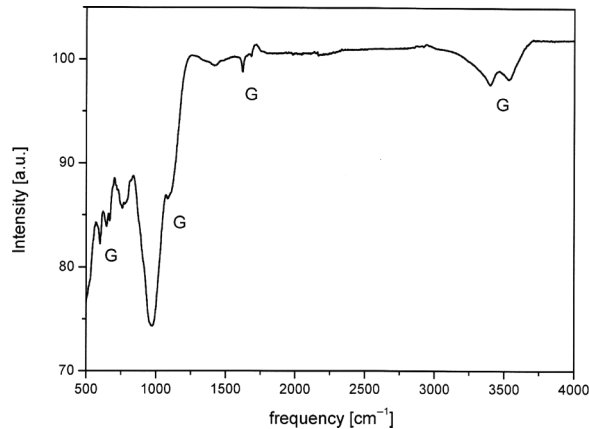
Figure 6. FT-IR spectra of a sandstone with a black crust (G=gypsum). The spectra reveal the presence of silicatic phases linked to the composition of sandstone.

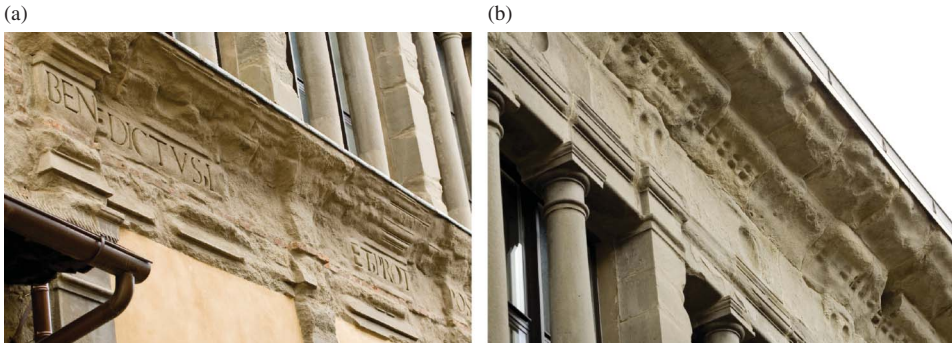
**Figure 8a, b.** Details of the Palace after restoration (color figure available online).

The data on the water absorption of the facade before and after the treatment with the selected commercial products are reported in Table 5. Some details of the restored facade are showed in Figures 8a and 8b. In order to verify the effectiveness of the treatment over the course of time, a monitoring schedule was instituted with the aim of establishing preventive maintenance, and so avoiding emergency interventions. The data collected during the first 14 months of monitoring of the water absorption of the facade, realized in four selected areas are reported in Table 6, while in Figure 9 the changes of L^* , a^* , b^* values are reported. No significant variations of colorimetric parameters are shown (in each case $\Delta E < 3$).
