Restoration of a sandstone facade: from the project to the monitoring

RESTORATION OF A SANDSTONE FACADE: FROM THE PROJECT TO THE MONITORING

Located on Via Guelfa in Cortona is the palace called “Cristofanello” (Figure 1), from its designer, originally a Laparelli property, then linked to Mancini Sernini and today the office of the Banca Popolare di Cortona. Designed and completed in the 1533 from Battista di Cristofanello of Bartolomeo di Senso (for others Giovanni Battista of Cristofano Infregliati, called Cristofanello), it was built using local sandstone (Mancini 1897). This stone has been subject to different decay phenomena, strictly connected with its mineralogic and petrographic properties. In the past, fragments of the facade fell and some conservation took place and was documented. The most important conservation treatment

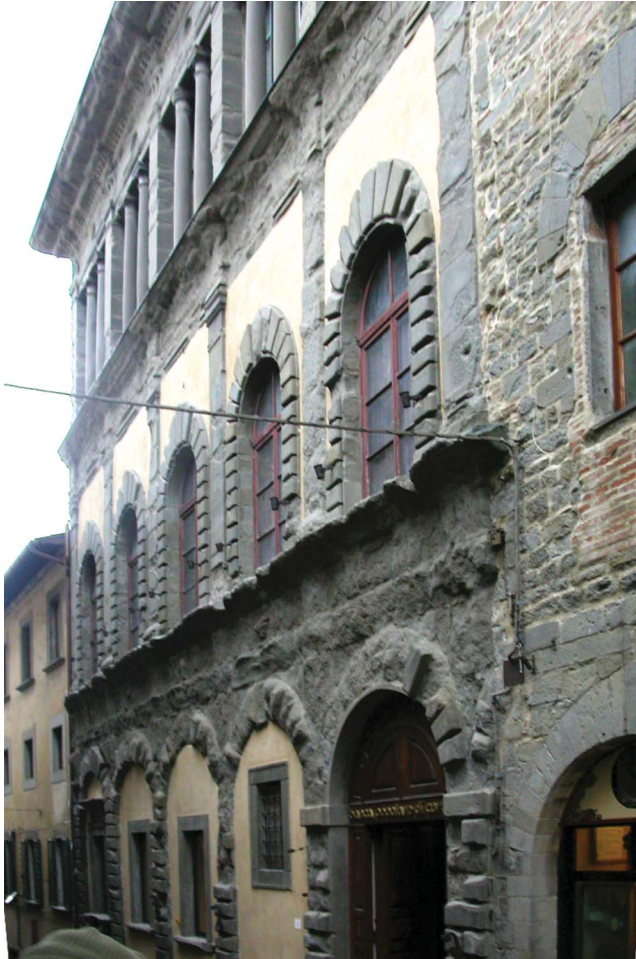
Figure 1. The facade of Cristofanello Palace (color figure available online).

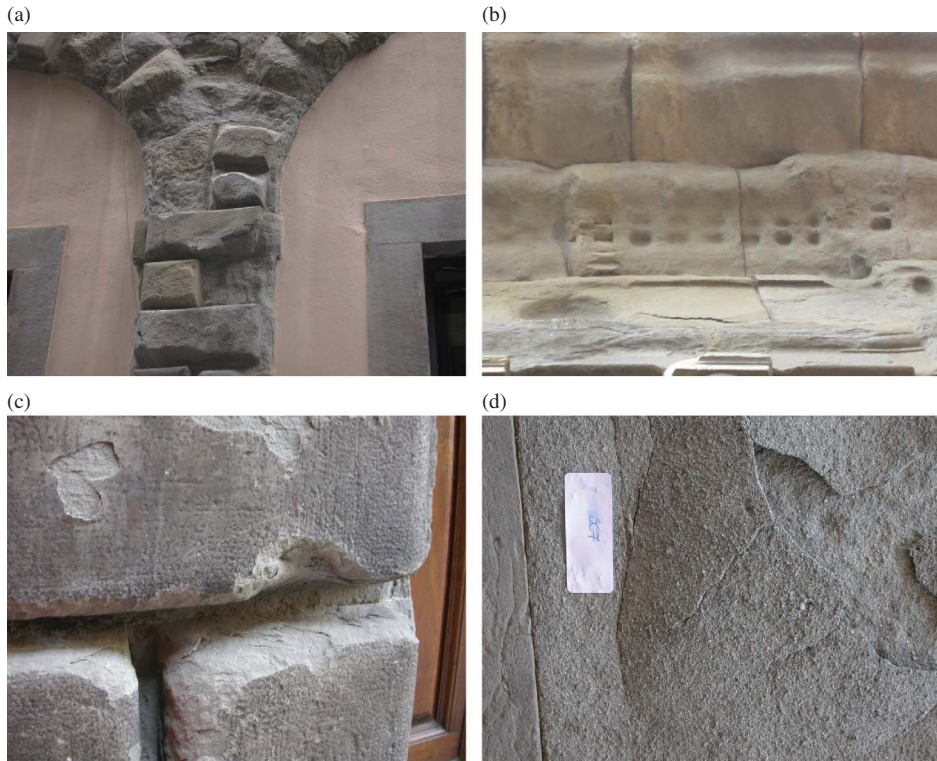
Initially a conservation status map of the building was prepared. This map confirmed that the conservation carried out in 1974 did not stop ongoing decay from penetrating water into the material, causing a loss of consistency of the building stone while the facade's form became almost indiscernible.

In the lower level of the facade black crusts were prevalent, especially in the area protected by percolating waters; under some crusts granular disintegration was also present. Exfoliation phenomena, detachment of portion of material and swelling were evident at the first floor level. A total loss of molding and of working traces was registered in some areas.

Other very dangerous decay phenomena were related to the presence of microcracking and to the detachment of the surfaces that can cause the fall of entire portions of blocks.

The frieze located above the second ledge became virtually unreadable, only some characters were clearly recognizable. At the top level decohesion, arenitization, and loss of material were recurrent phenomena, especially under the roof. At this level it was evident that in the 1974 intervention some columns have been replaced with new columns realized using similar sandstones, which remain in a good state of conservation.

Figure 3. Different decay phenomena at variable scales: erosion, scaling (a), decohesion and dissolution (b), flaking and scaling (c), swelling (d) (color figure available online).

The analyses confirm that local sandstone poorly cemented, with high capacity of water absorption, was used and the main decay phenomena were linked to the swelling of the clayey matrix. As a consequence some portions of the facade are subject to strong decohesion phenomena caused by the arenitization of sandstone. The applied commercial products (ETS and siloxane resin) show a good efficiency in the reduction of water absorption (the protective effectiveness evaluated in the laboratory after 7 months is 92%). Good colorimetric stability and maintenance of hydro repellence were also observed on the facade after 14 months of natural ageing.

The first stage of restoration at the Palace was the realization of a new system of roof gutters to avoid the presence on the facade of water percolating via the roof, because the presence of water is considered to be the main cause of the physical-mechanical decay.

The facade was then preconsolidated and the black crusts removed before treatment with selected commercial products. The preconsolidation was realized with ETS or injections of lime fluid mortar in the partially detached portions. The totally detached fragments were reattached with epoxy resins.

The black crusts were removed using a cellulose paste containing ammonium carbonate. In a second step, a biocide product was applied with a brush to remove the biological agents. The ancient plastering made of cement, iron springs and nails were removed, all the flows and micro-crackings were filled with a mortar composed of lime and stone powder. Some areas were selected to evaluate the conservation treatment on the basis of their accessibility after the removal of scaffolds.

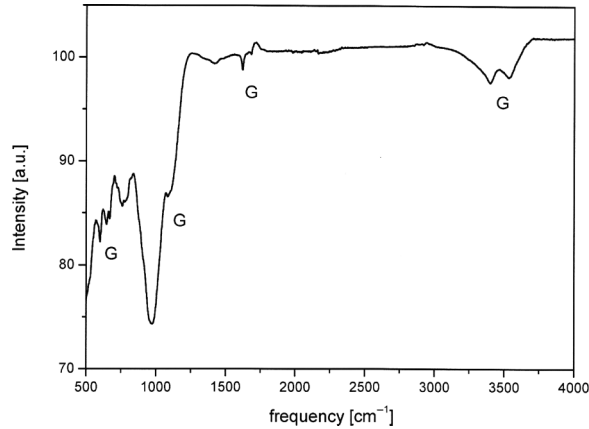
Figure 6. FT-IR spectra of a sandstone with a black crust (G=gypsum). The spectra reveal the presence of silicatic phases linked to the composition of sandstone.

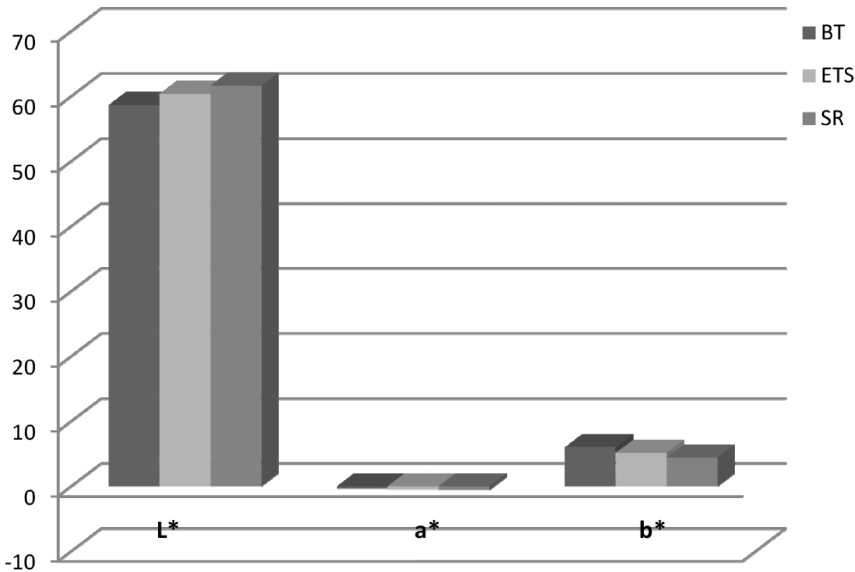
**Figure 7.** L*, a*, b* values of test samples before treatment and after treatment with ethyl silicates and siloxane resin.

The change of color was tested after the application of the two treatments. In Figure 7, the values of L*, a* and b* are reported, before treatment (BT) and after treatments with ETS and SR. The ΔE values are, respectively, 1.92 after ETS treatment, and 1.46 after the SR treatment.

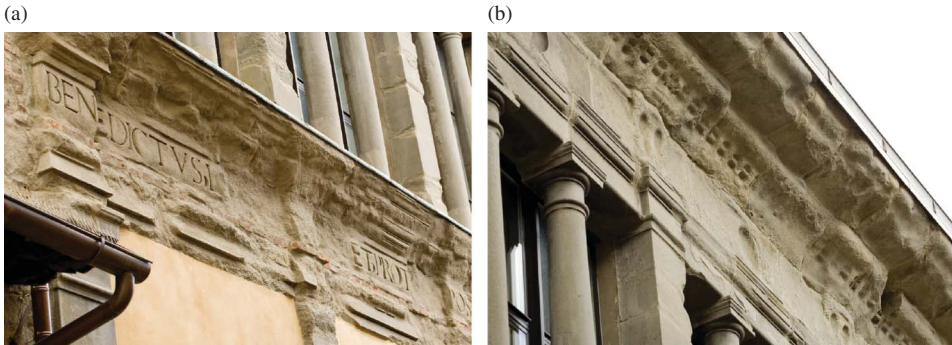
**Figure 8a, b.** Details of the Palace after restoration (color figure available online).

The data on the water absorption of the facade before and after the treatment with the selected commercial products are reported in Table 5. Some details of the restored facade are showed in Figures 8a and 8b. In order to verify the effectiveness of the treatment over the course of time, a monitoring schedule was instituted with the aim of establishing preventive maintenance, and so avoiding emergency interventions. The data collected during the first 14 months of monitoring of the water absorption of the facade, realized in four selected areas are reported in Table 6, while in Figure 9 the changes of L^* , a^* , b^* values are reported. No significant variations of colorimetric parameters are shown (in each case $\Delta E < 3$).
