Restoration of a Sandstone Facade: From the Project to the Monitoring

RESTORATION OF A SANDSTONE FACADE: FROM THE PROJECT TO THE MONITORING

This work describes the restoration of a facade of an historical building, constructed from typical local sandstone, characterized by different subsequent decay phenomena and subjected in the past to a conservation treatment. The sandstone was characterized, the quarry of provenance was identified, and the causes of the different decay phenomena were investigated. Potential commercial products for the restoration were tested first in the laboratory, then in situ selected products were applied and the effectiveness of treatment was subsequently monitored. Analytical methodologies such as x-ray diffraction (XRD), observation of thin sections under polarized microscope (OM), Fourier transform infrared spectroscopy (FT-IR), micro-Raman spectroscopy, and water absorption tests were employed in the laboratory, while nondestructive tests, performed with portable instrumentation such as colorimeter and sponge contact, were carried out in situ.

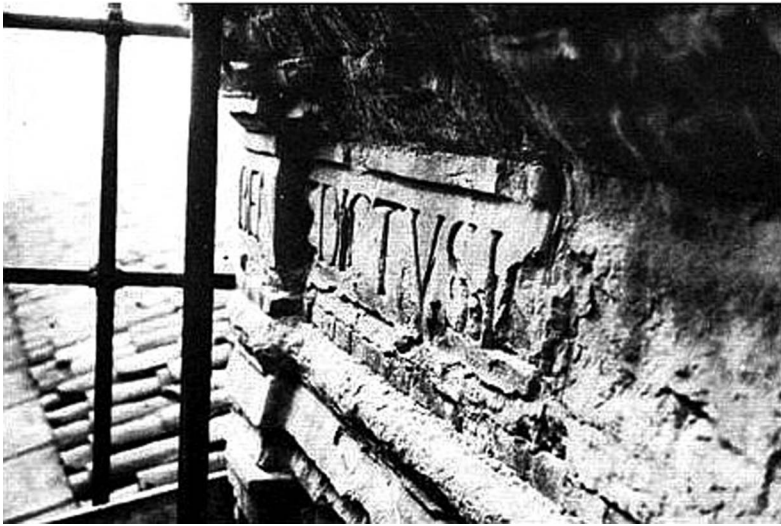
was performed in 1974. At that time, the detachment of stone and the loss of consistency of the building masonry not only obligated a restoration of the facade but also required a static consolidation. Some documents of that period report the consolidation of the building to its full height. This consolidation of the facade was very complex: less stable portions, such as columns and angular frames, were replaced; tiling was carried out on architectural elements characterized by the loss of shape, and a sealing of fissures, termed *mantelline*, were placed to guarantee the outflow of water. A consolidation product as well as a waterproofing treatment was applied on the facade, and, in order to bind some partially detached portions of stone, many holes were drilled to insert adhesive resins (Figure 2). This operation, very coherent for that time, was not able to prevent the subsequent decay; in fact, the detachment of the material with the fall of fragments started again.

Figure 2. The state of conservation of a portion of facade in 1974.

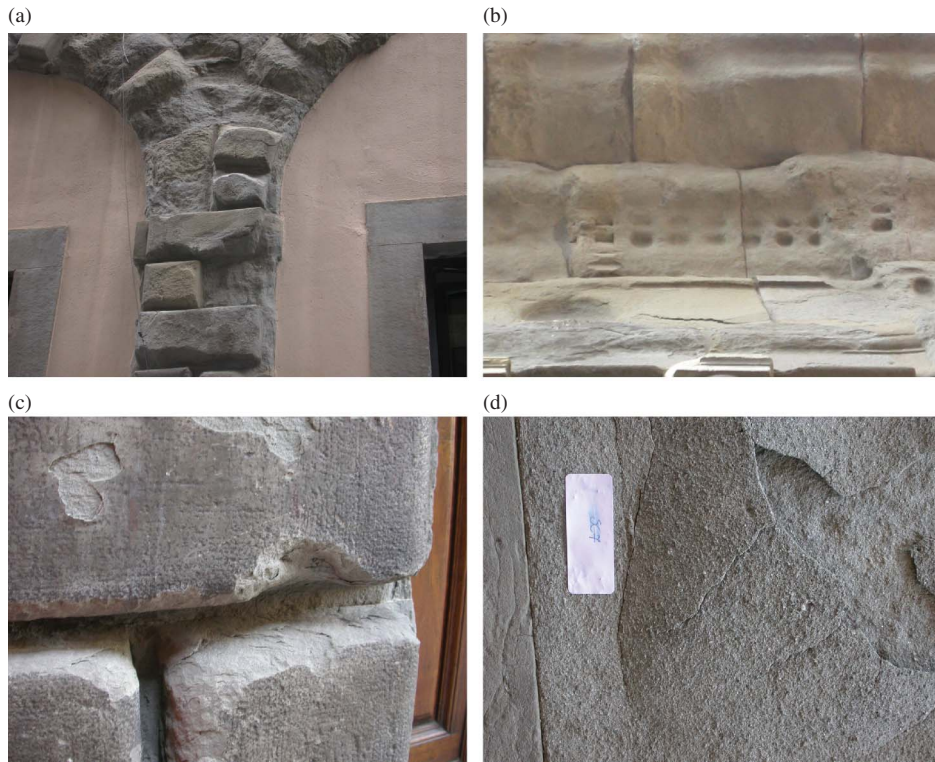
In the lower level of the facade black crusts were prevalent, especially in the area protected by percolating waters; under some crusts granular disintegration was also present. Exfoliation phenomena, detachment of portion of material and swelling were evident at the first floor level. A total loss of molding and of working traces was registered in some areas.

Other very dangerous decay phenomena were related to the presence of microcracking and to the detachment of the surfaces that can cause the fall of entire portions of blocks.

The frieze located above the second ledge became virtually unreadable, only some characters were clearly recognizable. At the top level decohesion, arenitization, and loss of material were recurrent phenomena, especially under the roof. At this level it was evident that in the 1974 intervention some columns have been replaced with new columns realized using similar sandstones, which remain in a good state of conservation.

Some decay phenomena are shown in the Figures 3a–d.

Figure 3. Different decay phenomena at variable scales: erosion, scaling (a), decohesion and dissolution (b), flaking and scaling (c), swelling (d) (color figure available online).

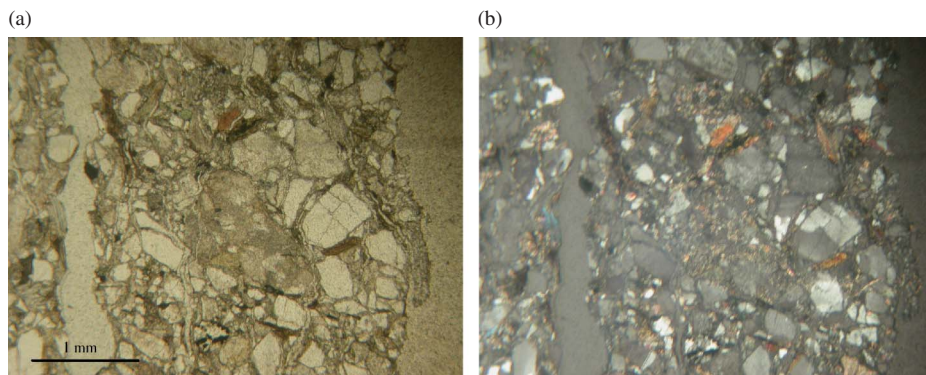
Optical microscope (OM) analyses allow the identification of the stone used for the facade as a sandstone constituted by a framework of fine grained quartz (mono and polycrystals), Kfeldspars, plagioclases, muscovite, biotite and metamorphic rock fragments. The matrix is predominantly clay, rarely calcite, and in the samples from the superficial portion ashlar is limited to a small amount. The plagioclase shows naturally alteration phenomena (sericitization). At microscopic level the incipient arenitization of the rock is evident, the clay matrix was almost all washed out (Figures 4a, 4b).

It is known that the decay of sandstones is specifically connected with the mineralogic, petrographic, and physical characteristics of material. The presence of water in the masonry determines the dissolution of calcium carbonate that subsequently, in the evaporation stage, reprecipitates on the surface, forming a less porous crust causing reduction of the permeability of the stone and affecting the detachment of material. Another cause of decay is linked to the presence of clay minerals in the matrix, causing the decohesion of material. The knowledge of the intrinsic characteristics of material and the extrinsic environmental conditions (presence of water, its circulation, its sources, presence of pollutants) is essential for planning a conservation intervention.

Figure 4. Thin section of a sample in which the detachment phenomenon is evident (polarized microscope: magnification 6,25X, $n // [a]$, $n \perp [b]$) (color figure available online).

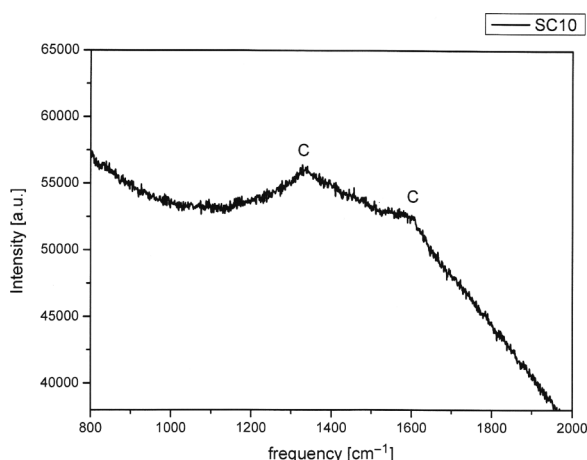
Figure 5. Micro-Raman spectra of a black crust (C= amorphous carbon).

The integrate FT-IR and micro-Raman analyses allow determination of the composition of powders and to exclude the presence of any treatment product, that over a span of 30 years disappeared at depth in the stone (Figures 5 and 6). The crusts were formed by gypsum and amorphous carbon. The physical tests performed with hydrostatic balance in the samples obtained from the fallen block, show a porosity accessible to water of 6.1% (± 0.8) and a water imbibitions coefficient (in weight) of 2.4% (± 0.3).

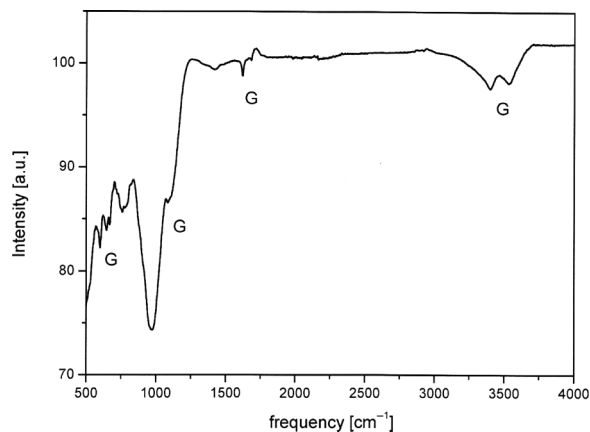
Figure 6. FT-IR spectra of a sandstone with a black crust (G=gypsum). The spectra reveal the presence of silicatic phases linked to the composition of sandstone.

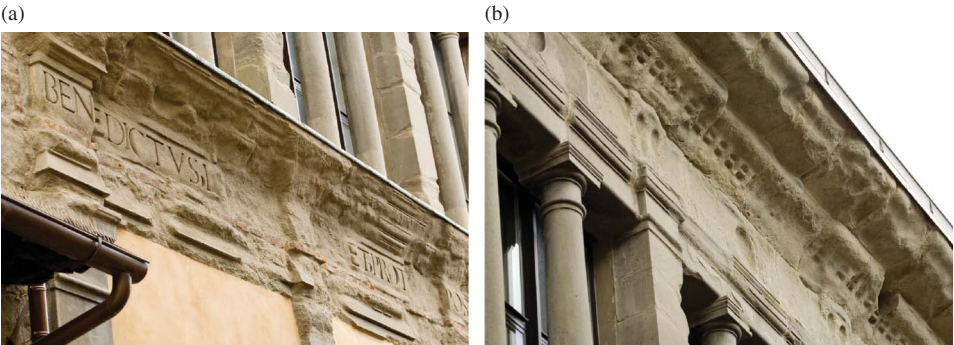
Figure 8a, b. Details of the Palace after restoration (color figure available online).

The data on the water absorption of the facade before and after the treatment with the selected commercial products are reported in Table 5. Some details of the restored facade are showed in Figures 8a and 8b. In order to verify the effectiveness of the treatment over the course of time, a monitoring schedule was instituted with the aim of establishing preventive maintenance, and so avoiding emergency interventions. The data collected during the first 14 months of monitoring of the water absorption of the facade, realized in four selected areas are reported in Table 6, while in Figure 9 the changes of L^* , a^* , b^* values are reported. No significant variations of colorimetric parameters are shown (in each case $\Delta E < 3$).

The facade was then preconsolidated and the black crusts removed before treatment with selected commercial products. The preconsolidation was realized with ETS or injections of lime fluid mortar in the partially detached portions. The totally detached fragments were reattached with epoxy resins.

The black crusts were removed using a cellulose paste containing ammonium carbonate. In a second step, a biocide product was applied with a brush to remove the biological agents. The ancient plastering made of cement, iron springs and nails were removed, all the flows and micro-crackings were filled with a mortar composed of lime and stone powder. Some areas were selected to evaluate the conservation treatment on the basis of their accessibility after the removal of scaffolds.

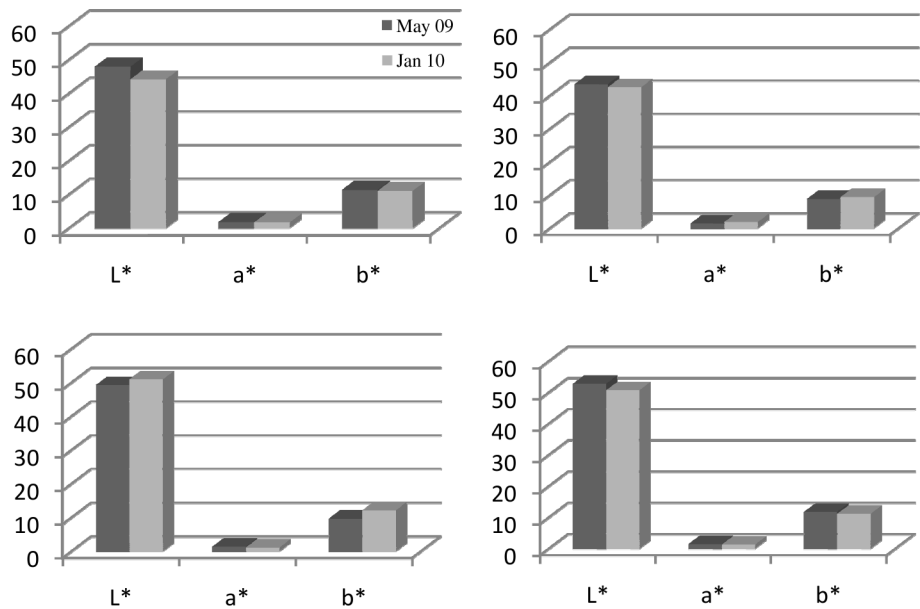
Figure 9. L*, a*, b* values in the four areas detected after 6 months (May 2009) and 14 months (January 2010) from the treatment.
