RESTORATION OF A SANDSTONE FACADE: FROM THE PROJECT TO THE MONITORING

This work describes the restoration of a facade of an historical building, constructed from typical local sandstone, characterized by different subsequent decay phenomena and subjected in the past to a conservation treatment. The sandstone was characterized, the quarry of provenance was identified, and the causes of the different decay phenomena were investigated. Potential commercial products for the restoration were tested first in the laboratory, then in situ selected products were applied and the effectiveness of treatment was subsequently monitored. Analytical methodologies such as x-ray diffraction (XRD), observation of thin sections under polarized microscope (OM), Fourier transform infrared spectroscopy (FT-IR), micro-Raman spectroscopy, and water absorption tests were employed in the laboratory, while nondestructive tests, performed with portable instrumentation such as colorimeter and sponge contact, were carried out in situ.

Located on Via Guelfa in Cortona is the palace called “Cristofanello” (Figure 1), from its designer, originally a Laparelli property, then linked to Mancini Sernini and today the

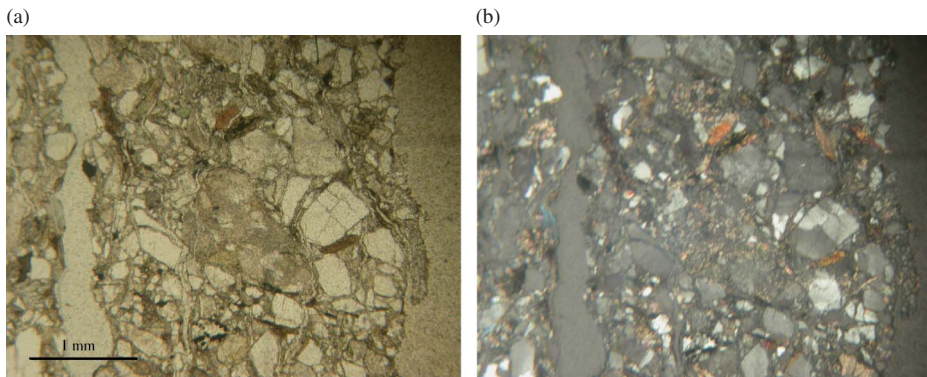
Optical microscope (OM) analyses allow the identification of the stone used for the facade as a sandstone constituted by a framework of fine grained quartz (mono and polycrystals), Kfeldspars, plagioclases, muscovite, biotite and metamorphic rock fragments. The matrix is predominantly clay, rarely calcite, and in the samples from the superficial portion ashlar is limited to a small amount. The plagioclase shows naturally alteration phenomena (sericitization). At microscopic level the incipient arenitization of the rock is evident, the clay matrix was almost all washed out (Figures 4a, 4b).

Figure 4. Thin section of a sample in which the detachment phenomenon is evident (polarized microscope: magnification 6,25X, $n // [a]$, $n \perp [b]$) (color figure available online).

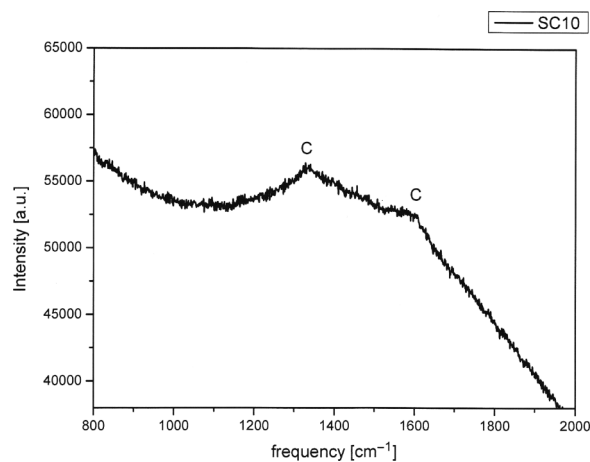
Figure 5. Micro-Raman spectra of a black crust (C= amorphous carbon).

The integrate FT-IR and micro-Raman analyses allow determination of the composition of powders and to exclude the presence of any treatment product, that over a span of 30 years disappeared at depth in the stone (Figures 5 and 6). The crusts were formed by gypsum and amorphous carbon. The physical tests performed with hydrostatic balance in the samples obtained from the fallen block, show a porosity accessible to water of 6.1% (± 0.8) and a water imbibitions coefficient (in weight) of 2.4% (± 0.3).
