## COST Timber Bridge Conference – CTBC 2014

# State of conservation of unprotected timber footbridges in Central/Northern Italy

Alberto Cavalli<sup>1</sup>, Marco Esposito<sup>2</sup>, Marco Togni<sup>3</sup>

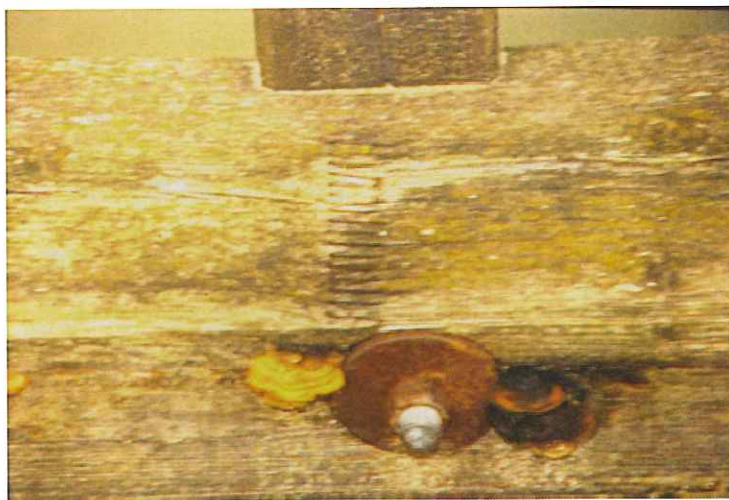
Figure 1: Timber-bridge n. 9. Fruiting bodies of brown-rot fungi, close to moisture trap (hole, bolt and washer).

5 bridges (1, 3, 6, 9, 10 - 42% of the total) were already showing a decay by brown-rot fungi; concerning the diffusion on timber members, decay was localised only in some specific timber members in bridges 1, 6 and 10, but with important local wood degradation and some easily visible fruiting bodies (Table 2, decay column, bridges n. 1, 6 and 10), showing the good development of the alteration organisms, while in bridges 3 and 9 the degradation was very severe and diffuse. All the 7 remaining footbridges were recent (R in Table 1) and so no sign of decayed wood was present. Nevertheless it has to be noted that the low durability of the wood of the beams (Norway spruce and silver fir are in the Durability class n. 4= low durable [5]) to the fungi alterations, expose them to high risk of decay: we can hypothesize that the decay will appear soon.

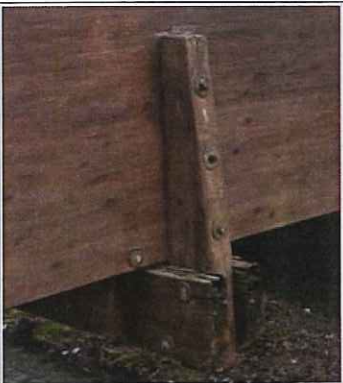
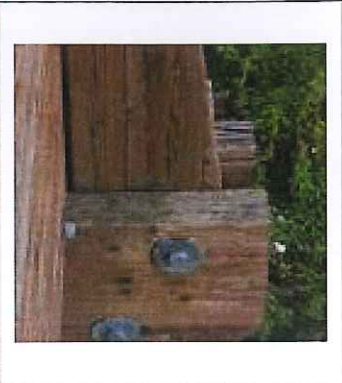
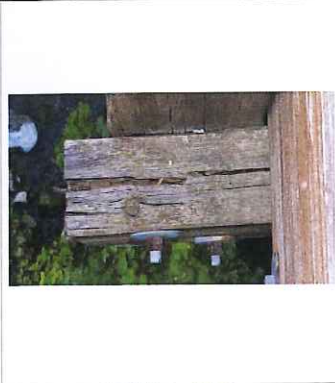
Table 2 – Exemplification of the main problems discovered on timber footbridges and relative images. Selected bridges characterised by incoming decay.

N.	<i>uncovered horizontal surfaces in load-bearing glulam com- ponents</i>	<i>moisture traps</i>	<i>decay: diffuse in 3 e 9 localised in 1, 6 and 10</i>
1
