5th International Congress
on

*“Science and Technology for the Safeguard of
Cultural Heritage in the Mediterranean Basin”*

THE CHESTNUT TIMBER STRUCTURE OF THE ROOF IN SANTA MARIA NUOVA (VITERBO, ITALY): ON-SITE INSPECTION, DATING, ASSESSMENT AND RESTORATION CRITERIA.

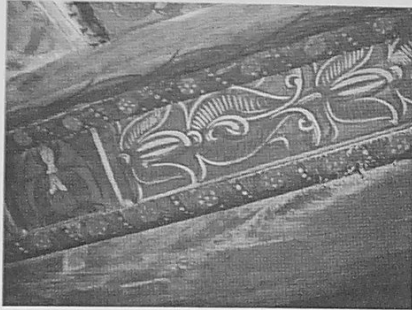
Santa Maria Nuova has one of the few painted roof on chestnut wood known in Italy. The decoration is on elements which have a structural function like purlins and joists so as on small planks (fig. 1) and the frame which encloses the fired clay tiles. The trusses are not painted. Red, green, white and black pigments are to be found in the wooden elements, their chemical

Fig. 1 detail of the painted roof.

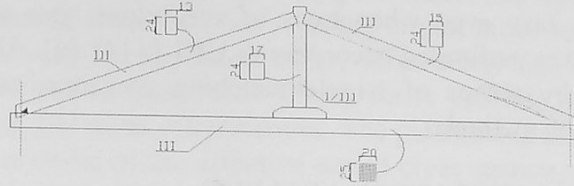
Restoration criteria were pointed out in order to lead the choice towards more reversible and compatible operations which are also more respectful of original wood. According to the Italian Standard knots, slope of the grain, ring shake presence were assessed and located on the structure so as to assign each element to the visual grade.

Fig. 2. Example of the schematic representation of chestnut 4th truss. Each timber member is graded (grade I, II, III) and the effective sound cross section is reported (data in cm).

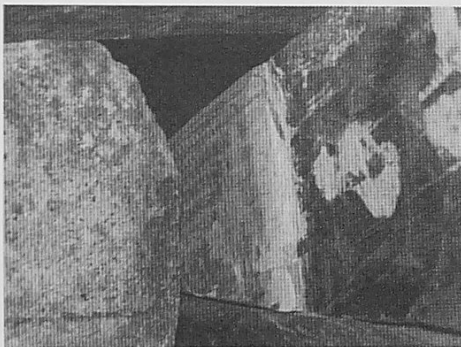
Sometimes rot decay has been found in the top- and bottom-chords in the portion inside the wall: possible high moisture, and low oxygen content, during the life period of the roof, have promoted rot decay. In such situation there is the possibility that the heel of the tie beam, which prevent the top-chord slip, is totally destroyed and a roof failure is resulting.

Fig. 3 new wooden part in the rafter of truss 1.

The tie beams of truss 1, 8 and 9 were restored using new wooden portion (fig. 3), using a more friendly and reversible restoration system respect to the original restoration plan which provided only for the use of epoxy resins. Then epoxy resins were used only when higher structural performances of timber elements were necessary according to the restoration design of the architect.

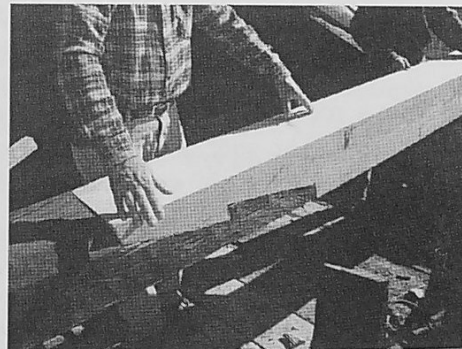
Fig. 4. The typical new wooden part with the shape "Dardo di Giove"

Some wood repaired ends, structurally connected, like "dardo di Giove" (fig. 4) are well known and assessed in restoration of wood load bearing structures. The restorers proposed also some interesting not common solutions: e.g. new beam portion, connected through a "swallow-tailed" joint, with bolts and resin; it seems to have all the characteristic to solve the possible tension value, expected in the tie beams. Further laboratory tests are planned to verify the effectiveness of the new joint proposed.
