# STABILITY ANALYSIS FOR THE ROCK BASEMENT OF THE CASTILLO DE LOS TRES REYES DEL MORRO, LA HABANA, CUBA

## Abstract

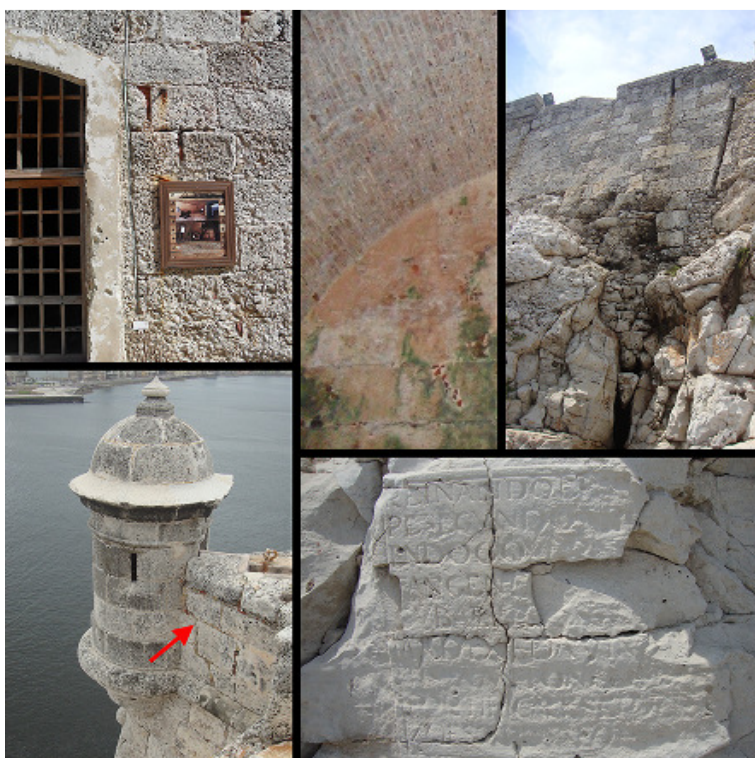
The complex is preserved intact although the state of environmental, material and structural degradation present some emergencies of no small importance (Fig. 3). The restoration at the end of the last century, although started with very different intentions, involving the entire area of the Military Historical Park, basically allowed it to be sufficiently usable, almost throughout, for visits by the public. Unfortunately, the restoration was never followed up, and combined with the lack of funds for maintenance, the situation has not improved. Only recently, since 2008, has the CMHM resumed restoration work, both at the Cabaña and the Morro but, however, has only managed to intervene with specific operations targeted to certain areas and lacks a comprehensive plan of the work to be done.

The rooms of the castle suffer greatly from the presence of moisture with a high salt concentration, which attacks the surfaces and materials causing widespread erosion of stonework, forming biological patinas, disintegration and detachment of the surface layers such as plaster. In many indoor environments, especially the less ventilated ones, there is the formation of saline concretions in the form of stalactites and stalagmites. The erosion is then accentuated by being highly exposed to strong winds and storm surges produced by cyclones, which cause the waves to violently crash onto the outer curtain wall and even to penetrate the complex. Just think of the conditions in which its inscriptions find themselves, those that attest to the laying of the foundation stone and among the oldest on the island. Their long term conservation is in absolute danger with sea water slowly eroding the relief, especially on the right part, where it is already compromised in many areas. In recent years, the conditions have been getting rapidly worse and yet no remedies for this problem have been put in place. To this situation can be added the lack of maintenance and safety of the spaces, where machines and bare wires are often found and there is frequently a lack of adequate protection for visitors. Furthermore, the monument and its spaces are poorly appreciated, starting from the lack of connections to the city. From a static point of view emergencies that deserve immediate attention concern the rocky base of the cliff, on which the castle rests, which presents a series of fractures along almost the entire perimeter as shown by a geological study carried out in 1989, which has never been followed up by a consolidation project or specific interventions. One of these fissures, to the side of the Estrella battery and below the Morillo point, has an opening of about one metre that goes inwards and stops before the beginning of the fortress' wall, which for now shows no visible instability. However, the depth of the crack together with the effect of the disintegrating action of sea could lead to serious problems of the complex's stability. Another concern is the condition of the sentry post at the summit of the Santiago bastion, the only part of the complex to keep the original eighteenth-century reconstructions and which so far has resisted damage or collapse, unlike the other three in the complex. Its wall has some fractures where it connects to the parapet: it can be seen that the fracture passes right through, from inside to outside to the side of the entrance but there is an important problem also on the other side, while the attachment of the sentry box to the base is not particularly unstable. This situation places the structure in serious danger as although the upper part, formed by the perimeter walls and dome, is firmly attached to the base, it is without - or at least limited in- the

necessary horizontal connections, that would ensure an adequate bond to the masonry. This situation can lead to the formation of an ideal joint at the base of the attachment that, under the weight of its own cantilever volume, as well as the horizontal action of the wind and rain produced by cyclones, could overturn the element itself, and lead to its collapse. The situation calls for urgent action, not just to safeguard a valuable element of the fortress, uniquely original in its kind, but also to avert serious injury to people. Finally, the presence of some fractures in the vaulted brick tunnels of the central building raise concerns for their size and because the problem has not yet been analysed with due attention.

*Figure 3 – Some current emergencies of degradation by various causes: environmental, material and structural deterioration*

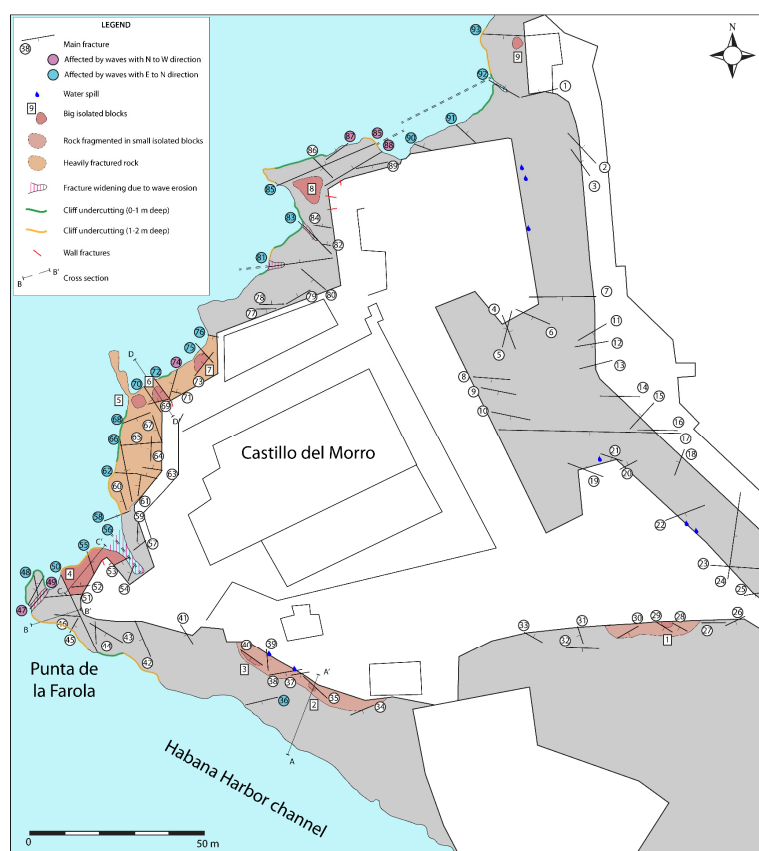
Figure 4 – Map reporting the main geological concerns of the Morro Castle promontory. Modified after ENIA, 1989.

Regarding the geotechnical concerns, the area can be divided in three sectors, according to the triangular shape of the promontory: 1) the eastern side, corresponding to the ditch area; 2) the southern side, facing to the Habana Harbor channel; 3) the northwestern side, facing to the open sea.

In Sector 1 (delimited by fractures #1 and #26) the lithological contact between the Vedado and Morro formations is exposed. This is mainly a plane area where, besides being fractured, the rock is also widely affected by karst phenomena up to an elevation of 6 m a.s.l. Both in the northern and southern parts of the ditch there are several fractures from which water spills. This is to be considered to plan the interventions for the reinforcement of the rock mass. In Sector 2 (bounded by fractures #26 and #48), where the beds are arranged anti-dip slope, there are some significant fractures that rise up to the base of the walls and need to be constantly monitored. This is the case of fracture #41, which was reported as possibly dangerous for the walls' stability by different authors (ENIA, 1989; report of Ing. Felix de la Noval Ravelo, 1997) and seems to have its natural prosecution on the other side of the promontory, with fracture #56. This sector is also characterized by the presence of two areas where numerous small isolated blocks, produced by rock fragmentation, concentrate: one in the eastern margin of the sector and one in its middle part. Besides these blocks of small dimensions, these areas present the occurrence of larger ones in critical positions (e.g. block n° 2 in Fig. 2). In proximity of fractures #37 and #38 water spills are present.

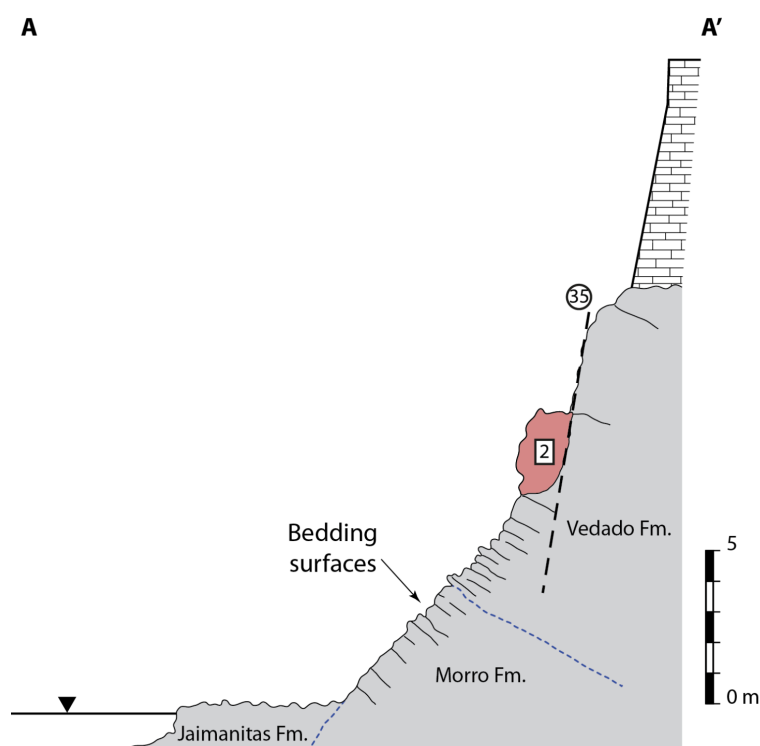
Figure 5 – Section A-A' along the southern margin of the promontory. Vertical and horizontal scales do not coincide, as the former is exaggerated. Modified after ENIA, 1989.

Moving towards the western margin of this sector, corresponding to the southern side of the lighthouse tip (Punta de la Farola), the slope presents some significant undercutting of the cliff due to marine erosion (ENIA, 1989), as shown in Fig. 3, and fracturing becomes more intense. These features are

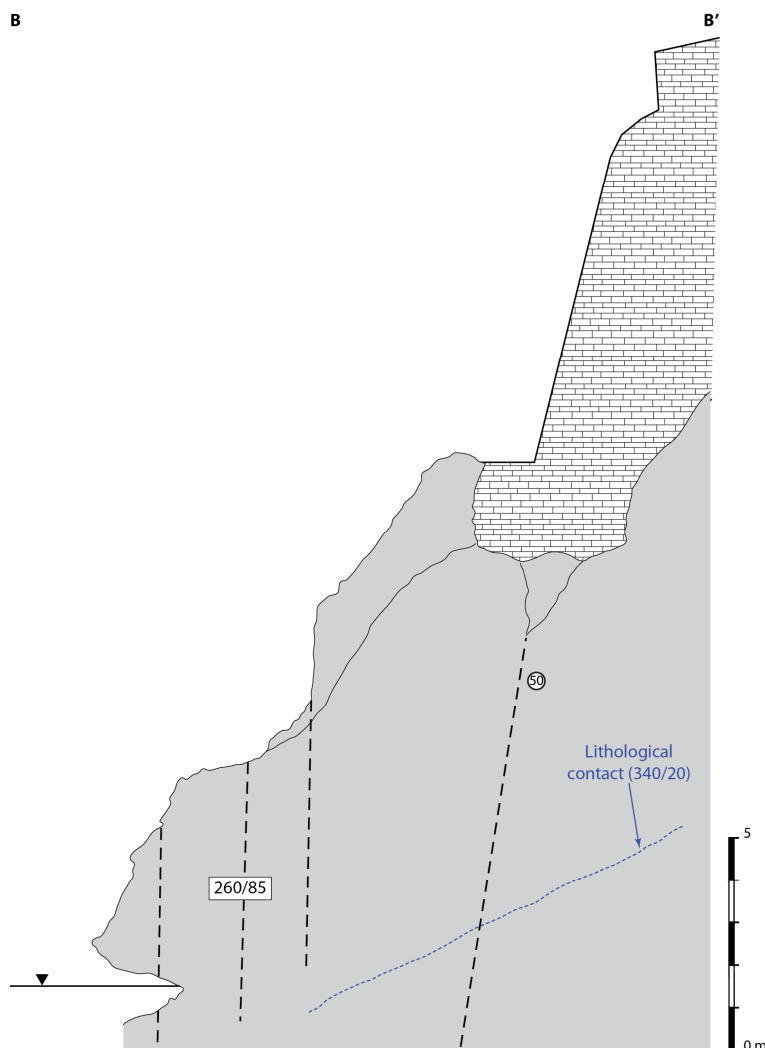
probably related to the increasing strength of the wave action on the cliff, as long as it approaches the open sea. Sector 3 (comprised between fractures #48 and #93) appears to be that most affected by fracturing and marine erosion, likely due to its complete exposition to wave action. Most of the cliff is affected by undercutting and a relevant number of fractures extending to the sea level are significantly widened by erosional phenomena (Fig. 4). A huge block (n° 4, see Fig. 4), delimited by NW-SE oriented discontinuities (#50 and #56) on the sides and by a lithological contact below, rests in a critical position just below the walls. ENIA (1989) calculated that, despite its location, even storm events with a return period of 100 years (impact pressure of 0.14 MPa) couldn't put this block in unstable conditions. Nevertheless the walls resting just above this block present some fractures that need to be monitored. The portion of the slope comprised between fractures #58 and #76 is that one showing the most intense fracturing, which is mainly N-S and W-E oriented and gives to the slope itself a block structure. Many of the fractures are gaping and extend from the sea level to the foot of the walls. Some large size isolated blocks are also present and some of them appear in critical position, e.g. block n°6 (Fig. 5). Also in this case the wall resting on the slope behind the block shows a fracture.

Figure 6 – Section B-B' crossing the slope of Punta de la Farola. Vertical and horizontal scales do not coincide, as the former is exaggerated. Modified after ENIA, 1989.

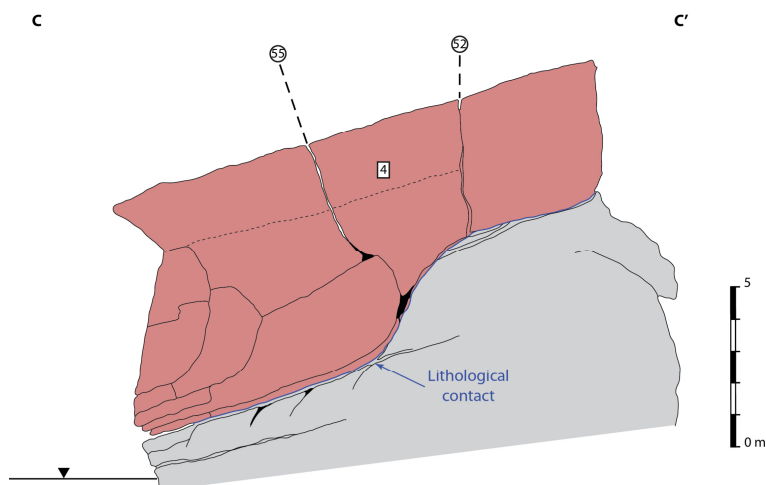
The northern part of Sector 3 (north of fracture #76) is affected by a minor number of fractures and presents many erosional and karst phenomena, such as surficial cavities of different size. Though fractures are persistent and wide.

Figure 7 – Section C-CB' parallel to the northern side of Punta de la Farola. Vertical and horizontal scales do not coincide, as the former is exaggerated. Modified after ENIA, 1989.
