The restoration of San Paolo Church in Pisa: geotechnical aspects

Nunziante Squeglia,* Stefano Stacul,* Elena Diddi**

Summary

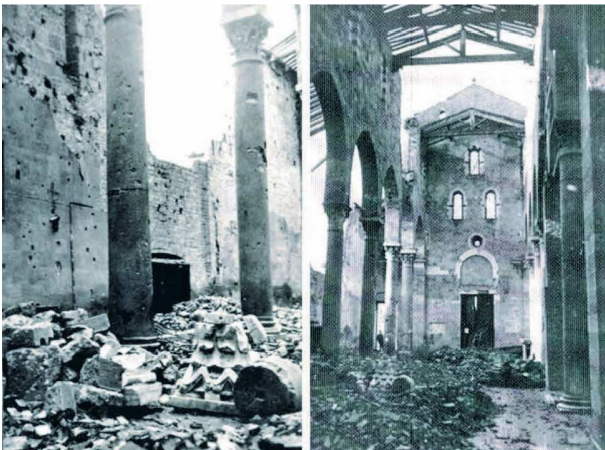
On August 31st, 1943 the southern side of Pisa was intensely bombed and the Church was heavily damaged (Fig. 2), with the destruction of the wooden roof and the partial collapse of the southern wall. The reconstruction, which lasted 16 years, took place between 1944 and 1960.

Fig. 2 – Damages due to bombing of 1943.

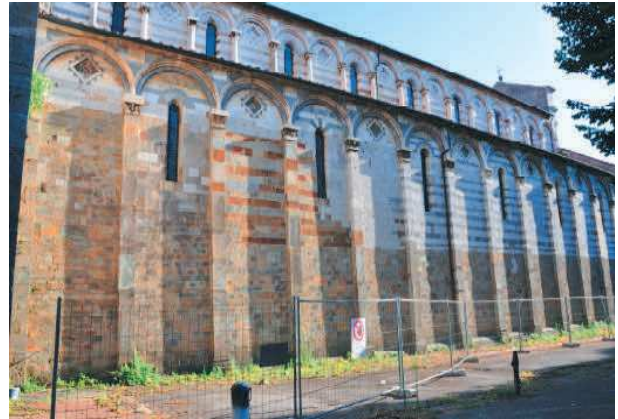
Fig. 3 – North side of the Church.

thern wall (Fig. 3) is different from the southern one (Fig. 4) thanks to the monastery that bordered the Church. The layout of the foundations was also influenced by the different phases of construction; as a matter of fact, the different portions of the Church have a different geometry of foundation. It is well known that the southern wall is weaker than the northern one and poorly arranged not only in the reconstructed portion, but also in the original one.

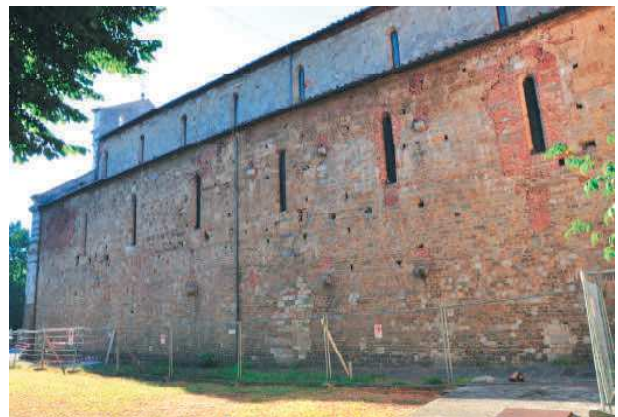
Fig. 4 – South side of the Church.
