Assessment of landslide-induced damage to structures: the Agnone landslide case study (southern Italy)

Keywords Landslides · Structurally complex formations · Damage classification · Buildings · Agnone

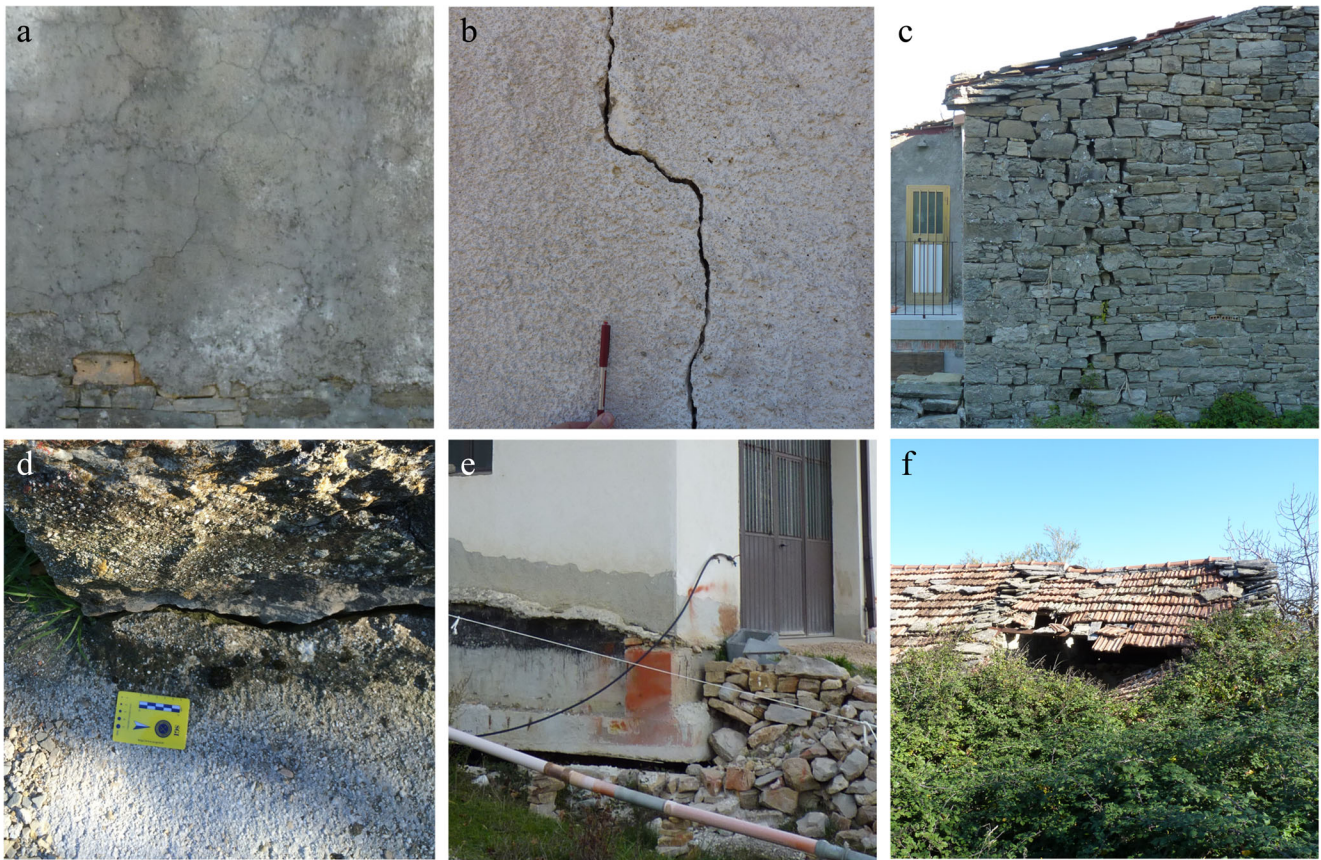
- hairline cracks (Fig. 7a);
- open fractures on external walls (Fig. 7b and c);
- ruptures between walls and external pavements (Fig. 7d and e); and
- in rare cases, roof collapses (Fig. 7f).

Fig. 7 Damage identified on buildings. a) Hairline crack in the plaster of a masonry wall; b) open crack, approximately 1.0–1.2 cm wide, in a wall of a reinforced concrete building; c) open crack, approximately 4 cm wide, in a wall of a masonry building; d) open crack between a wall

and the pavement in a masonry building; e) open crack, more than 10 cm wide, between a wall and the ground surface of a reinforced concrete building; f) collapsed roof in a masonry building

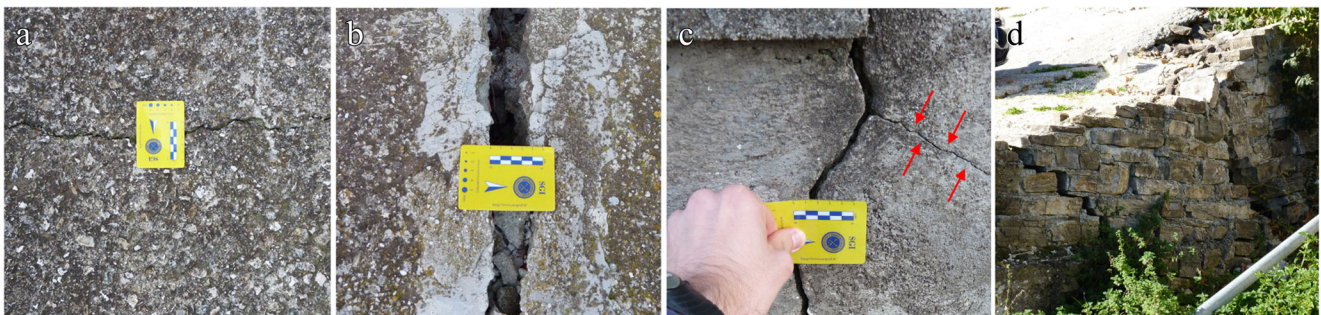
- hairline cracks (Fig. 8a and the red arrow in 8c) and
- open cracks (Fig. 8b–d).

Fig. 8 Damage recognized on concrete slabs and walls. a) Hairline crack in pavement; b) open rupture in a slab; c) hairline (red arrows) and open fractures in a concrete wall; d) damage to a masonry wall

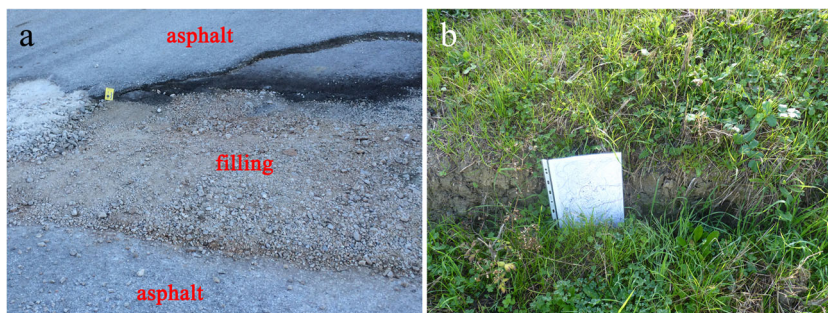
Cracks recognized on the ground (Fig. 9b) or on pavements (Fig. 9a) were plotted on a topographic map and photographed as well as spatially identified with a GPS tracker.

Fig. 9 Cracks located close to the landslide on (a) the pavement of a road and (b) the ground surface. In photograph (b), a vertical slip is recognized

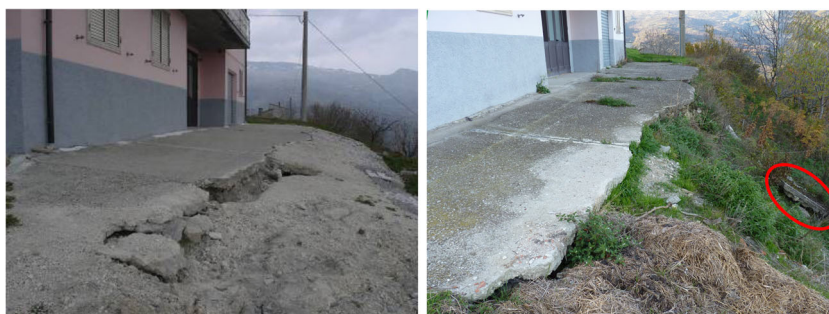
An example can be made taking into account a sidewalk made of reinforced concrete (Fig. 10) that is located in the present crown of the landslide that currently shows an important open crack pattern with detachment of a portion (Fig. 10b). In recent years, the crown of the landslide has retrogressed, widening its boundaries and increasing its dimensions, as reflected in the opening of new tension cracks and the collapse of a part of the sidewalk bordering a building that does not show severe damage to the external façades.

Fig. 10 Evolution between 2003 (left) and 2015 (right) of a reinforced concrete perimeter sidewalk of a building located on the crown of the landslide

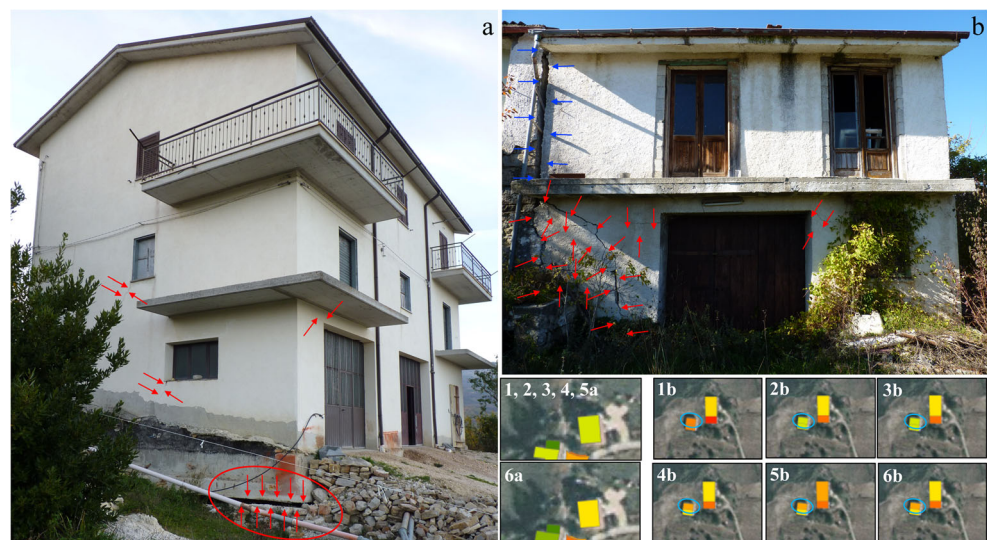
The second building is located on the left flank of the landslide and is formerly connected to another adjacent structure but is now separated by a gaping construction joint (blue arrows Fig. 12b). The building is currently abandoned, the damage to the structure includes relevant (e.g., see the red arrows in Fig. 12b) and open cracks and distortions of walls and elements as well as losses of material. The application of the six approaches shows three different levels of damage classification for this structure. The differences can be explained considering the parameters considered by the various authors. According to Alexander (1986) and Chiocchio et al. (1997), the grade of damage is evaluated as *Moderate*. Chiocchio et al. (1997) consider centimeters as the unit to describe the opening of the cracks and include severe

Fig. 12 Damage assessment for two buildings located in the study area by means of different approaches: a) three-level concrete structure located close to the landslide crown; b) two-level masonry building positioned on the left flank of the landslide. Both edifices were classified according to the (1) Burland et al. (1977), (2) Alexander (1986), (3) Chiocchio et al. (1997), (4) Cooper (2008), (5) Baggio et al. (2009), and (6) Del Soldato et al. (2017) approaches. Damage are highlighted by red arrows, and open joints between the nearby structures are shown in blue

damage in the intermediate class. Similarly, Alexander's classification (1986) considers cracks that affect structural elements and distortion angles to belong to the *Moderate* class. The approaches described by Burland (1977) and Cooper et al. (2008) categorize the recorded damage to structures in terms of the width and number of cracks more severely than the two previously mentioned schemes, and the investigated building falls into the *Severe* rank. The classifications proposed by the DPC (Baggio et al. 2009) and Del Soldato et al. (2017) are the only two that classified the building as *Very severe*. The severity and conservative results from these two approaches could be justified by their original aim to provide quick assessments of fitness for human habitation. In addition, they are unique in that they consider the extension of the damage with respect to the entire structure combined with severity. The entity of the damage is confirmed by the conservation status of the structure, which was abandoned for several years.
