Ph.D. Thesis

**SEISMIC FRAGILITY ASSESSMENT OF
UNREINFORCED MASONRY CHURCHES IN
CENTRAL CHILE**

A dissertation presented by
Nuria Chiara PALAZZI

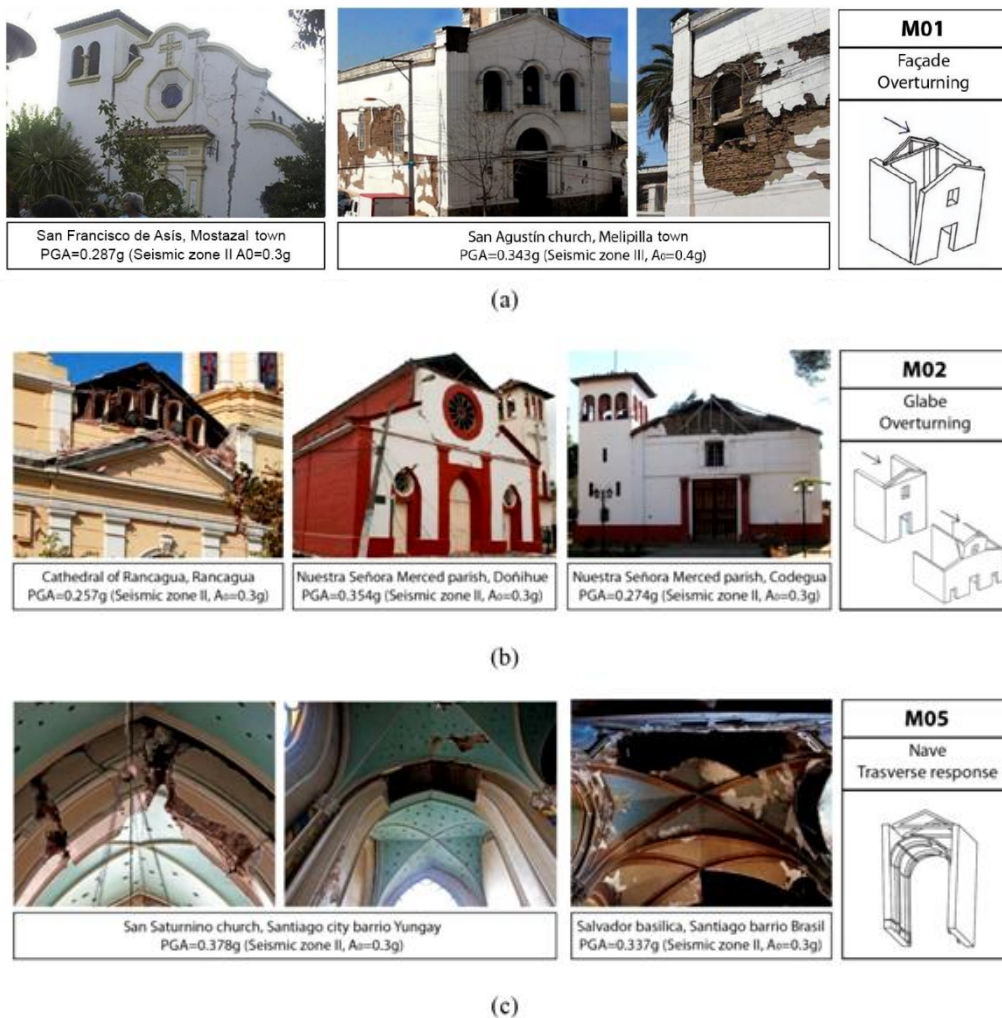
A typical out-of-plane mechanism of the central part of façade was observed in the San Francisco de Mostazal's church (PGA=0.287g) in the municipality of Rancagua built in 1858. Deep vertical cracks were observed due to the lack of connection between the façade, the longitudinal nave walls, and the bell-tower (Fig. 4.5a). In the San Agustín's church (PGA=0.343g), located in the town of Melipilla and built in 1744, triggering of the first mode mechanism of the façade was detected. Different materials in the façade (brick masonry) and the side walls (adobe) were a critical link between structural elements. Maule's shaking produced detachment of the entire façade with 7m wide and 1.5m height extension (Fig.4.5a) and the collapsed stucco, (Lira&Arévalo, 2010). The presence of good quality connections between the façade and lateral walls of the side aisles limited the collapse of the façade macro-element at the upper part (i.e. gable). In several Colonial churches, the collapse of tympanums was observed. Its reconstruction with wooden elements and brick (*tabiquería*), and the lack of a good connection between the roof and façade represent an important discontinuity and weakness to present an overturning of the wall.

Figure 4.5 - (a) Out-of-plane mechanisms of the façade due to poor connections at the corners: in the San Francisco de Mostazal the simple overturning involved the central part of façade, and in the San Agustín church the complete façade; (b) gable overturning effect of inadequate connection between roof structure and masonry wall of the upper part of façade on Cathedral of Rancagua, Doñihue's parish, and Codegua's church; and (c) observed collapses on the haunch of the transverse arches of side aisles

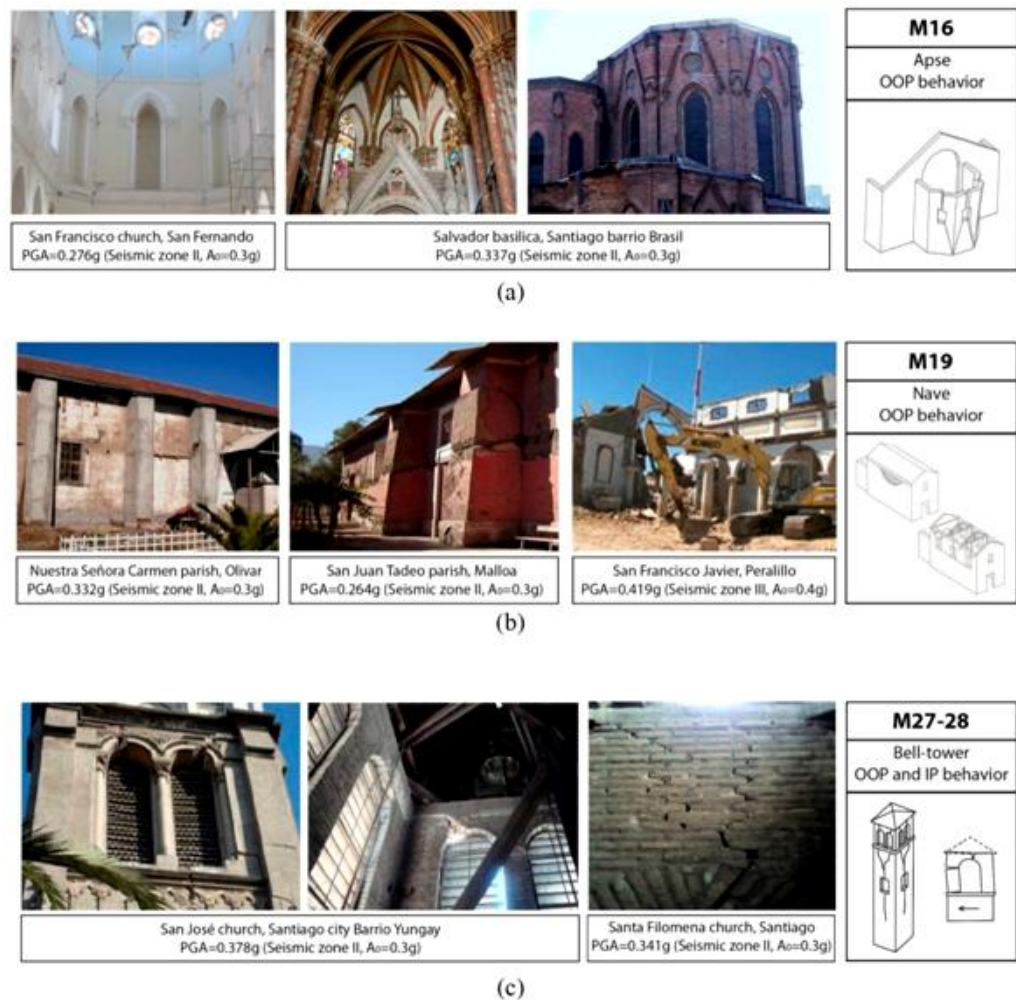
Figure 4.6- (a) Vertical cracks in windows due to the hammering roof covering; (b) deep horizontal cracks windows and buttresses, and total collapse of the lateral wall due to the hammering roof and connection between the wooden trusses and the masonry walls; and (c) diagonal cracks on bell-tower walls.

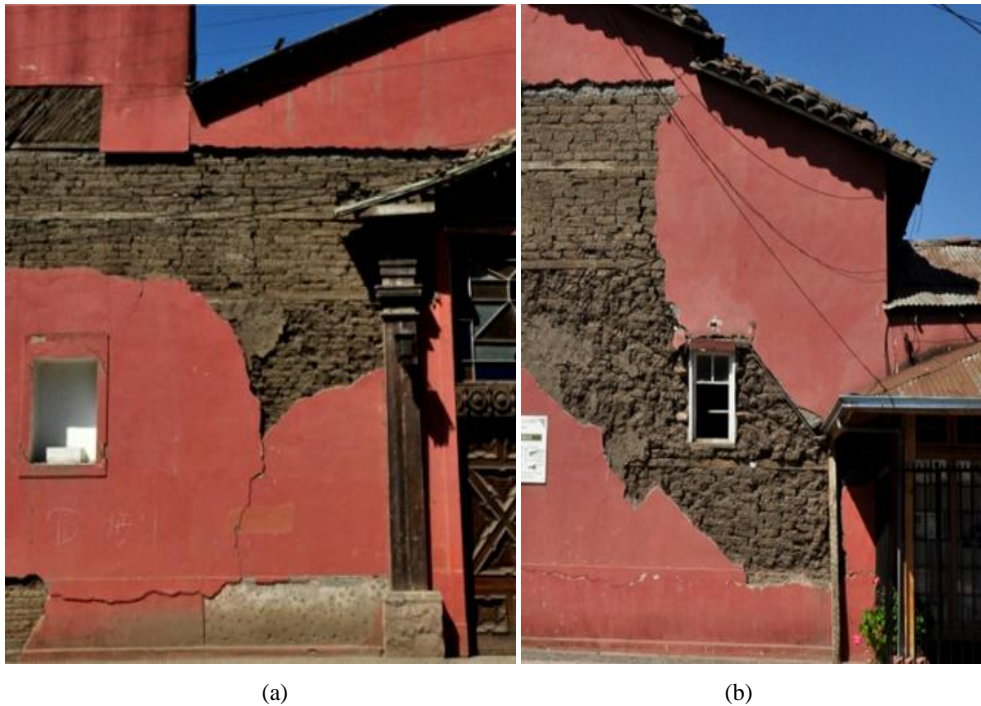
Figure 5.1.7 – Deep vertical cracks in the main façade (Surtierra, 2011).

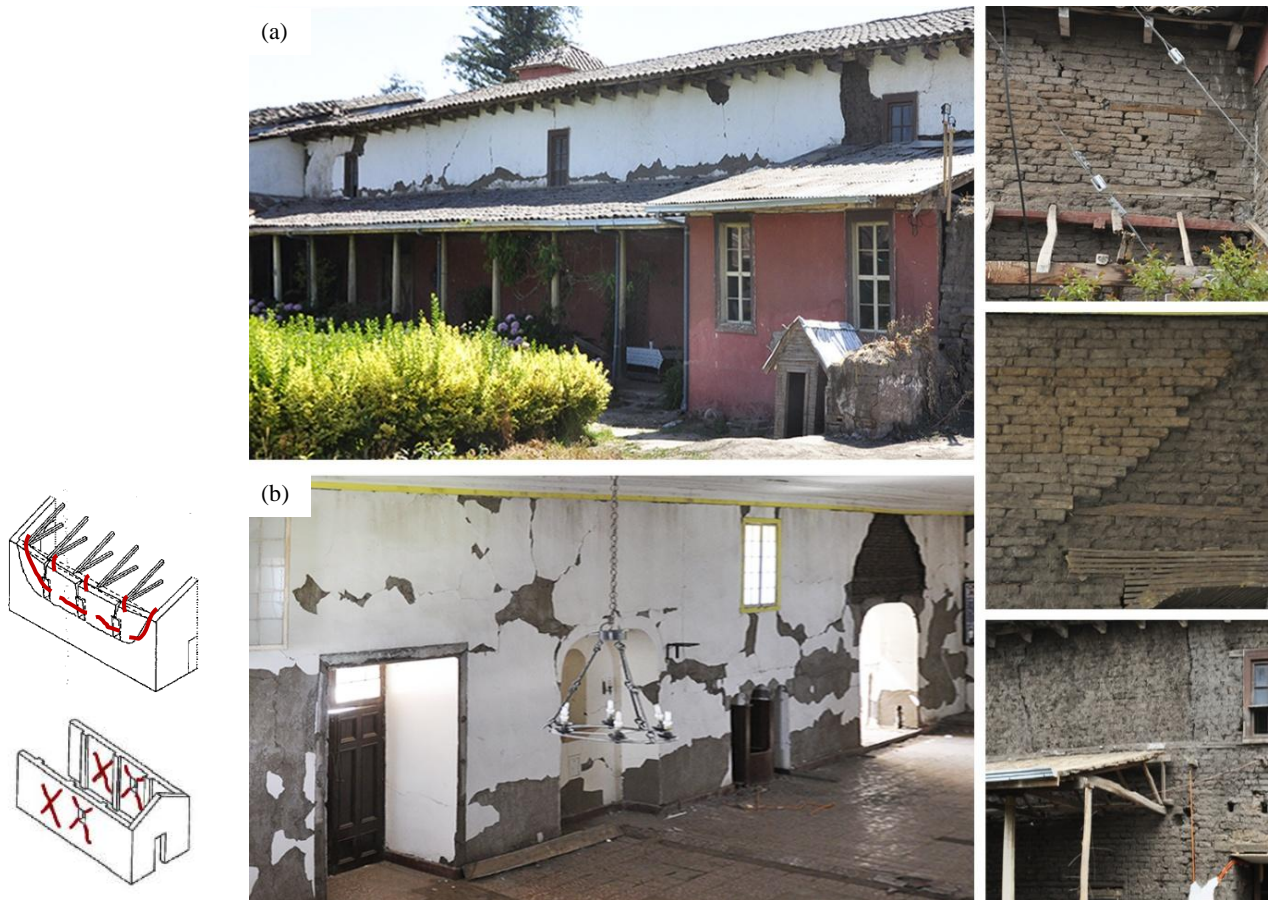
Figure 5.1.8 – Deep vertical cracks observable in the (a) internal and (b) external elevations of side walls (Surtierra, 2011).

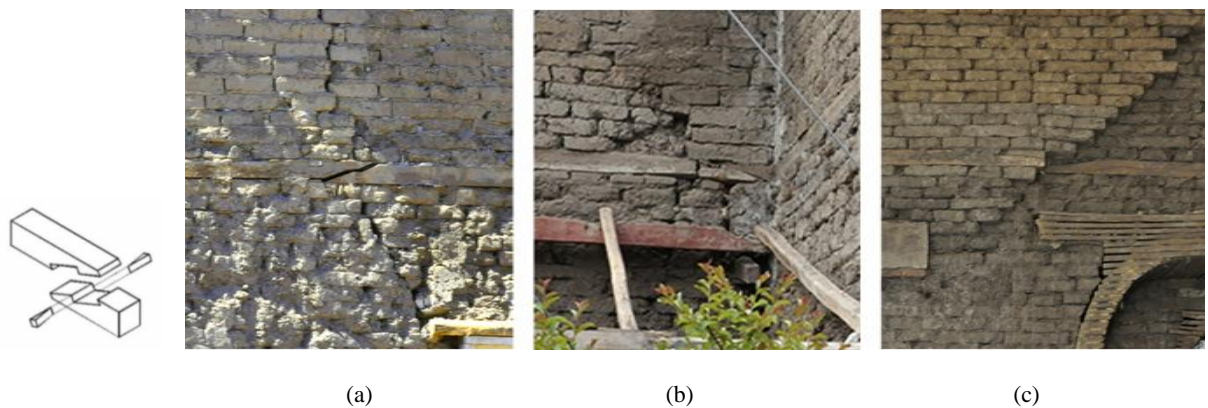
Figure 5.1.9 - Failure modes of hooked scarf joints after 2010 Maule earthquake in the ring-beam.

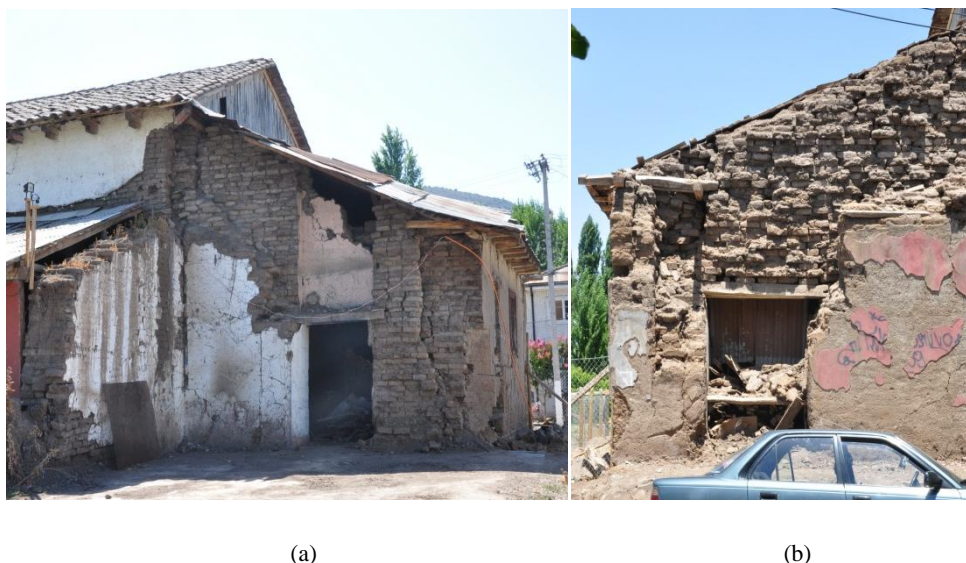
Figure 5.1.10 - *Local collapses of Sacristy (Surtierra, 2011).*

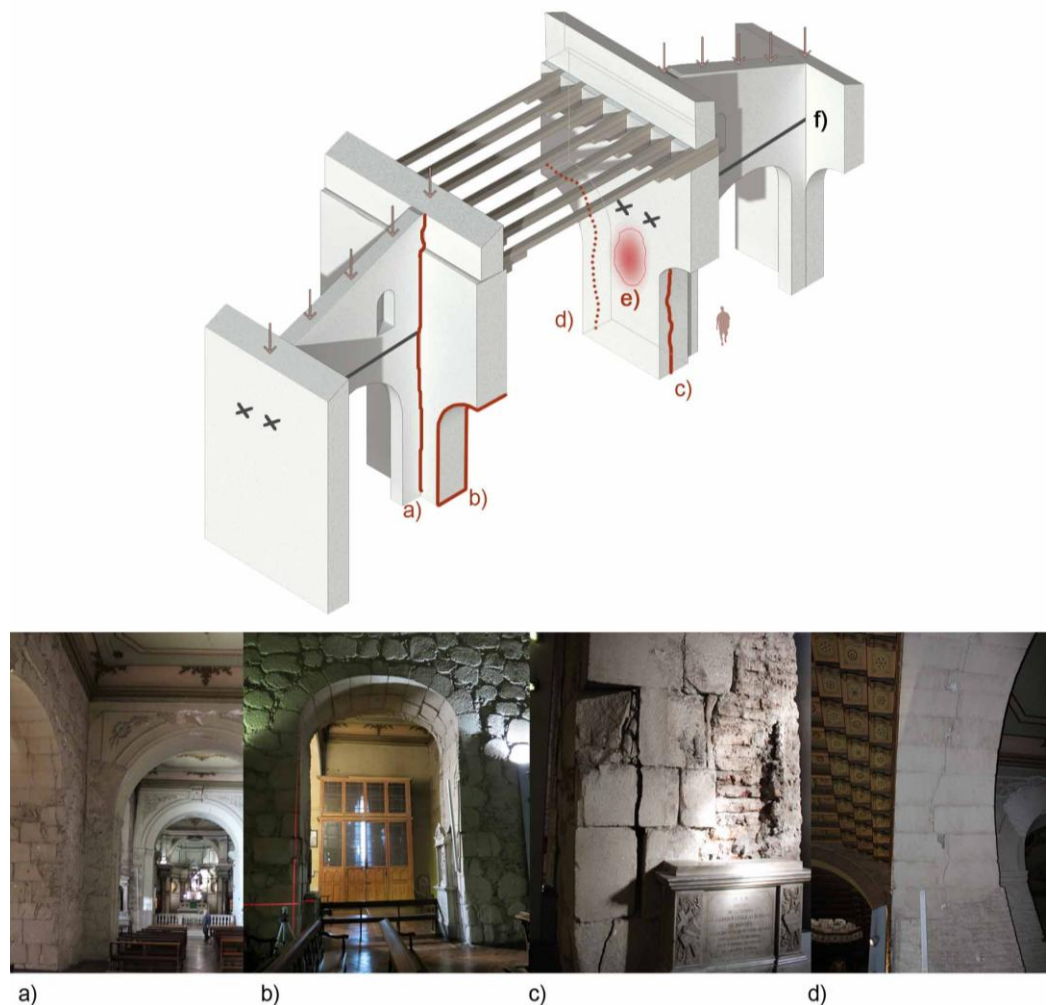
Figure 5.2.9- Cracks in transverse arches(Jorquera et al., 2017).

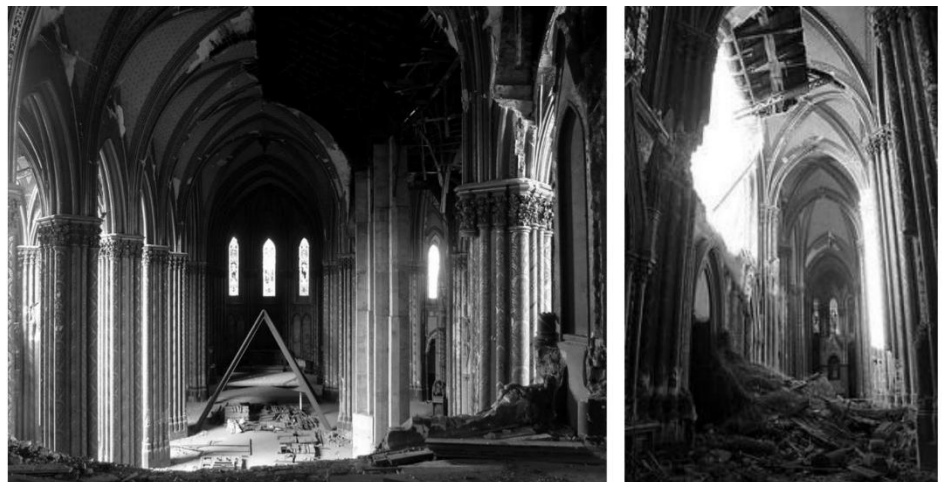
Figure 5.3.4 - Photo (a) and (b): worrying crack pattern and local failures of east side aisle wall, central arch of narthex, arcades of the external gallery and columns of the central nave. (Ministry of Public Works).

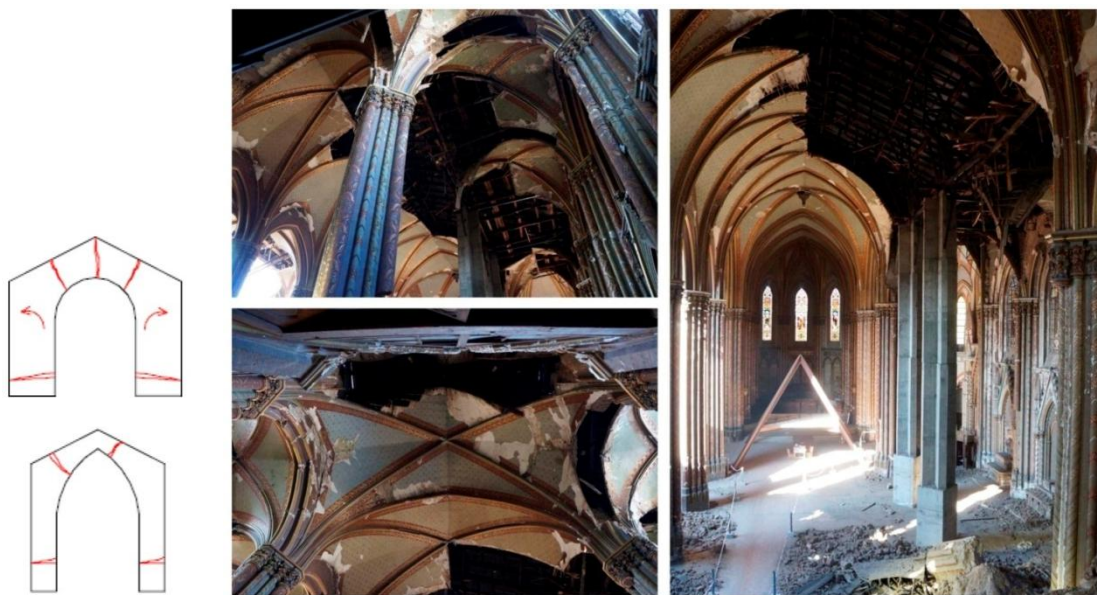
Figure 5.3.11 -Collapses of the transverse arches and arches of the longitudinal west wall.

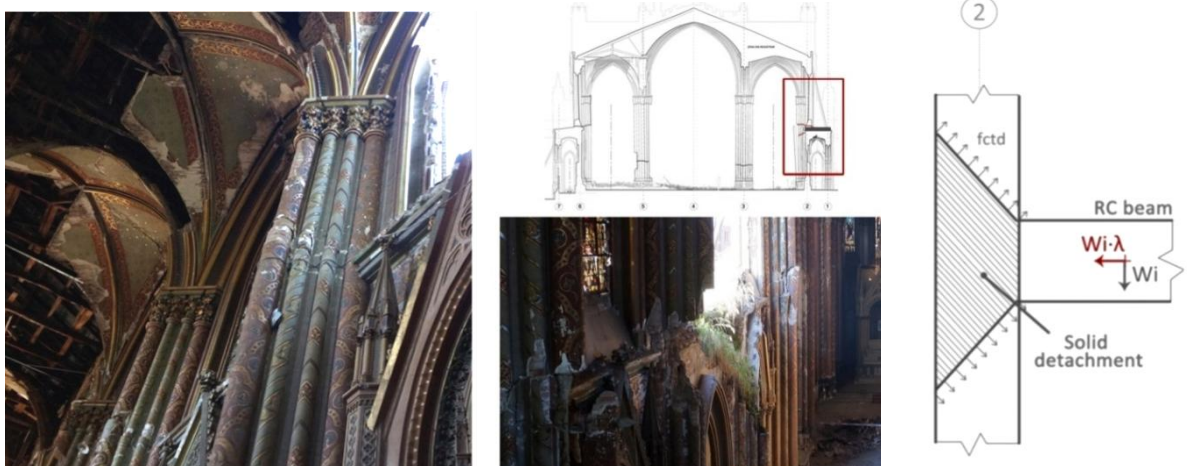
Figure 5.3.12 –Punching mechanism in the east aisle generate by RC beams

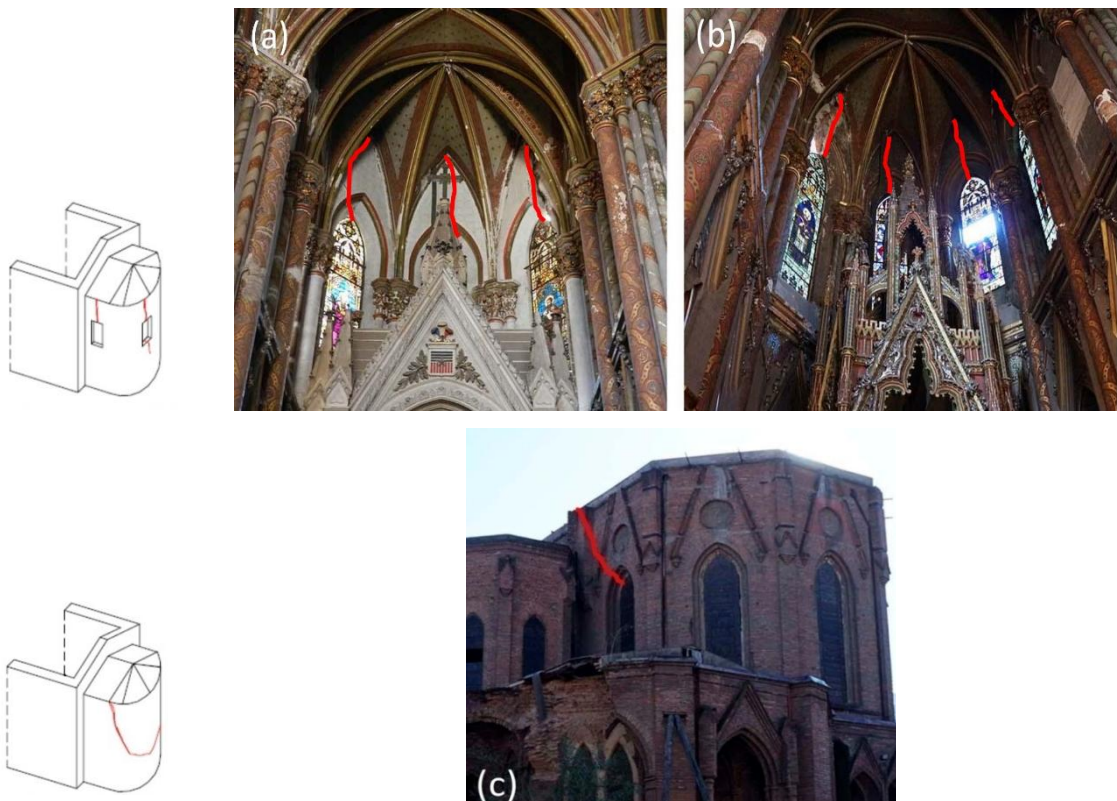
Figure 5.3.13 - Deep cracks in the lateral apses (a) and (b), and in the central apse (c).

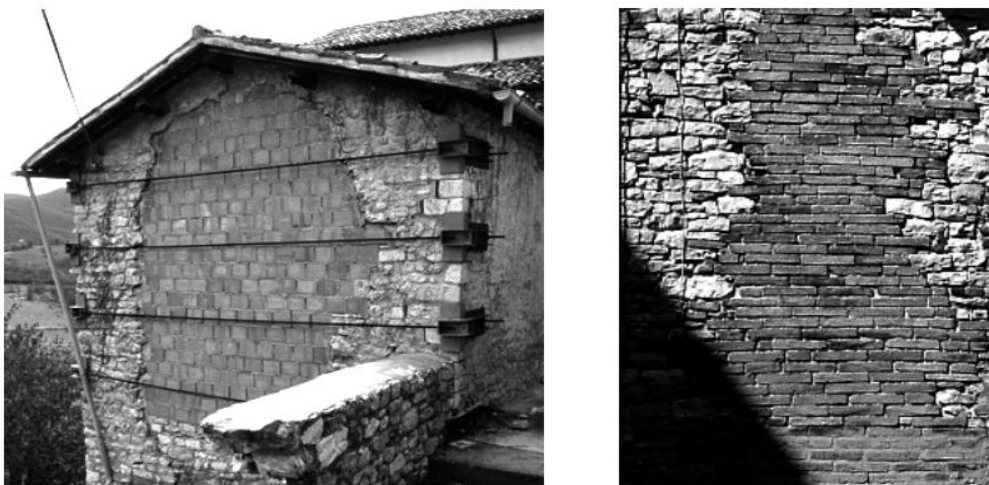
Figure 6.12 - Masonry replacement intervention. The repairs are ineffective due to the lack of compatibility between the masonry portions (Frumento et al., 2006).

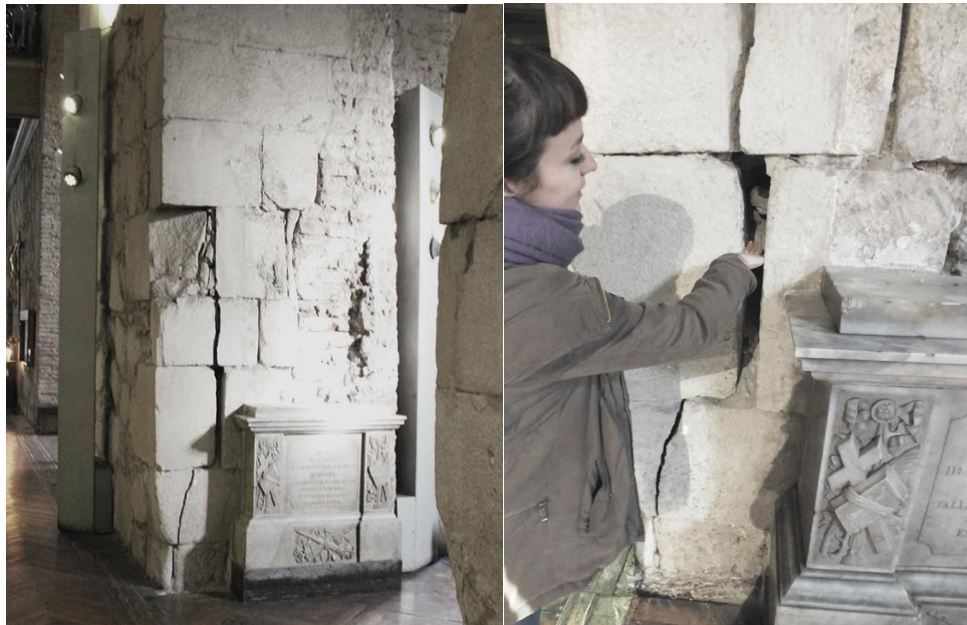
Figure 6.19 - Worrying deep vertical crack in arch piers of central nave pillar axis F.
