# An Innovative Method Based on In Situ Deformometric Monitoring to Support Decisions for the Structural Restoration of a Historic Panel Painting

**Abstract:** This paper describes an innovative method developed by the authors to support basic decisions concerning the structural restoration of a large historical panel painting which had been damaged by inappropriate attachment to a wall and ongoing exposure to severe changes in environmental humidity. The *Lapidazione di Santo Stefano* is a large panel (2.78 × 3.92 m<sup>2</sup>) painted by Giorgio Vasari in 1571 and has been housed since then in the Church of Santo Stefano dei Cavalieri in Pisa (Italy). Its wooden support is made of large horizontal planks glued together along their edges and stiffened by vertical, dovetailed crossbeams. The panel was tightly fastened to a church wall with several rigid bolts; due to the moisture cycling produced by rainwater leakage and a subsequent “compression set”, it had developed severe tension stresses perpendicular to the grain, resulting in cracks affecting both the wood and the paint layers. To decide how to carry out the structural restoration of the panel, it was necessary to know whe

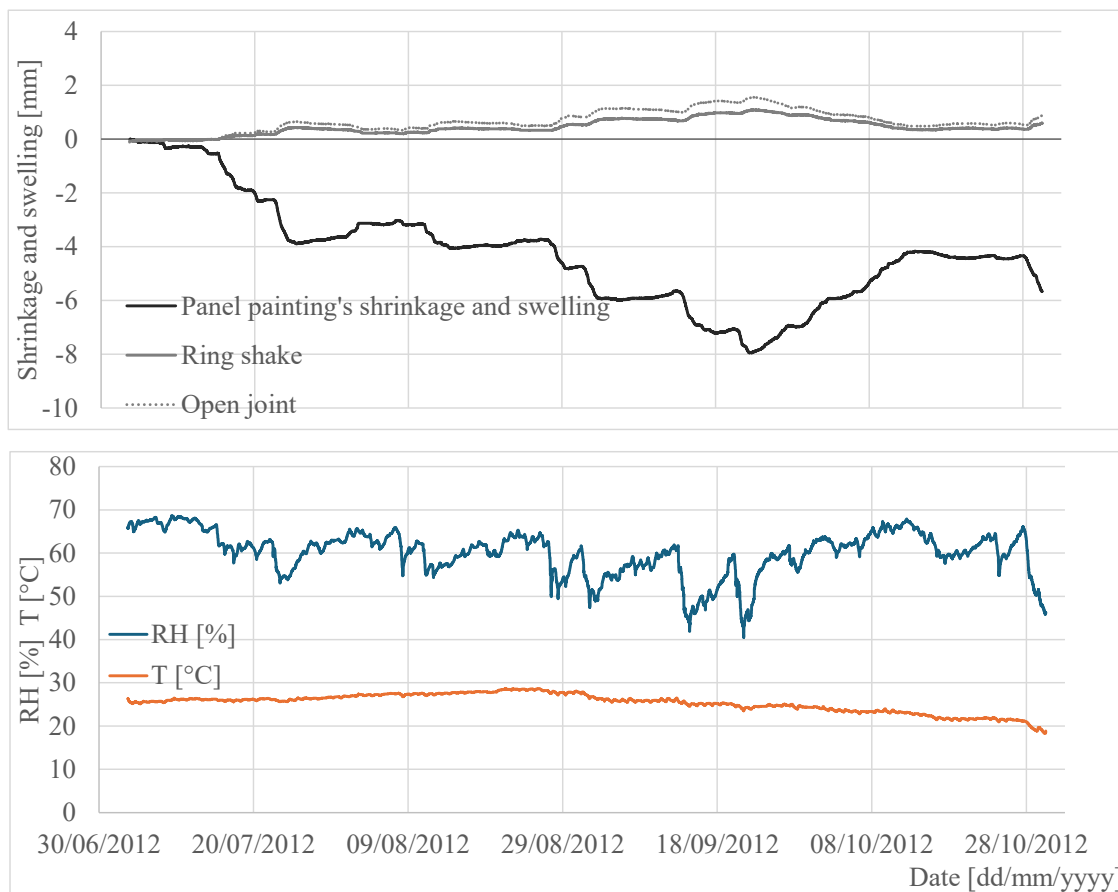
**Figure 6.** Before restoration: Width variation of the ring shake and open joint and vertical shrinkage/swelling of the whole panel along Line 1; the RH and T variation are also reported. Note. The accuracy of the swelling and shrinkage curves is  $\pm 0.002$  mm, the accuracy of the temperature sensor is  $\pm 0.35$  °C and the accuracy of the RH sensor is  $\pm 2.5\%$ .

The graphs show that as the RH decreases, the wood shrinkage perpendicular to the grain makes the panel's height decrease and the width of the cracks increase and vice versa. The shrinkage was measured along Line 1, where the planking is whole (i.e., not divided by the cracks) and therefore represents the shrinkage of the entire panel. In Figure 6, we can see that the whole panel shrinks considerably due to the decrease in RH. However, the widths of the broken glue line and the ring shake increase due to the decreasing RH.
