Full-Size Truss Joints Made of Old Wood: Laboratory Tests on Shear Failures

Hektor Thoma*, **Marco Togni****, **Luca Uzielli****

Forestry Faculty, Agricultural University of Tirana, Kamez, Tirana, Albania*

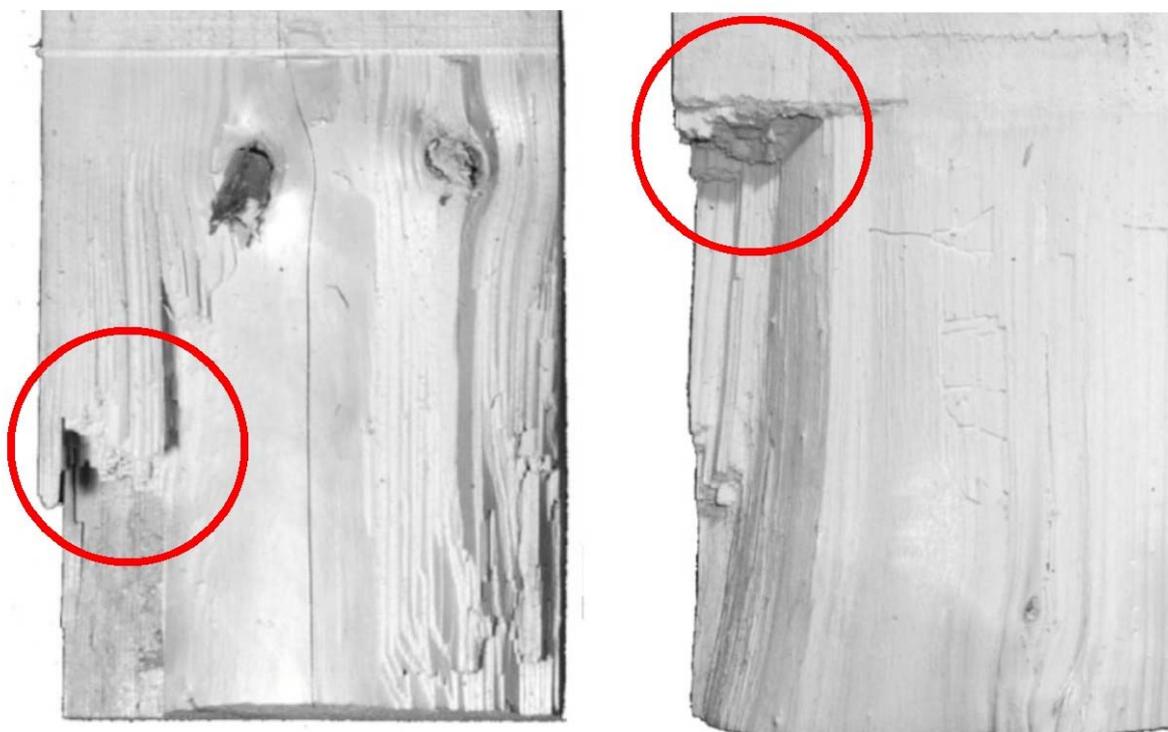
The full size truss joints failed by shear with the simple sliding of the heels, as expected, except in fir-2 and poplar-3, where a small portion of the cross section of the bottom-chord have split from the heel by a failure in tension, so that these failures can be described as a combination of shear and tension.

Figure 7. Partial failure in tension in two bottom-chords (after failure, view from above).

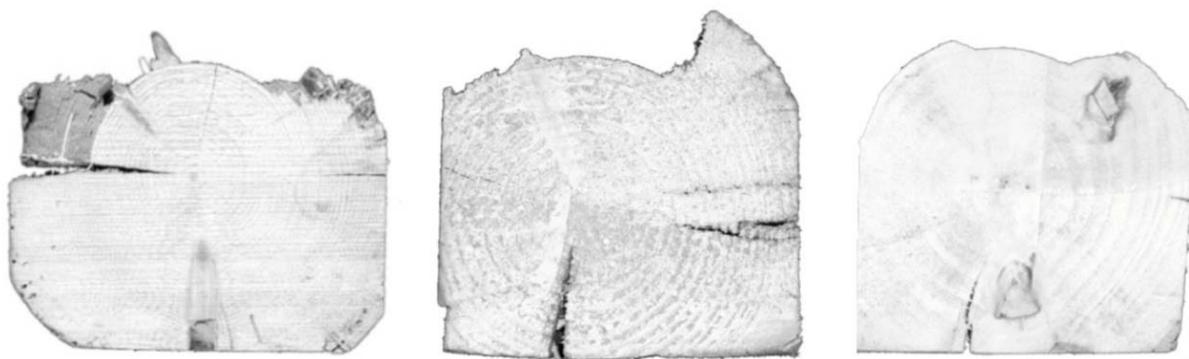
Figure 8. More than 50% shear along the ring

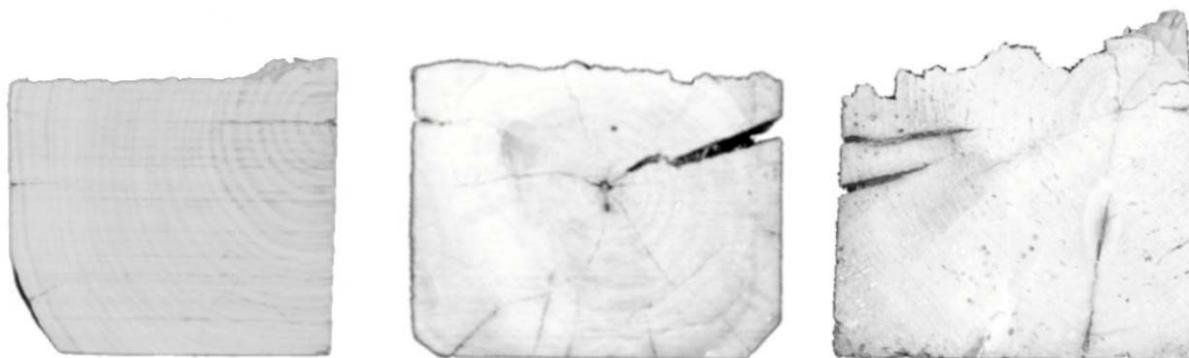
Figure 9. More than 50% shear along the LR plane (radial and subradial surface)

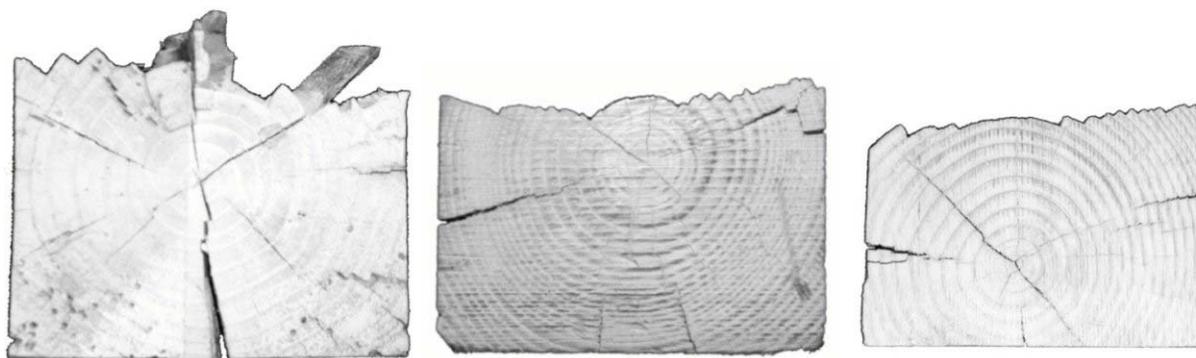
Figure 10. Intermediate shear failures

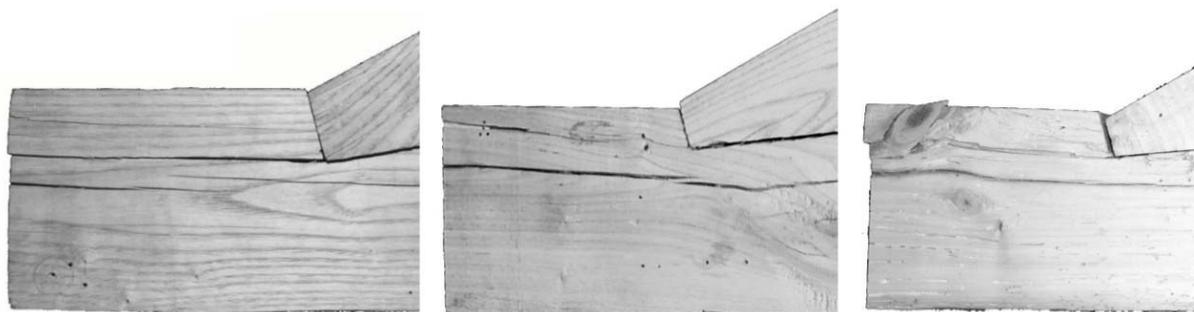
The failures have developed following the grain and its general longitudinal slope. In all the softwood specimens tested and in poplar-1 the grain deviation due to the knots and in poplar-3 the local deviation of the grain, meant a general increase of the dimensions of sliding surfaces.

Figure 11. General slope of the grain

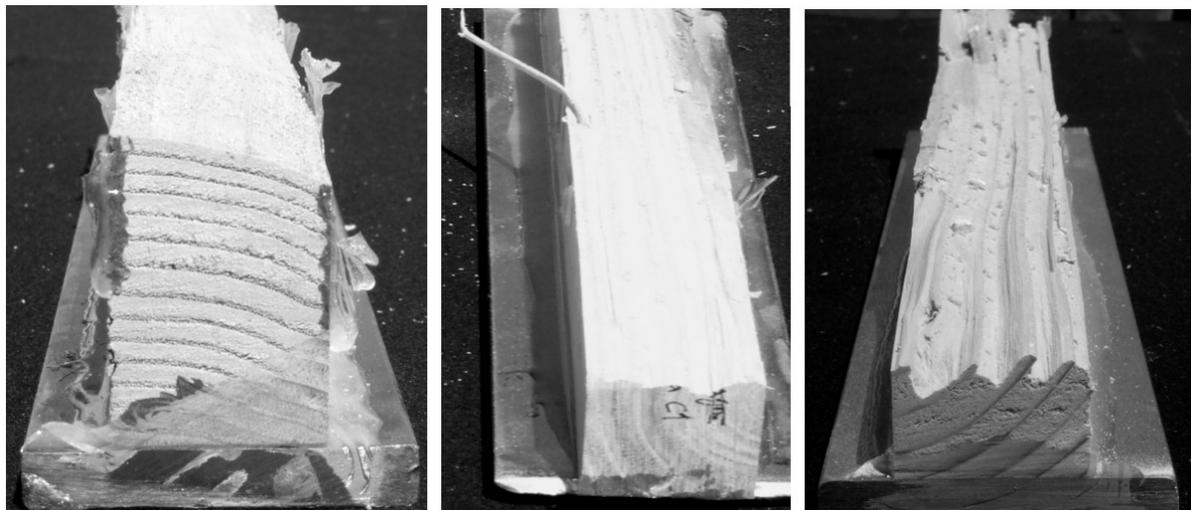
The same variety of behaviour has been observed in the shear failure of the EN 1193 specimens, principally depending on the three-dimensional orientation of the wood.

Figure 12. Shear on a ring (LT plane), on a LR plane, and intermediate

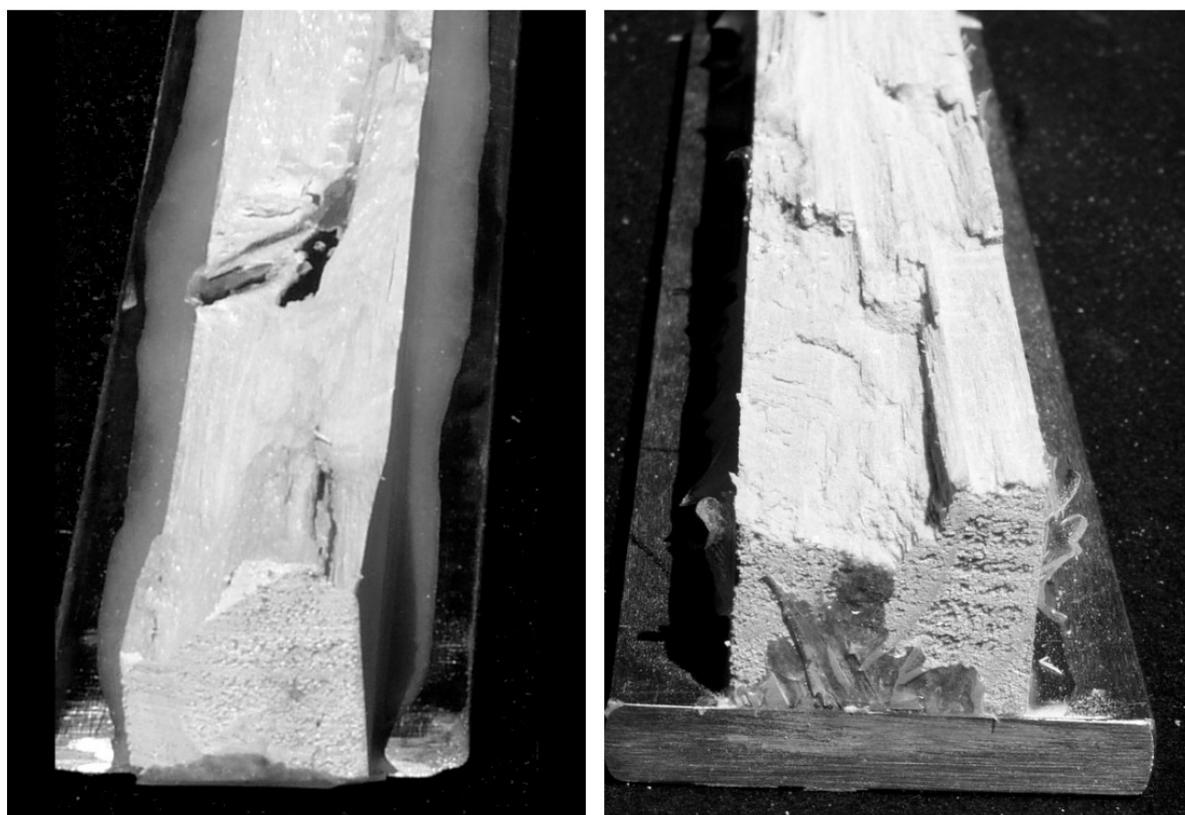
Similarly the other defects have produced the same effect on the way failure has occurred, as local slope of the grain; some partial failures in tension have been also possible.

Figure 13. Local slope of the grain and partial failure in tension

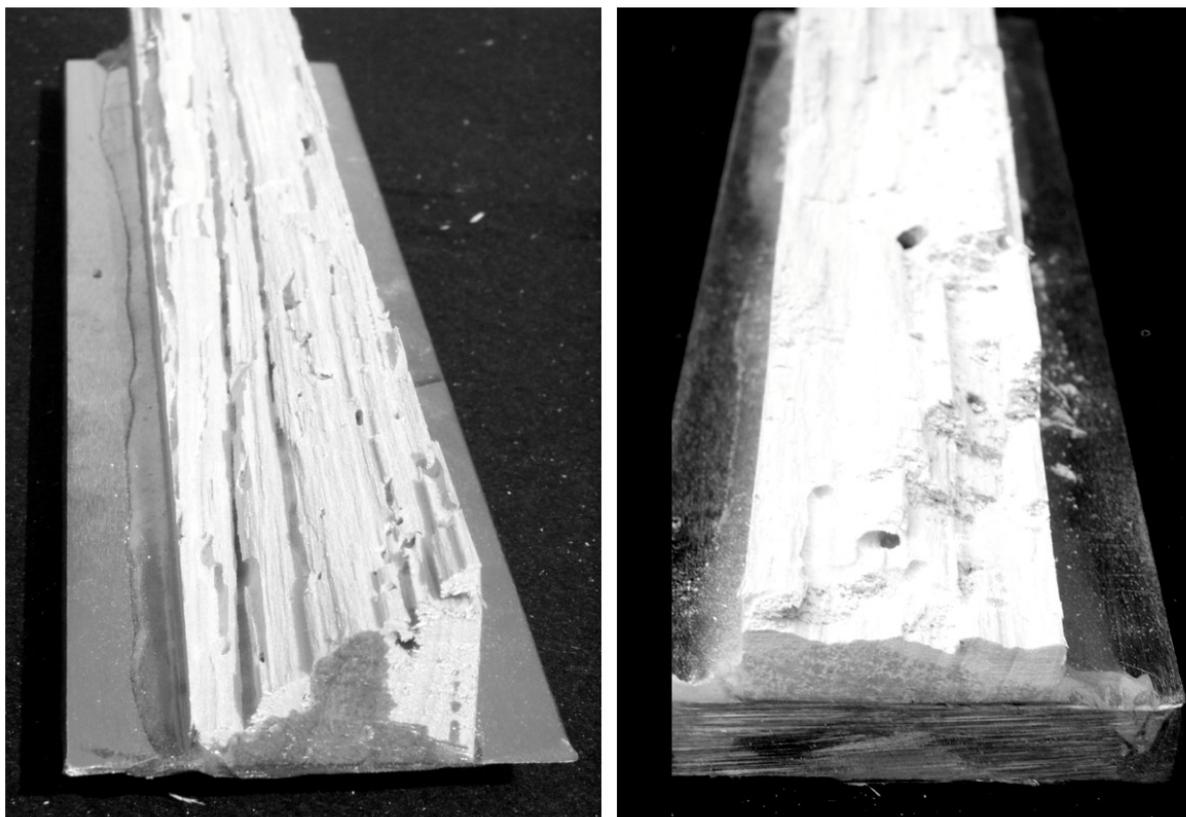
At the same time some tunnels of wood-boring beetles have been revealed on the failure shear surfaces.

Figure 14. Tunnels of wood boring beetles (Fam. *Anobidae*) parallel and perpendicular to the grain.

The presence of tunnels due to wood boring beetles did not have any notable effects on the final strength. Also the way of failure (on LR, or LT plane, or intermediate) did not have particular consequences on the resulting values. The slope of grain and the knots seem to have an improving effect on strength, or differently a null effect; no reduction effect has been discovered due to these characteristics.

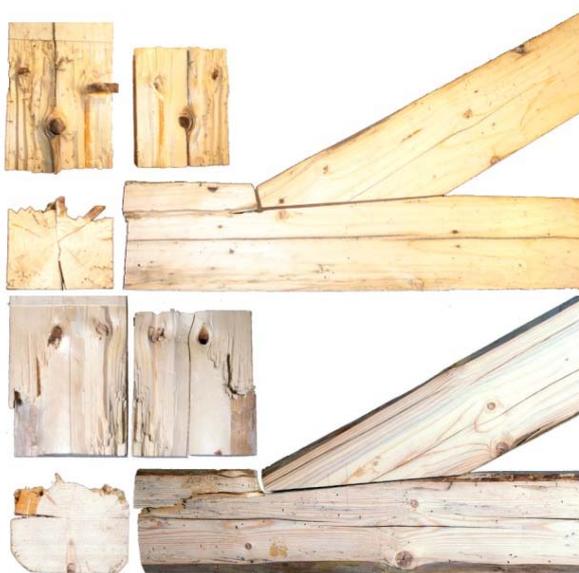
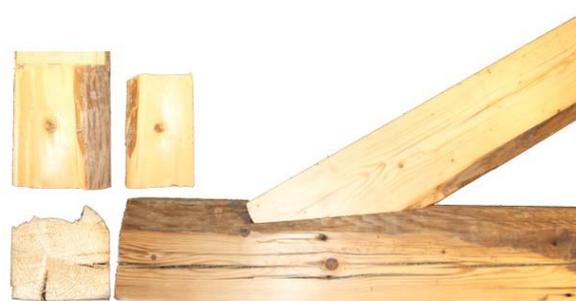
Spruce: heel with 3 knots and 1 pitch pocket
Fir-1: nominal surface opposing to the stress, decreased by the large wane. Failure mainly on 1 only ring.
Fir-2: shear failure mainly on 1 ring; concurrent a partial failure on tension. 2 knots and consequent local grain deviation.

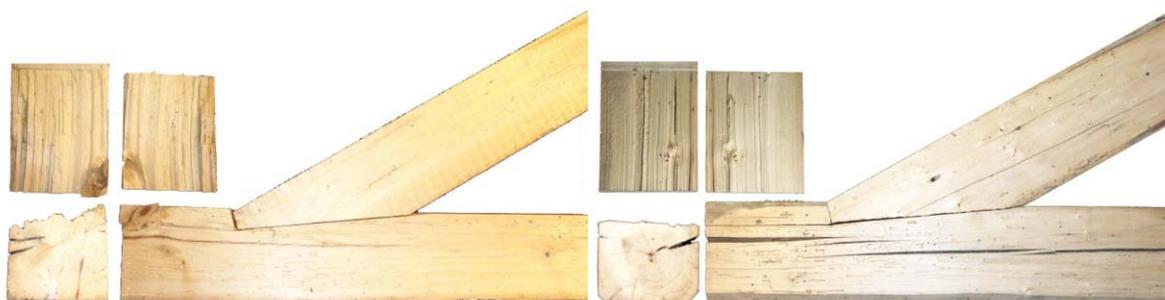
Poplar-1: longitudinal tunnels of wood boring beetles, 1 knot and the local grain deviation. Shrinkage fissure close to stressed surface.
Poplar-2: beetles longitudinal tunnels. Shrinkage fissure very close to stressed surface.
Poplar-3: local slope of the grain; concurrent partial failure on tension. Failure on 1 only ring.

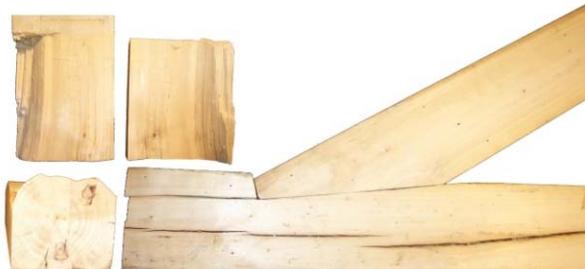
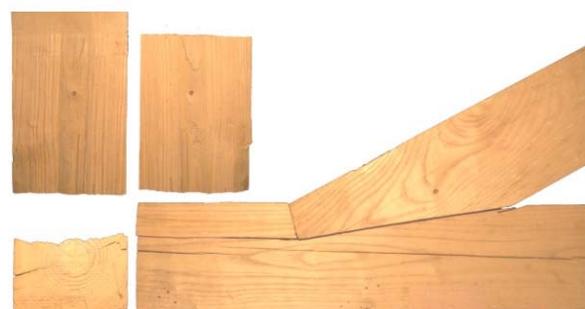
Chestnut-1: shrinkage fissure close to the shear surface.
Chestnut-2: general slope of the grain. Shrinkage fissure close to the shear surface.
Chestnut-3: general slope of the grain.

⁸ This expression has been used to describe the tendency of the shear breaking plane to join the shrinkage fissures of the beam. If the distance between shear plane and fissure is enough, the strength in tension of wood does not permit this joining. In the test the closest shrinkage fissure was in chestnut-1, at a distance of 11 mm from the shear plane.
