The Historic Timber Roof of "Giordano's Warehouse" in Vallombrosa: Design, Story and Collapse

Marco Togni *, **Luca Uzielli***, **Nicola Venturi ***, **Alberto Bronzi ****

DISTAF – Department of Forest Environmental Sciences and Technologies, Firenze *, CFS – *Corpo Forestale dello Stato*, Firenze **

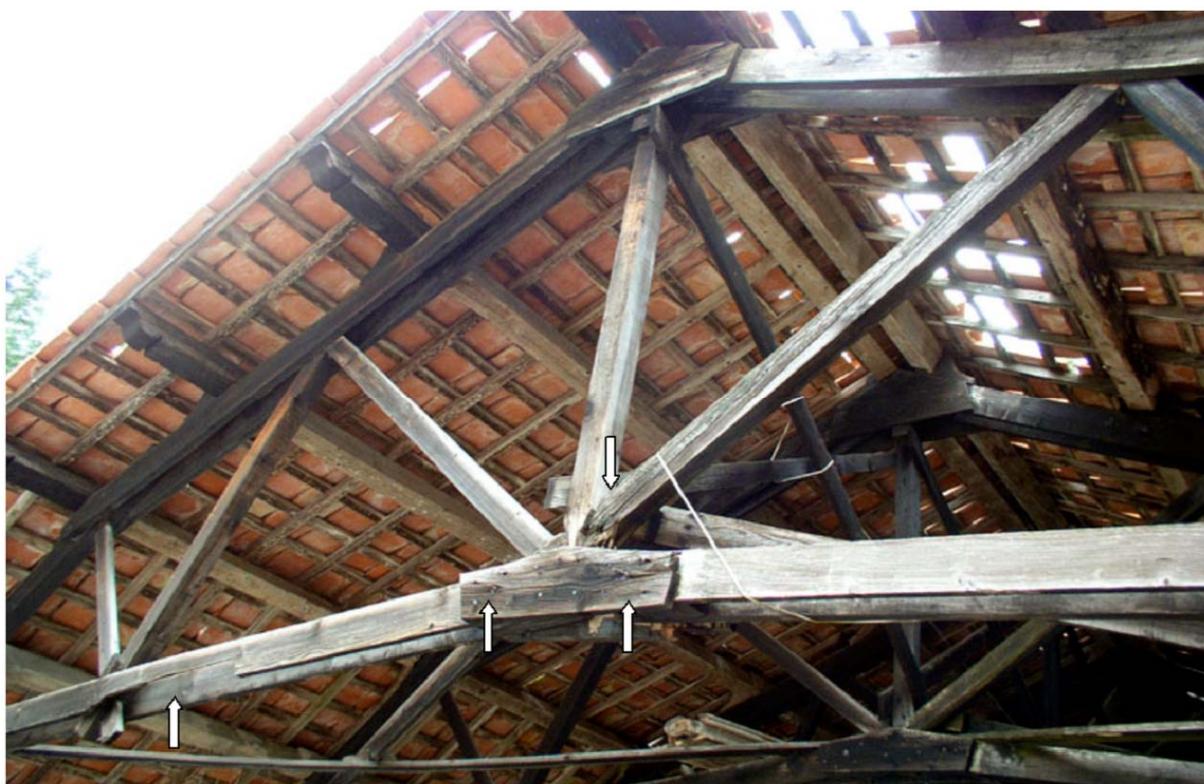
Image 1. The warehouse in the Nineties. Damages on the first truss: the bottom chord was broken (left arrow), the joint "N" was severely disconnected with end tie rod badly decayed and bolts evidently bent (central

arrows). Roof was showing many holes.

Impact of a truck damaged the lowest part of the first truss: the bottom chord was hurt and partially broken. Other similar events were not remarkable and they were not reported in archives [AAVV].

The long exposition to weathering caused some disconnection and also some holes in the roofing, made by hip-tiles⁵ (Image n.1). Water came through the holes and wetted the timber; in particular the inner part of the connection which, without ventilation, held the moisture for an extended time.

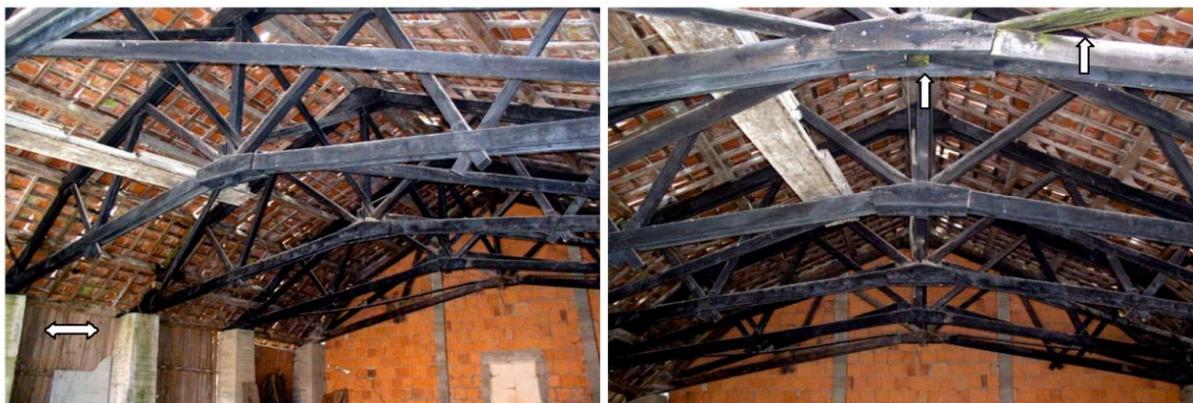
The recurrent wet condition, as well as decay (see below), was proved by the patina of green algae (Images n.2 and 3): on some lumbers the biofilm was grown on a trickling line, revealing the presence of water⁶, time after time.

Images 2-3. The warehouse in the nineties. The green biofilm is present and visible on the roofing, on two columns (image 2, white arrow) and on the plank converging on joint named "N" of the second truss (image 2, white arrows).

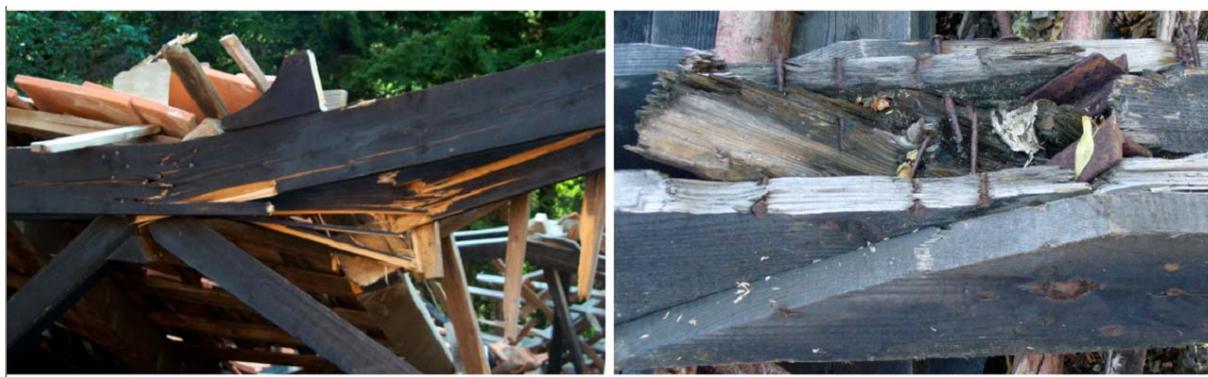
Images 4–5. Joint "E" or "C" (left) and heel joint "A" or "G" (right), respectively ductile and brittle failures. Brown-rot decay was in the heart of heel connection ("A" or "G").

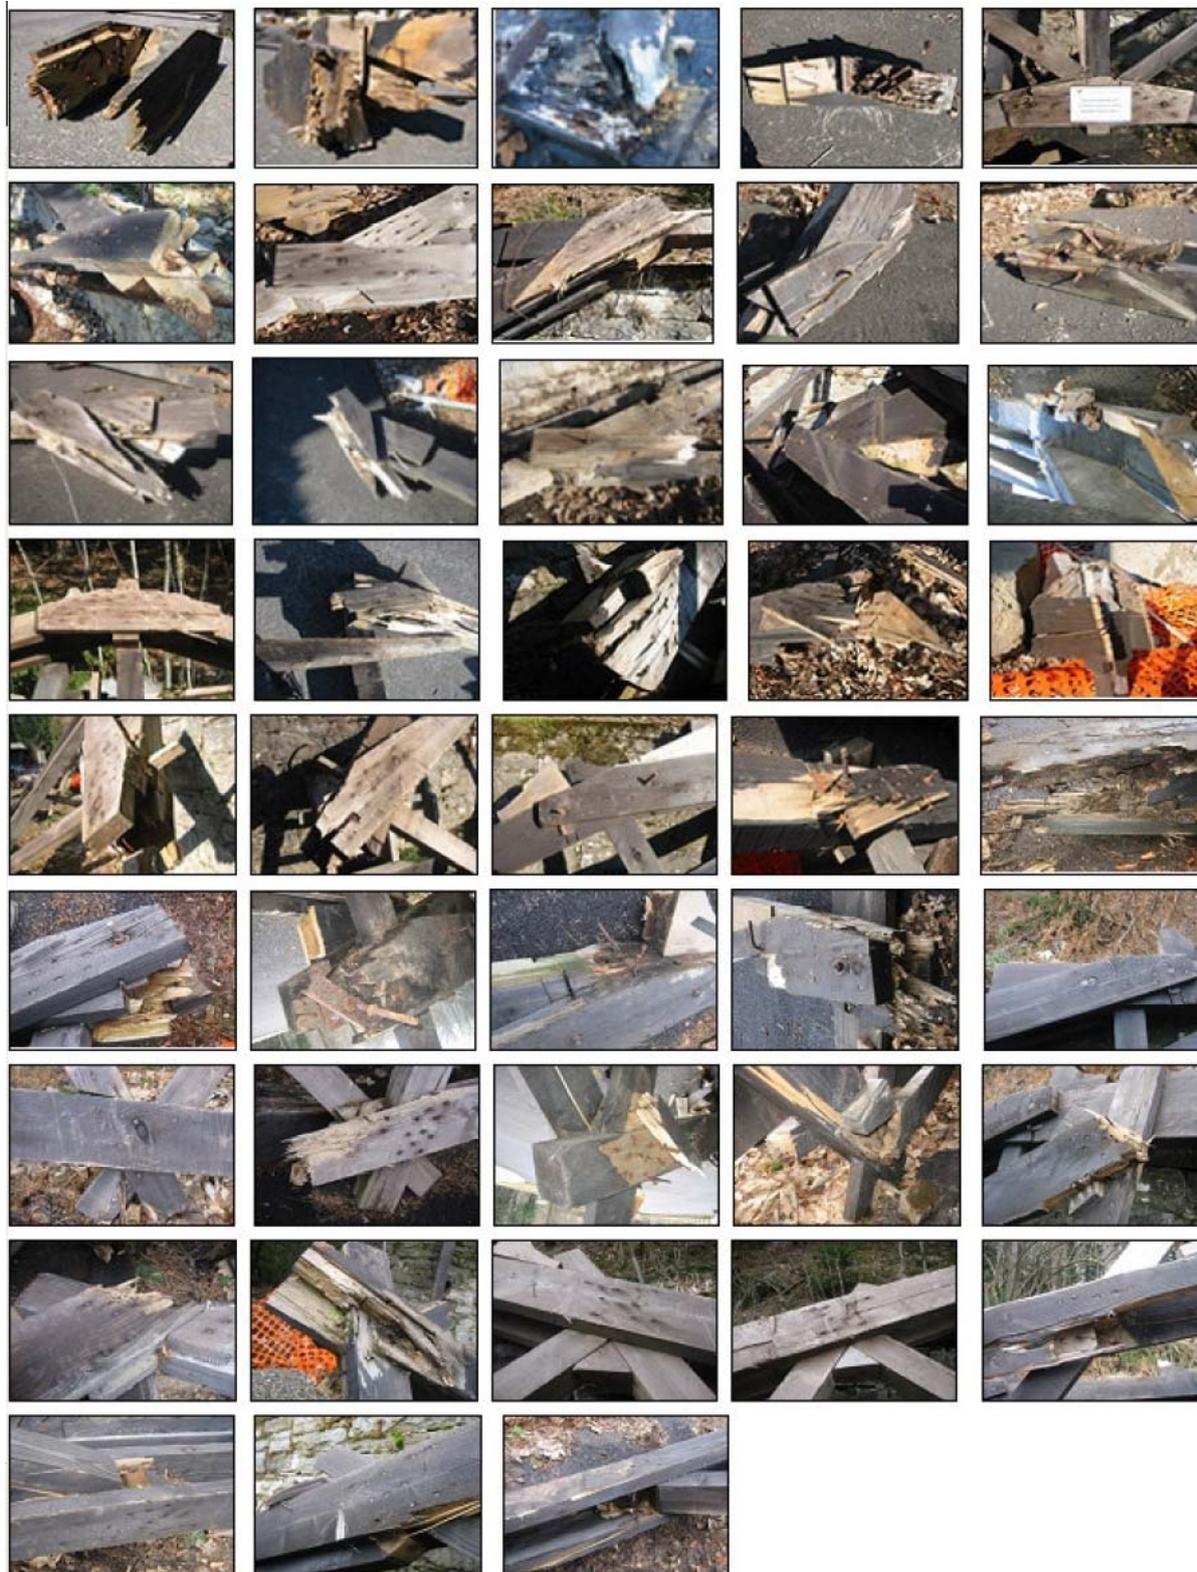
Name of connection	Joints surveyed	Joints decayed		Failure pattern		Joints lost	Decayed and lost
		rot fungi	insect	ductile or undamaged	brittle		
A – G	10	20%	0%	80%	20%	2	33%
B – F	10	10%	20%	90%	10%	2	33%
C – E	6	0%	0%	100%	0%	6	50%
D	5	20%	20%	80%	20%	1	33%
M – P	7	57%	14%	43%	57%	5	75%
N	5	40%	40%	60%	40%	1	50%
total	43	23%	14%	77%	23%	17	47%

Image 6. The 43 joints found in the rubble

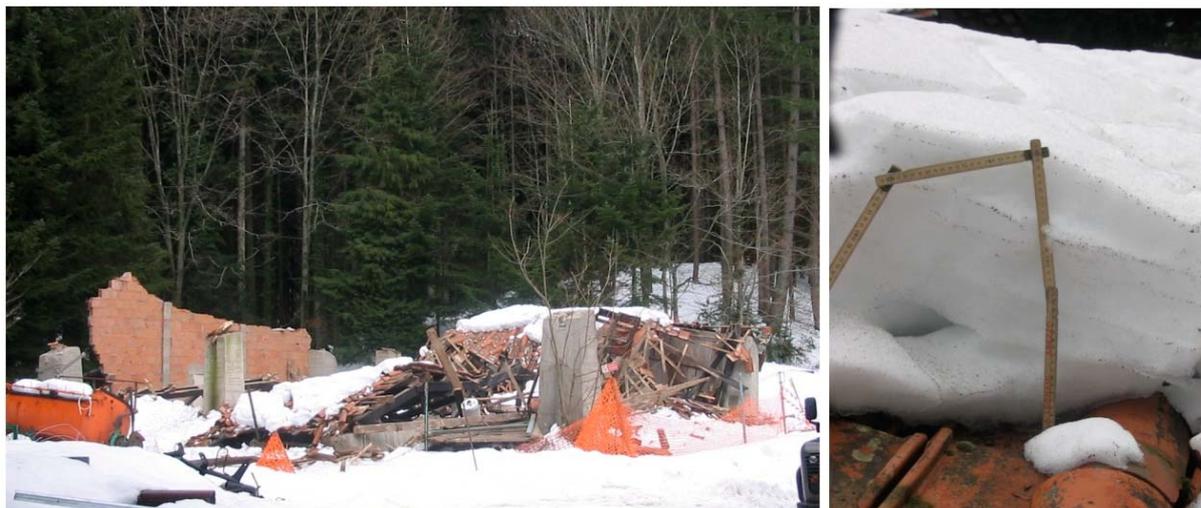
The actual snow load causing the collapse has not been found by Authors, but some days after the last failure, the snow layer measured on the roof was about 40cm deep, that means a load from 100 to 260 kg/m² according to the characteristics of the snow (free water content). The long duration of the high load has been assumed as concurrent to the two collapses, according to DOL master curve¹¹.

Images 7–8. The warehouse some days after the total collapse and the depth of the snow.

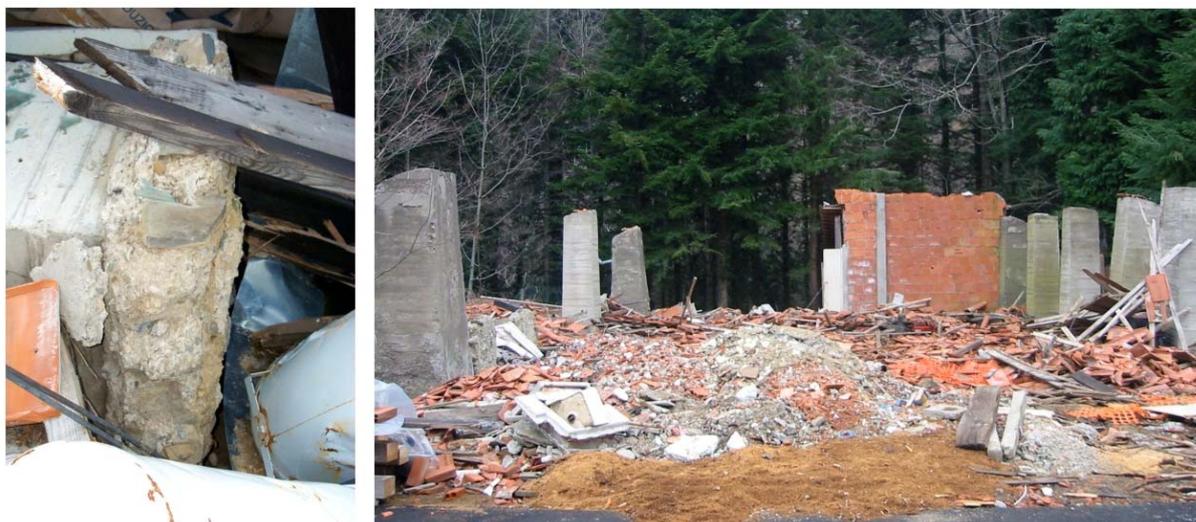
¹⁰ After the collapse it has been possible to measure the foundation of the columns whose depth resulted 20-30cm only. The explanation for this occurrence has not been found.

Images 9–10. The foundation of the 4 rotated columns, 20-30 cm deep, with no anchor, and the position of 8 columns remaining vertical (more or less) after the collapse, after removal of the timber.

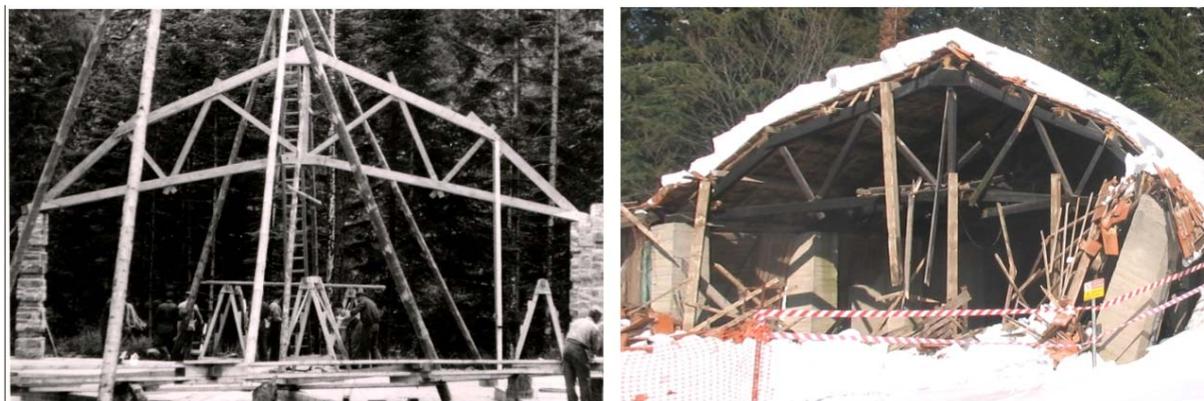
Images 11–12. Comparison between two symbolic instants of the shelter life: the first truss erected, reproduced in an original photo, dated 1952, and the warehouse without the first truss, collapsed under the snow load, in 2005.
