Finite element modelling for seismic assessment of historic masonry buildings / Betti, Michele; Galano, Luciano; Vignoli, Andrea. - STAMPA. - (2016), pp. 377-416. [10.1007/978-3-319-21753-6_14]

Finite Element Modelling for Seismic Assessment of Historic Masonry Buildings

Michele Betti, Luciano Galano and Andrea Vignoli

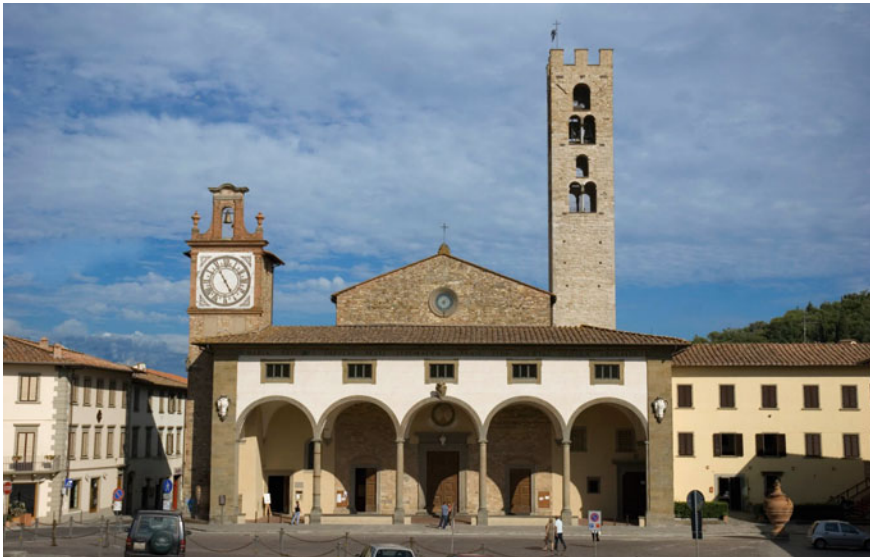
Fig. 12 Front view of the Basilica of Santa Maria all'Impruneta (Tuscany)

As a first application, the analysis of the 14th century Basilica of Santa Maria all'Impruneta near Florence is discussed (Fig. 12). The plan view of the church (Fig. 13) shows the typical layout with a single nave and a polygonal apse separated by a triumphal arch. A pronaos, composed of five wide arches, and surmounted by rectangular windows, was built in 1634 and covers almost totally the old façade (Fig. 12).

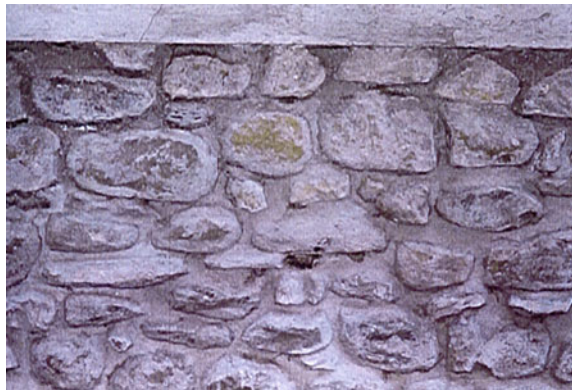
Fig. 23 View of the masonry texture

The masonry walls are made of rubble stone masonry (an example of the chaotic texture is reported in Fig. 23) with the exception of the corners, where regular-shaped well-connected stones are visible. On the first floor there are two
