### **Finite element modelling for seismic assessment of historic masonry buildings**

# Finite Element Modelling for Seismic Assessment of Historic Masonry Buildings

Michele Betti, Luciano Galano and Andrea Vignoli

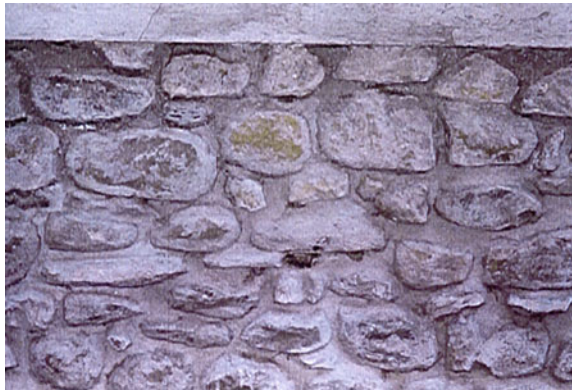
**Fig. 23** View of the masonry texture

The masonry walls are made of rubble stone masonry (an example of the chaotic texture is reported in Fig. 23) with the exception of the corners, where regular-shaped well-connected stones are visible. On the first floor there are two
