Finite element modelling for seismic assessment of historic masonry buildings / Betti, Michele; Galano, Luciano; Vignoli, Andrea. - STAMPA. - (2016), pp. 377-416. [10.1007/978-3-319-21753-6 14]

Finite Element Modelling for Seismic Assessment of Historic Masonry Buildings

Michele Betti, Luciano Galano and Andrea Vignoli

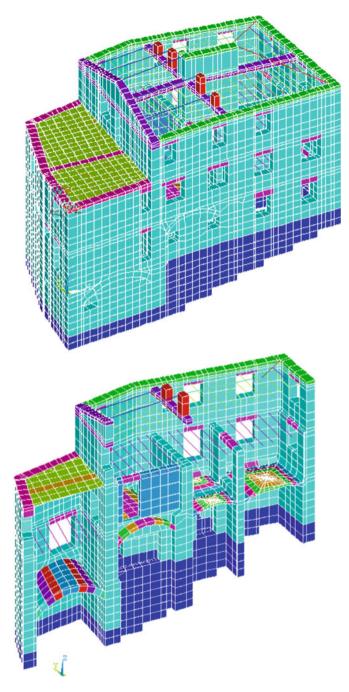
Fig. 25 Finite element model of the building in Fivizzano (Lunigiana)
