## Ruins by the sea. Spanish towers in northern Puglia, between knowledge and risk of loss

**Abstract.** The heritage of the 16th century towers built along the coast of the Kingdom of Naples against the Turkish attacks is today in heterogeneous conditions. Their best preservation is sometimes the result of a continuous use over time or strong restoration-reconstruction actions. Many towers, gradually abandoned since the end of 18th century, are in ruins, isolated in the country and excluded from visit trails, increasingly inaccessible. The position on the seafront makes their state of conservation very critical, with degenerative phenomena rapidly changing. A research conducted by the University of Florence and the POLIMI, is focusing on the study of the towers with a high risk of loss. The aim is to reach the best knowledge of construction, transformation and decay processes of these artefacts and an adequate level of risk awareness. This in order to identify the type, the urgency and the intensity of possible conservation works. Here we present the results of investigations carried out on a sample of the north coast of Puglia. After the complete documentation of the buildings,

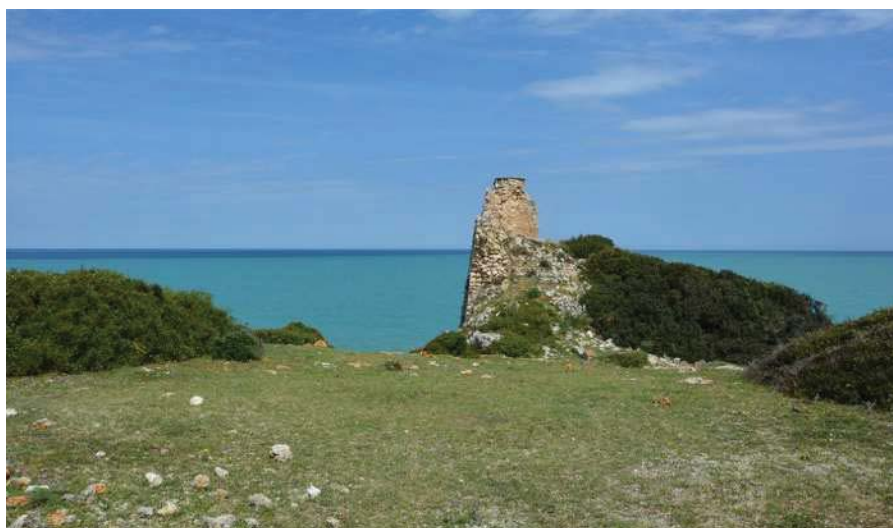
*Fig. 01 : The ruins of the Tower of Calarossa*

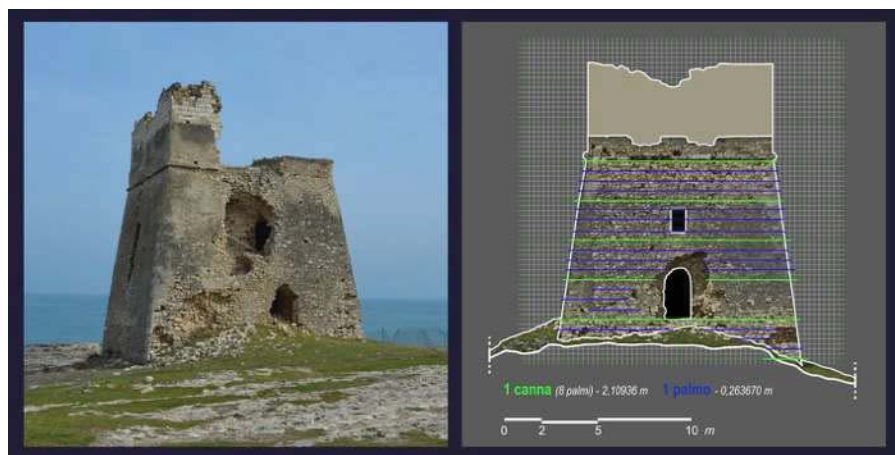
Fig. 02 : Sfinale Tower. Masonry horizontal alignments of the South side

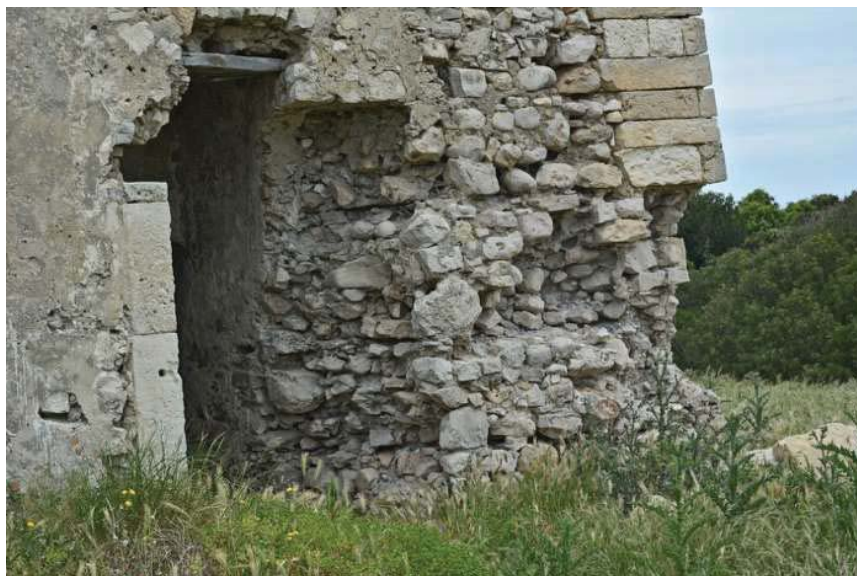
Fig. 03 : Torre Scampamorte. Loss of stone elements from the southern wall

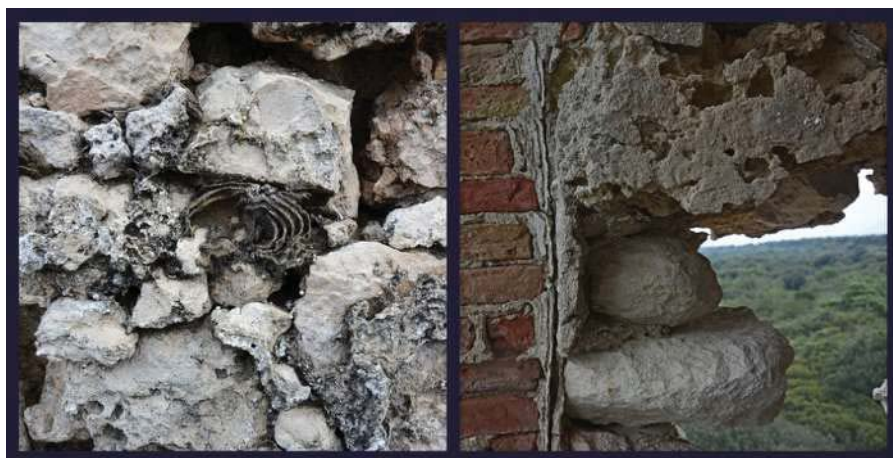
*Fig. 04 : Weathering of lime mortars by the marine aerosol*

The abandonment conditions outline a very precise picture of degenerative processes. However, if substantial previous actions such as breccias, partial demolitions or collapses are excluded (such as those of Calarossa), the remains set up do not present problems of general instability, but rather the disintegration of the masonry work itself due to problems of rainwater infiltration and above all of mortars' erosion. The macroscopic recognition of degenerative phenomena shows a strong erosion due to the action of marine aerosol. Signs of "rosette" degradation
