UNIVERSITÀ  
DEGLI STUDI  
FIRENZE

DOTTORATO DI RICERCA IN  
SCIENZE DELLA TERRA

***Analysis and monitoring of geohazards in  
cultural heritage sites***

Anni 2015/2018

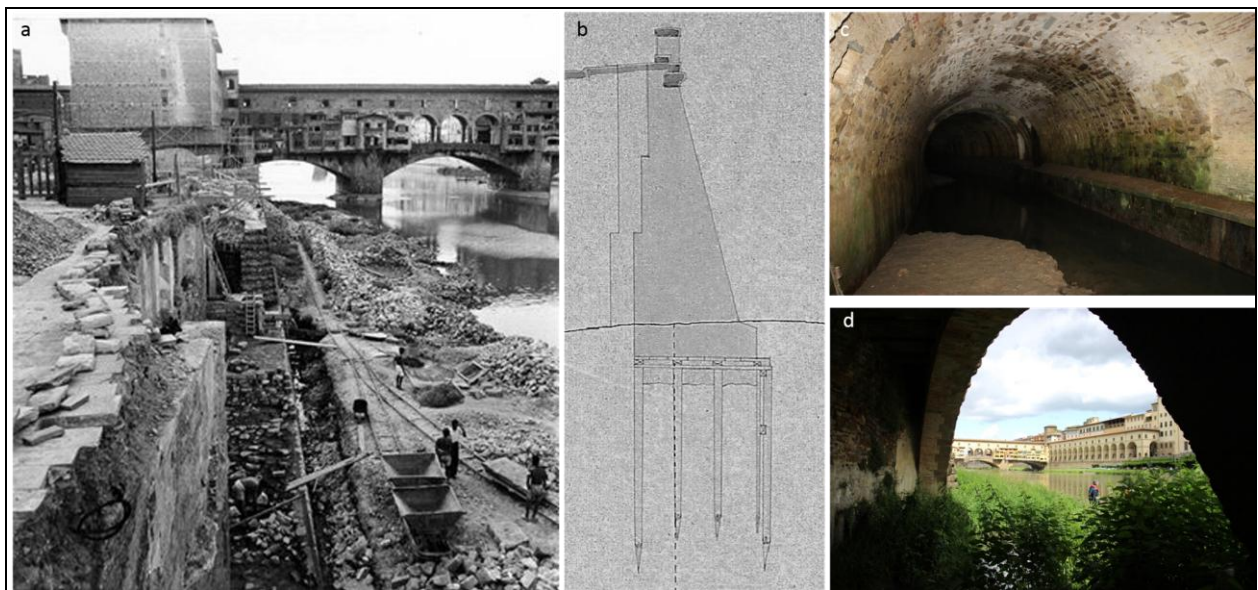
**Figure 36.** a) Original photo of the Torrigiani riverbank embankment at the beginning of its construction in 1866, (b) the section of the retaining wall from the original design drawings, and the discharge channel inside the Lungarno Torrigiani embankment, as visible in 2017 (c, d). (Morelli et al., 2018).

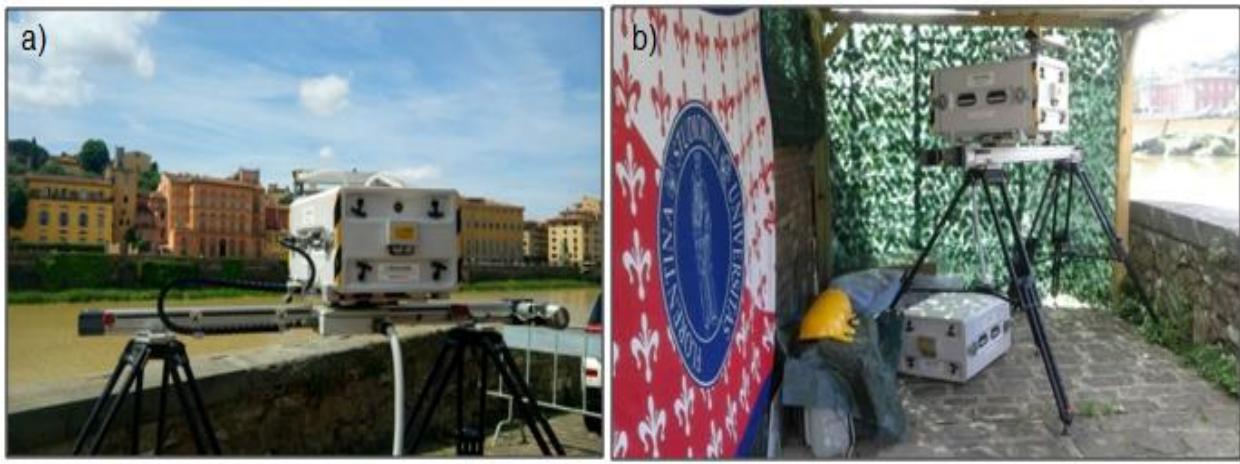
**Figure 42.** a) GBIInSAR instrumentation positioned in the riverbanks opposite to Lungarno Torrigiani, and b) wooden cabin built to protect the GBIInSAR.

This instrument has been located in a stable place in the opposite riverbank to the Lungarno Torrigiani, in order to guarantee a fixed observational geometry (zero baseline condition). The stability of the system location has been certified by a PSInSAR analysis of recent satellite data that has been conducted before choosing the site. Furthermore, considering that the radar interferometry provides only the displacement component along the LOS, the viewpoint of the radar has been selected as parallel as possible to the expected direction of the sliding movements (Figure 42a). Later, the instrument has been protected from atmospheric agents through a wooden cabin that was specially built to leave the LOS unobstructed (Figure 42b).

The GBIInSAR, implemented by the Ellegi-LiSALab s.r.l. company, is property of the University of Florence, and it is composed of a 2.0 m long linear rail and a continuous-wave step-frequency (CW-SF) transceiver unit, characterized by a transmitting and receiving antenna, operating in the ku-band (wavelength range of 2.5–1.67 cm; central frequency of 17.2 GHz and 200 MHz bandwidth). This system allows obtaining sub-millimeter sensitivity in the estimation of LOS displacements.

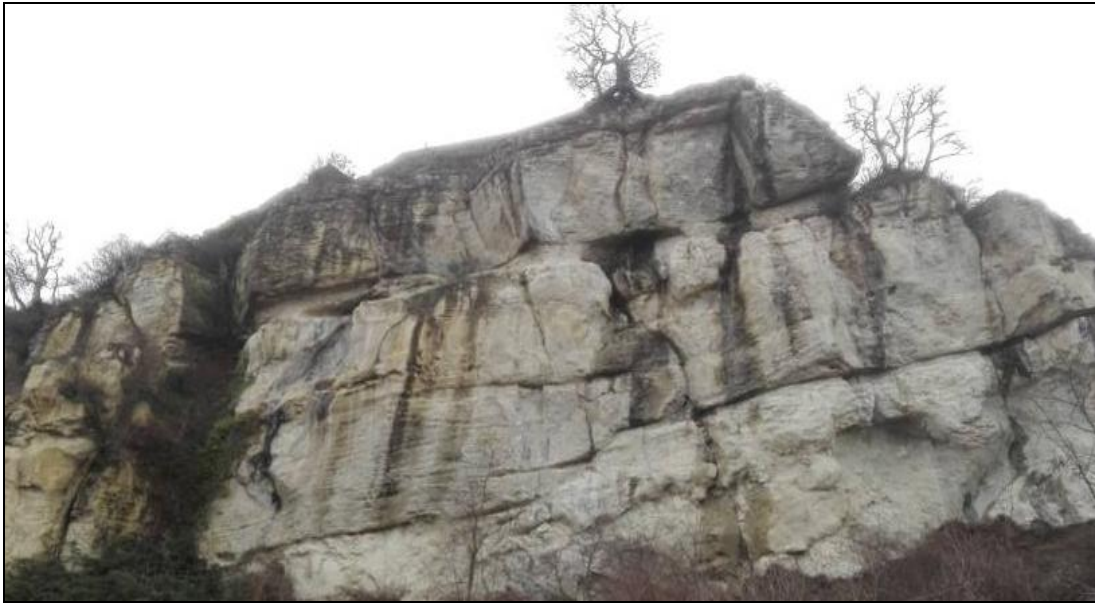
**Figure 53.** Sub-vertical fractures on the rocky wall of Canossa Cliff.

In addition to the “plate-substratum system” evolution, that is an extremely slow mechanism, several rapid phenomena such as rockfalls, slips and overturns of rocky blocks represent a serious risk for inhabitants, tourists and the exposed property. These phenomena are mainly due to the several sub-vertical fractures of the “Sandstones of Bismantova” that affect the cliff throughout its thickness (Figure 53), and are the cause of the cracks that currently are present in the castle ruins (Casagli et al., 2006).

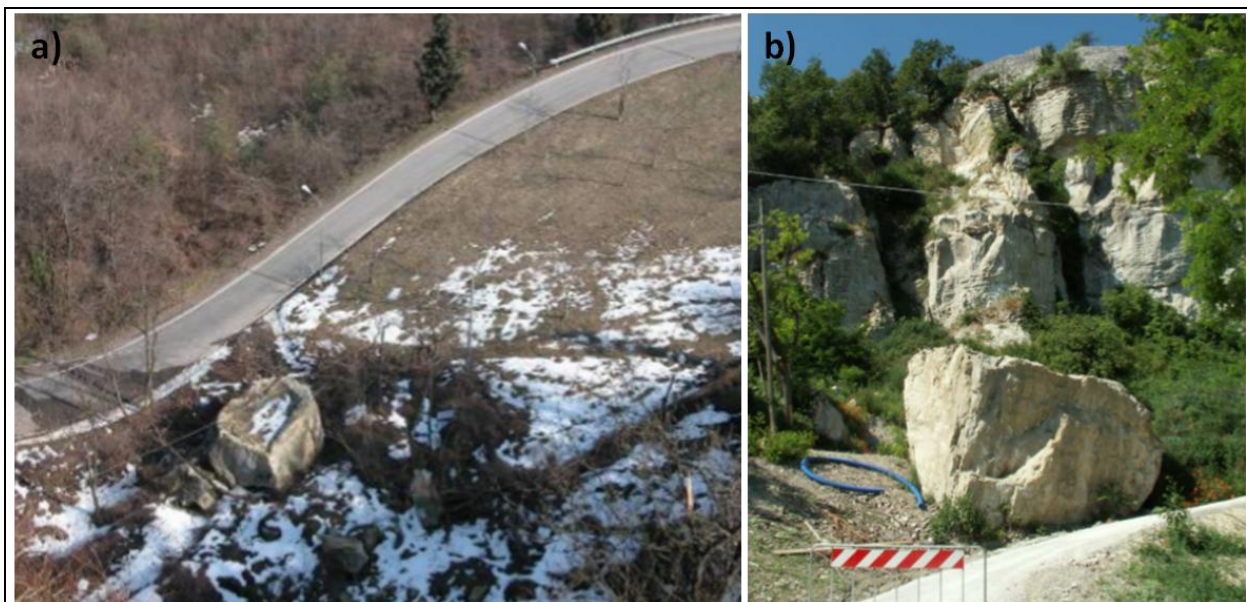
**Figure 57.** View from a) above and from b) below of the block of about  $80 \text{ m}^3$  that collapsed from the rock face on February 2004 (Casagli et al., 2006).
