## Experimental evaluation of tramway track wear by means of 3D metrological optical scanners

M. C. Valigi , S. Logozzo , E. Butini , E. Meli , L. Marini & A. Rindi

Wear evaluation of rolling components is crucial for tramway dynamics, maintenance and safety. 2D contact wear measurement techniques are the most commonly used to detect the health conditions of rails. In this paper, the novel use of a portable metrological 3D optical scanner is proposed and compared to the prior 2D methods. Laboratory results show that the application of 3D optical digitizers gives results consistent with the 2D results but gives also a more complete and global view of the wear phenomenon. Different inspection procedures are compared and discussed in order to propose the best method to perform 3D wear mapping. The results of on-line experimental campaigns on the real tramway line of Florence (Italy), performed with the current and the new proposed instruments and methods, are also presented and compared. From the results of this paper, new strategies for the maintenance service of tramways, and especially of the Florentine tramway, can be proposed.

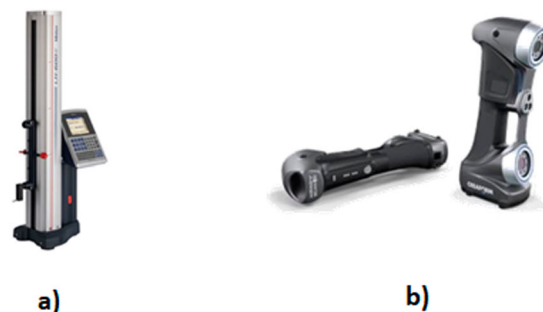
**Figure 2.** Measuring instruments: (a) 2D contact profilometer; (b) 3D laser scanner.

The 2D measuring instrument used in this work is Linear Height LH-600E/EG – Series 518 (Mitutoyo Corp., Kawasaki, Japan). This is a contact stylus profilometer (Figure 2(a)) and its technical specifications are reported in Table 1.

The 3D digitizing instrument is HandySCAN 700 (Creaform Inc., Lévis, Quebec), a portable optical non-contact 3D laser scanner for metrology (see Figure 2b), whose technical specifications are reported in Table 2.

In this device, a red laser source projects 7 + 1 laser crosses on the scene and the embedded 3D acquisition software VXelements (Creaform Inc., Lévis, Quebec) allows real-time 3D reconstructions of the specimen. The scanning procedure is performed by using physical targets as positioning references. Those targets are white highly reactive adhesive circles with black contours (Figure 1(b)), to be applied on the background or directly on the target object.

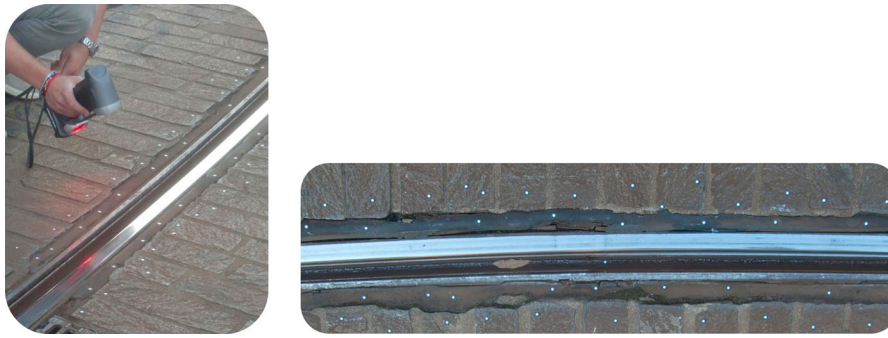
**Figure 10.** On-line 3D scanning campaigns.

the positioning model and to avoid misalignments (Figure 10). Real-time 3D collected data had a resolution of 0.1 mm. The on-line measurements took one hour. The post processing time for the on-line tests, comprising the wear measurements took one hour.

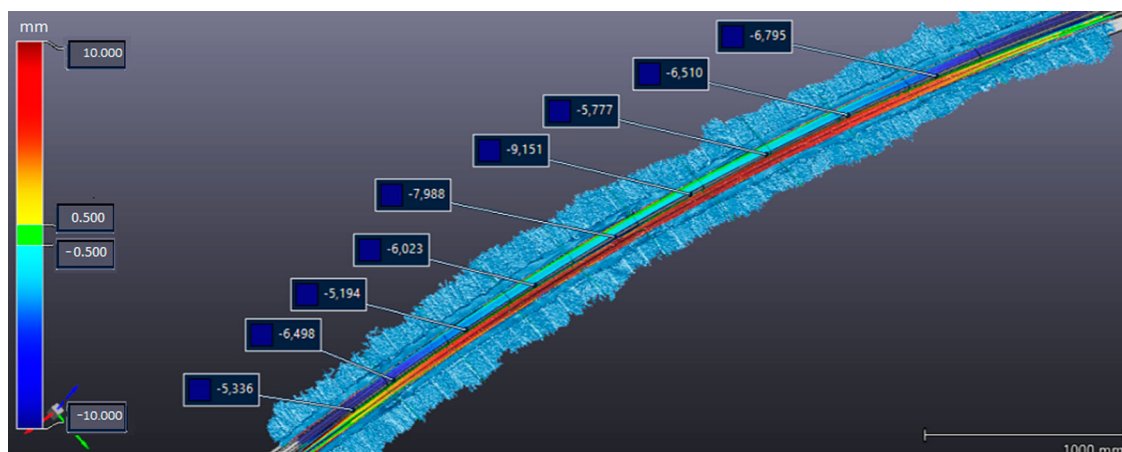
**Figure 12.** 3D wear map of the curvilinear portion.

Figure 12 shows the wear map corresponding to the curvilinear portion consisting of a circumferential arc and a clothoid.

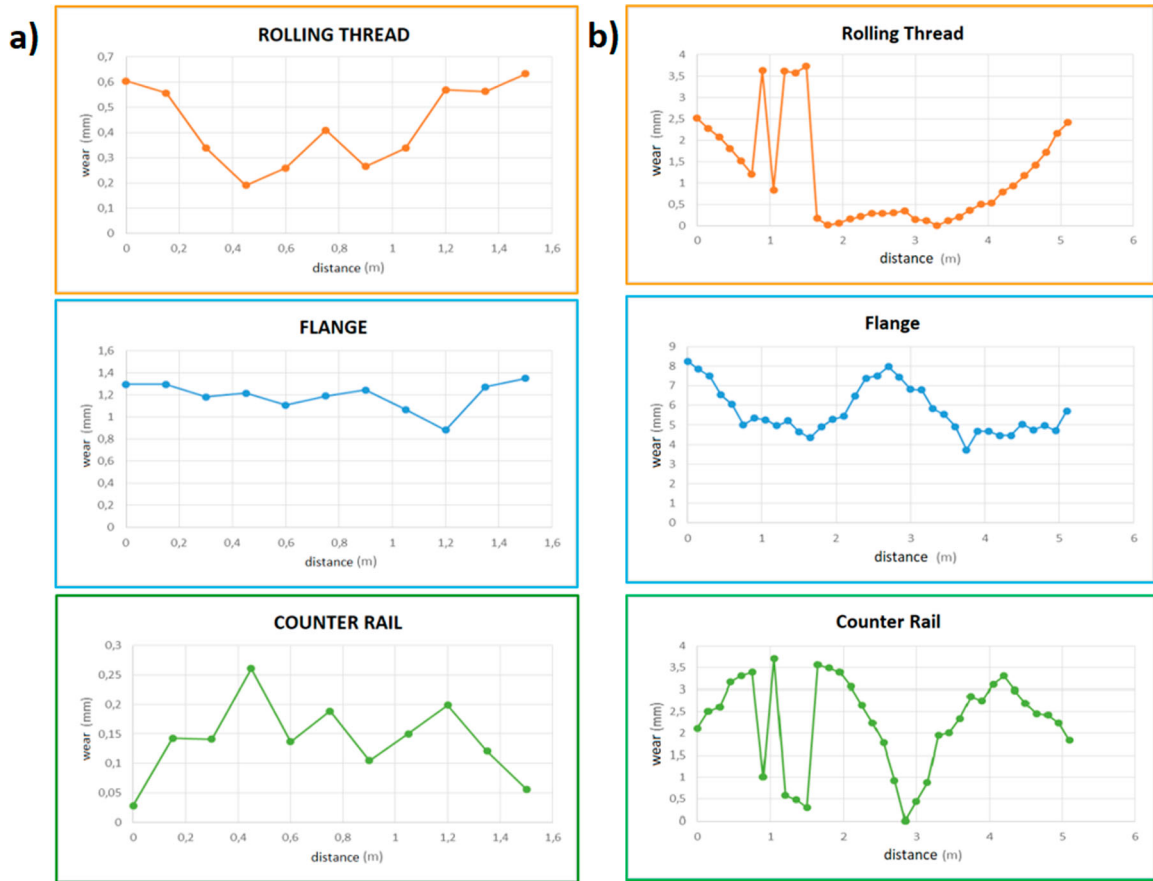
Figure 13. Wear depth every 150 mm: (a) over the rectilinear portion; (b) over the curvilinear portion.

From those two 3D wear maps, 2D sections and wear values in correspondence of the flange, the rolling thread and the counter rail were extracted every 150 mm from the beginning, as the current instruments measure. The results of both the rectilinear and curvilinear portions are shown in Figure 13. The maximum wear depth over the rectilinear portion of the rail is about 1.5 mm, while over the curvilinear portion it is about 8.5 mm.
