### Uffizi Gallery monitoring for IAQ assessment

# Uffizi Gallery monitoring for IAQ assessment

**Abstract.** In museums, poor indoor air quality combined with unsuitable thermal and hygrometric conditions can affect the visitors and staff well-being as well as cause the deterioration processes of the exhibit objects. In order to assess indoor air quality of the museum, a survey was carried out in some rooms of the Uffizi Gallery of Florence by the researchers of the Laboratory of Environmental Physics of the University of Florence. Indoor temperature, relative humidity, chemical and microbiological pollutants were sampled, and the results analyzed and discussed. To do that a general methodology of investigation and evaluation of the results was defined and applied to several rooms of the Gallery. The presence of critical pollutant concentration was underlined and proper investigations on the HVAC system were scheduled. In this paper the results regarding a representative room are shown and discussed.

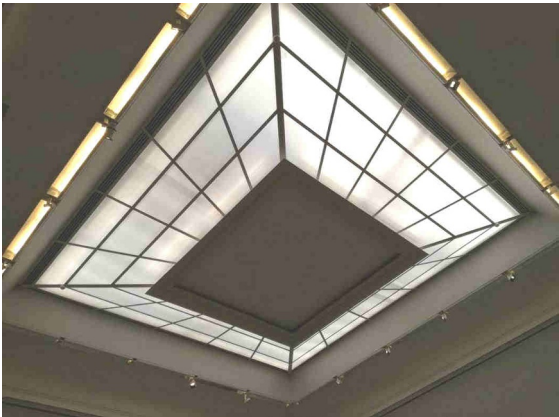
**Fig. 5.** Room 41: linear air inlet grids near the skylight.

As concerns the air conditioning of the museum, different AHUs provide heating, ventilating, and air-conditioning in the different rooms, while some of the investigated rooms are non-provided with air conditioning. In particular, HVAC system for room 41 has a variable percentage of air recirculation both in winter and summer conditions with a nominal air flow rate of 10000 m<sup>3</sup>/h (Figure 4). Air inlet is provided by linear grids (in the upper part of the room near the skylight) while air outlet grids are built-in the floor (Figures

- some high rooms can present temperature stratification problems together with a poor effectiveness of mechanical ventilation due to the position of the air inlet-outlet grids; this can result in an increasing CO<sub>2</sub> concentration with the same boundary condition of the HVAC system (air flow and air change rate) in different rooms such as room 41 and room 10 where maximum concentration with museum opened respectively is 889 and 1442 ppm;
- the control of relative humidity can be put in relation with the air treatments in the AHU when it works out of the “standard” boundary conditions;

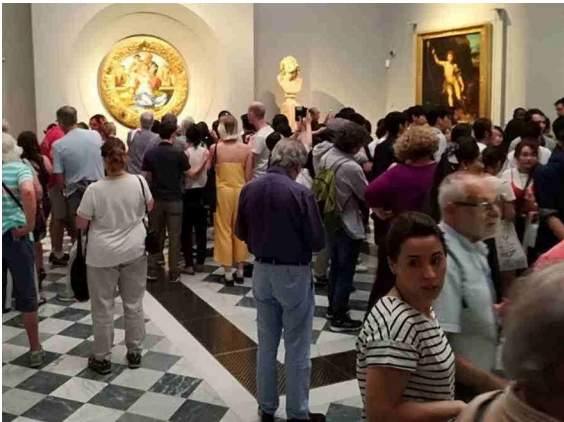
**Fig. 6.** Room 41: air outlet grids built-in the floor.

5 and 6). The AHU is located in a very narrow attic room and maintenance procedures can be particularly difficult (Figure 7).

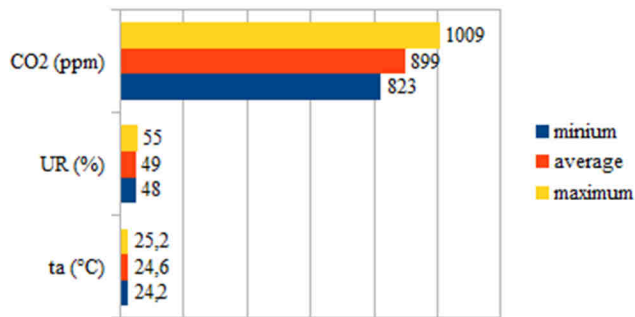
**Fig. 9.** Minimum, mean, and maximum values for carbon dioxide, relative humidity and air temperature in room 41 of the Uffizi Gallery.

For air temperature and relative humidity recommended ranges for correct conservation are respectively 19÷25°C and 45÷65% [11], while for carbon dioxide a concentration of 1000 is considered as limit value as is reported in Table 2. The sampled compared with the recommended limits shows almost acceptable values for temperature and relative humidity and an acceptable CO<sub>2</sub> concentration.

- carbon dioxide concentration depends both to external environment ( $\text{CO}_2=400$  ppm) and the presence of visitors and staff in the museum;
- $\text{CO}_2$  concentration trend and VOCs trend are very similar, so strategies aimed at carbon dioxide concentration control can be effective also for VOCs control;
