# Archaeoseismological project in Ostia: Tracking evidence on seismic damage by nonlinear numerical simulations

Within the framework of an archaeoseismological project in Ostia (Italy), this paper discusses archaeological evidence of historic seismic damage of one of the arcade pillars in a building originally used as a warehouse for goods - "Piccolo Mercato" - located in the North-West part of the archaeological site. This interdisciplinary study is aimed at providing an interpretation of the detected damage by performing some numerical simulations. One of the pillars was represented by a finite element (FE) model, considering natural ground motion records. FE model allowed to conduct complete nonlinear time-history analyses. The results cross-validate the already provided interpretation of the historic damage, and suggest a possible dateline.

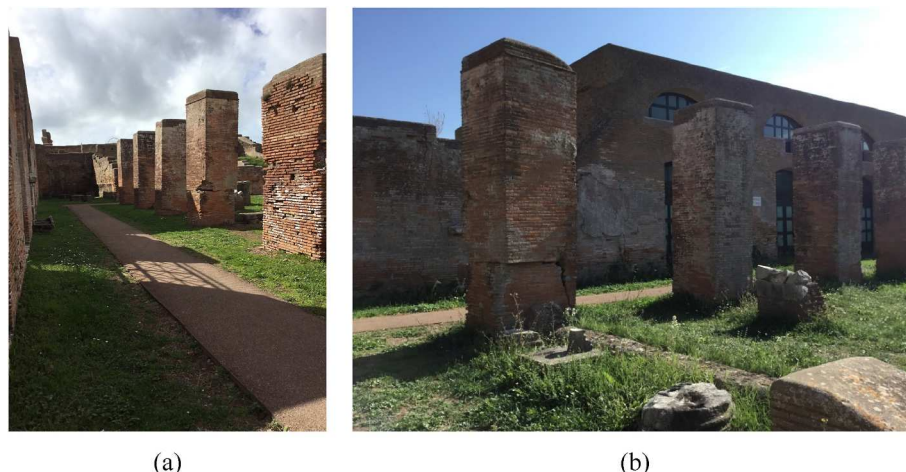
Fig. 5. Pillars of the arcade: a) view from the corridor b) view from the courtyard.

The pillar investigated in this paper is shown in Fig. 5. It belonged in ancient times, with other three pillars, to an arcade: it was a corner element where two internal corridors, with a width of 4.70 m and 4.40 m, intersected. The cross-section of the pillar is about  $1.1 \times 1.1$  m, and the today height is about 6 m. The typology of the vaulted corridors can be deduced from similar cases, such as the Insula degli Aurighi. It is possible to speculate the original presence of a barrel vault with lateral lunettes, pointing to the cross, compatible with rectangular structural modules (corridor wider than the front module).

Focusing on the construction technique of the pillars, it is noticeable that bonding (o leveling) courses of bipedales layers (large bricks ca. 58 cm square) are present that give an aesthetic interval and provide better load distribution. Courses of bipedales are common features in the brick-faced walls of many second-century buildings on Opus Testaceum in Rome. Bipedales were used to carry out the detailed design layout directly on site, with the dimensions measured in situ forming the basis. The pattern of the bonding courses suggests that they were used as organizational tools by setting certain key heights and in at least one case by providing a "benchmark" level to which all walls were brought before proceeding. In addition, normally bonding courses of bipedales and brick linings were used as formwork for vaulting.

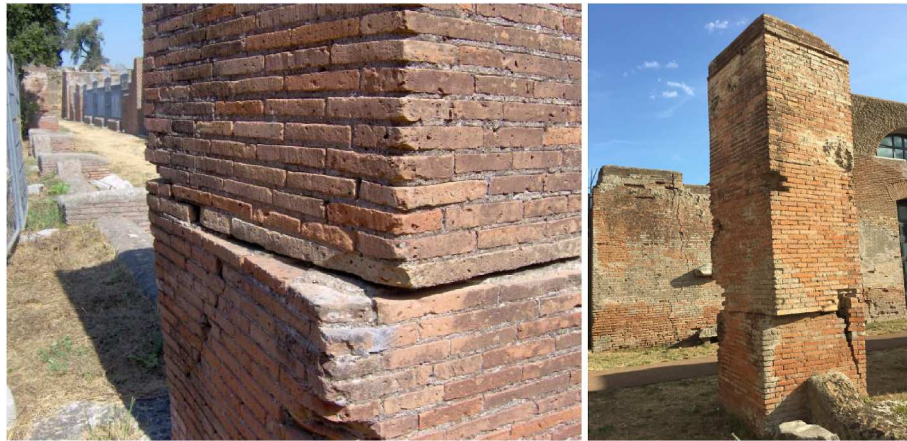
Fig. 6. Historic damage in one of the pillars of the “Piccolo Mercato”. The fracture zone due to the twisting of the pillar is clearly visible.

All the pillars of the arcade mentioned above show similar damage, which is more evident on the one here analyzed (Fig. 6). This pillar

exhibited rotation around its vertical axis at the level of the bipedals. In 1918, R. Lanciani (Lanciani, 1918), attributed this damage to a seismic event, later confirmed in recent literature. Among the other, a kinematic analysis was applied in (Pecchioli et al., 2018) to analyse the crack patterns and to hypothesize the dynamic and direction of the seismic event.

To perform the numerical analyses, a relatively simple FE model of the reference pillar which exhibits possible historic seismic damage (Fig. 6) was built using the FE code ANSYS (Betti et al., 2016; Bartoli et al., 2017). The model was employed to conduct some preliminary dynamic analyses aimed at assessing the possible configuration of this pillar when the damage occurred.
