Indoor Air Quality in the Uffizi Gallery of Florence: Sampling, Assessment and Improvement Strategies

Abstract: The assessment of indoor air quality (IAQ) in museums is a complex issue. In this study, a comprehensive investigation methodology was defined and applied to a museum to be validated. This methodology includes the analysis of exposed objects, the optimal conditions for conservation, the building features and the HVAC systems, and the indoor thermo-hygrometric and air quality conditions. In 2019, a survey in the Uffizi Gallery of Florence, one of the most important museums in the world, was carried out to assess the IAQ conditions in the museum, and the workers and visitors' well-being, by focusing on some representative rooms (nine) of the museum complex in terms of visitor turnout and HVAC systems, including rooms closed to the public. Since IAQ is related to the possible presence and concentration of chemical and biological pollutants, these indicators, as well as thermo-hygrometric parameters, were monitored. The monitoring results were analyzed, evaluated, and compared with those suggested by the literature, guidelines and legislative documents dealing with IAQ in mu

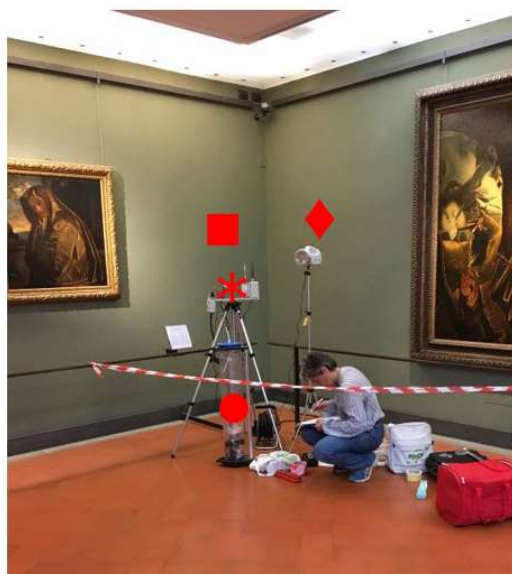
- t, RH and CO₂
- VOCs
- ◆ TBL and molds (active sampling)
- * TBL and molds (passive sampling)

Figure 5. Equipment for IAQ monitoring positioned in a representative room of the Uffizi Gallery (Room 160).

Figure 5 shows the equipment for IAQ monitoring positioned in a representative room of the case study (Room 160).

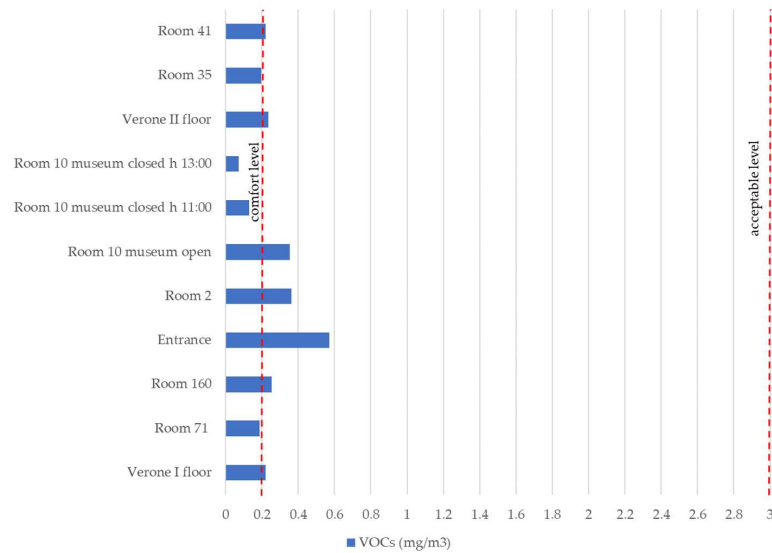
In Figure 8, for each analyzed room, the measured values for VOCs concentration are reported and compared with comfort ($<0.200 \text{ mg/m}^3$) and acceptable ($0.200 \div 3 \text{ mg/m}^3$) values for these pollutants [10,12]. For Room 10, one of the most visited areas, samples were also taken on a closed day of the museum (3 June 2019), during which there was only one guided tour by a small group of visitors at 11:00, while the measurement of 13:00 refers to the museum totally without visitors.

Figure 8. Sampled values for VOCs (mg/m^3) in the analyzed rooms of the Uffizi Gallery compared with comfort ($<0.200 \text{ mg/m}^3$) and acceptable ($0.200 \div 3 \text{ mg/m}^3$) values for people.

Regarding the VOCs concentration (Figure 8), comparison of the values from sampling carried out in Room 10 when the museum was closed with days of high visitor turnout confirmed the hypothesis of human influence on the release of volatile organic compounds. The two VOCs values relating to the first and second sampling in Room 10 on the day of closure to the public provide significant information on the effectiveness and importance of the air exchange provided by the ventilation system: two hours between the passage of the first group of visitors (11:00) and the following group (13:00) were sufficient to reduce the VOCs concentration by 44%.

The values compared with the recommended limits reported in Table 3 showed comfortable (Room 35, Room 41, and Room 71) or acceptable levels for the VOCs concentrations.
