Indoor Air Quality in the Uffizi Gallery of Florence: Sampling, Assessment and Improvement Strategies

Abstract: The assessment of indoor air quality (IAQ) in museums is a complex issue. In this study, a comprehensive investigation methodology was defined and applied to a museum to be validated. This methodology includes the analysis of exposed objects, the optimal conditions for conservation, the building features and the HVAC systems, and the indoor thermo-hygrometric and air quality conditions. In 2019, a survey in the Uffizi Gallery of Florence, one of the most important museums in the world, was carried out to assess the IAQ conditions in the museum, and the workers and visitors' well-being, by focusing on some representative rooms (nine) of the museum complex in terms of visitor turnout and HVAC systems, including rooms closed to the public. Since IAQ is related to the possible presence and concentration of chemical and biological pollutants, these indicators, as well as thermo-hygrometric parameters, were monitored. The monitoring results were analyzed, evaluated, and compared with those suggested by the literature, guidelines and legislative documents dealing with IAQ in mu

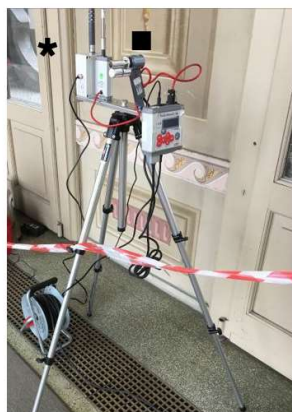
To monitor the indoor air temperature, relative humidity and CO₂ concentration, a datalogger connected with a psychrometer (air temperature [°C] and relative humidity [%]), and a CO₂ probe [ppm] were used. This microclimate station measured the parameters every minute for 30 min in sequence in each room analyzed. Table 6 summarizes the main features of the microclimate station [35].

■ Psychrometer	
Sensor	Pt100 (1/3DIN)
Accuracy	0.10 °C (0 °C); 0.13 °C (20 °C) 2% (15 ÷ 40%); 1% (40 ÷ 70%); 0.5% (70 ÷ 98%)
Response time	90'' (operating fan)
Measurement range	t _{db} *: 25 ÷ 150 °C; t _{wb} **: 0 ÷ 60 °C RH: 0 ÷ 100%
*CO ₂ Probe	
Sensor	Absorption infra-red cell
Accuracy	3% measure range
Response time	<30''
Measurement range	0 ÷ 3000 ppm

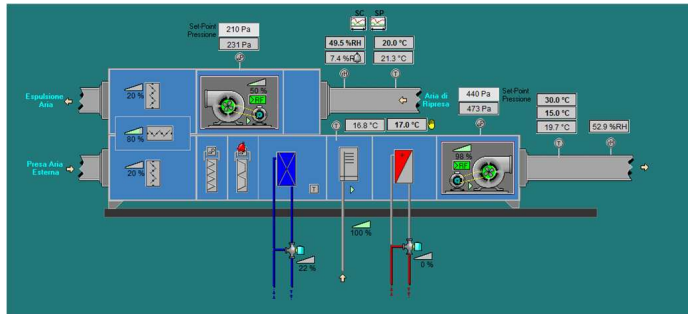
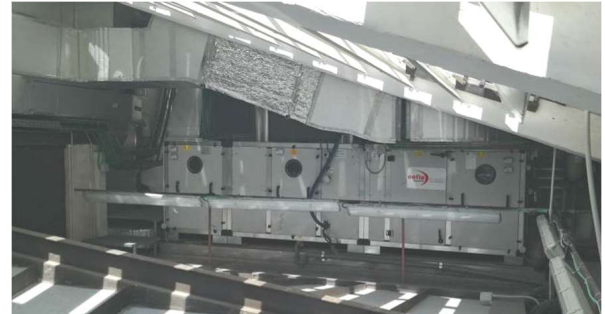
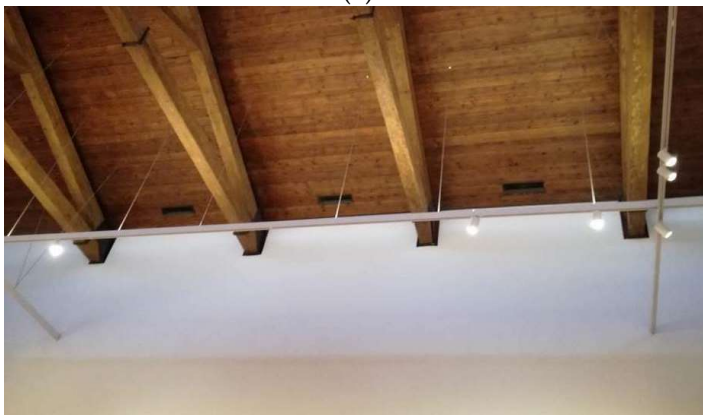
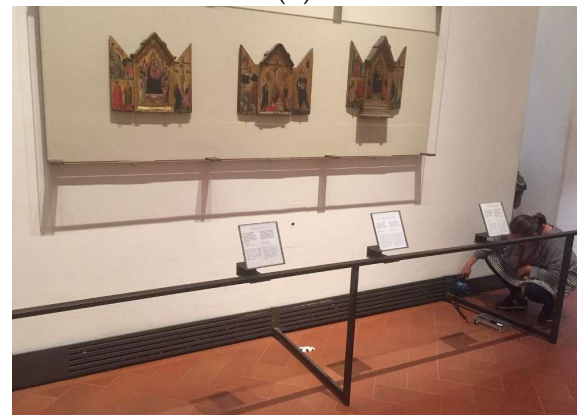
Figure 2. (a) AHU control system scheme, (b) AHU in the attic room, (c) air inlet grids from the top of the roof, and (d) air outlet grids at the bottom of the opposite wall of Room 2.

With respect to the HVAC system serving the building, the Uffizi Gallery is mainly equipped with HVAC systems which recirculate the air, for the control of air temperature and relative humidity, all year. Moreover, the system is managed by a remote monitoring and control system, positioned in a technical room, that also controls the fire system, the security system, and the electrical system. As an example, Figure 2 shows the air handling unit (AHU) control system of Room 2 and some pictures of the room.

Room 2 (Figure 4c) has no external walls. Inside the room, the very famous “Maestà di Ognissanti” by Giotto (about 1310), a tempera and gold painting on wood, is displayed. Samplings were carried out near the painting. The room has a floor area of 198.27 m², a height of 9.85 m and a volume of 1952.96 m³. It is equipped with an HVAC system for the control all year of temperature and relative humidity, managed by a remote monitoring and control system. The AHU, housed in an attic room, allows all year centralized air treatment with recirculation and is equipped with supply and return fans with variable flow (nominal air flow rate of 8000 m³/h). The air inlet grids are positioned at the top of the roof, while the air outlet grids are located at the bottom of the opposite wall.

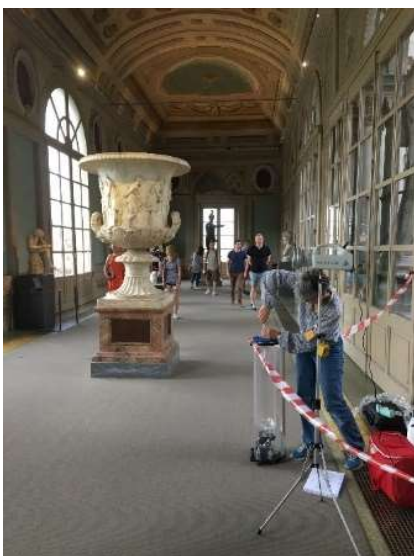
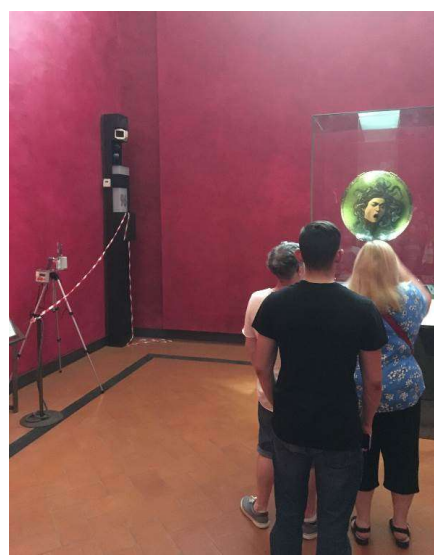
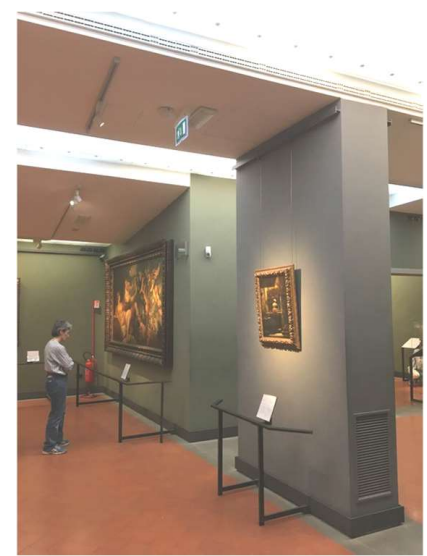
Figure 3. Analyzed rooms on the first floor of the Uffizi Gallery: (a) Verone I floor, (b) Room 41 and (c) Room 160.

On the first floor of the museum, three rooms were considered (Figure 3). The Verone I floor (Figure 3a) has views from every orientation with large windows and mainly hosts ancient statues and busts. Sampling was performed near the north-facing window. The Verone I floor has a floor area of 201.04 m², a height of 8.17 m and a volume of 1642.50 m³. It is equipped with an HVAC system for control all year of temperature

and relative humidity, managed by a remote monitoring and control system. The primary ventilation air comes from the AHU, using supply fans with variable flow (nominal air flow rate of 1400 m³/h), and enters the room through floor inductors. There is no recirculated air.

Room 71 (Figure 3b) has non-external walls. Inside the room, the “Scudo con testa di Medusa” of Michelangelo Merisi from Caravaggio is displayed, an oil painting on canvas (1597). Samplings were carried out near the painting. The room has a floor area of 69.28 m², a height of 8.02 m and a volume of 555.62 m³. It is equipped with an HVAC system for the control all year of temperature and relative humidity, managed by a remote monitoring and control system. The AHU, housed in an attic room, allows for centralized air treatment in summer mode, while, in winter mode, there is also the possibility of post-heating by means of zone batteries; the outdoor air intake is on the roof and there are variable flow fans (nominal air flow rate of 9000 m³/h). Air inlet and outlet takes place through floor grids with adjustable nozzles.

Room 160 (Figure 3c) has a north-west oriented windowless external wall and a skylight. It houses the collection donated by Contini-Bonacossi, with paintings and marble statues. Samplings were carried out near the precious paintings. The room has a floor area of 89.10 m², a height of 3.17 m and a volume of 282.45 m³. It is equipped with an HVAC system for the control all year of temperature and relative humidity, managed by a remote monitoring and control system. The AHU, housed in a technical room located inside a storage area of the museum, allows centralized air treatment with recirculation in summer mode, while, in winter mode, there is also the possibility of post-heating by means of zone batteries; the outdoor air intake is on the roof and there are supply and return fans with variable flow (nominal air flow rate of 8000 m³/h). The air inlets grids are positioned at the top under the skylight and the air outlet grids are located at the bottom of the wall. In this room only, there is a system for continuous monitoring of CO₂ and VOCs owned by the museum.

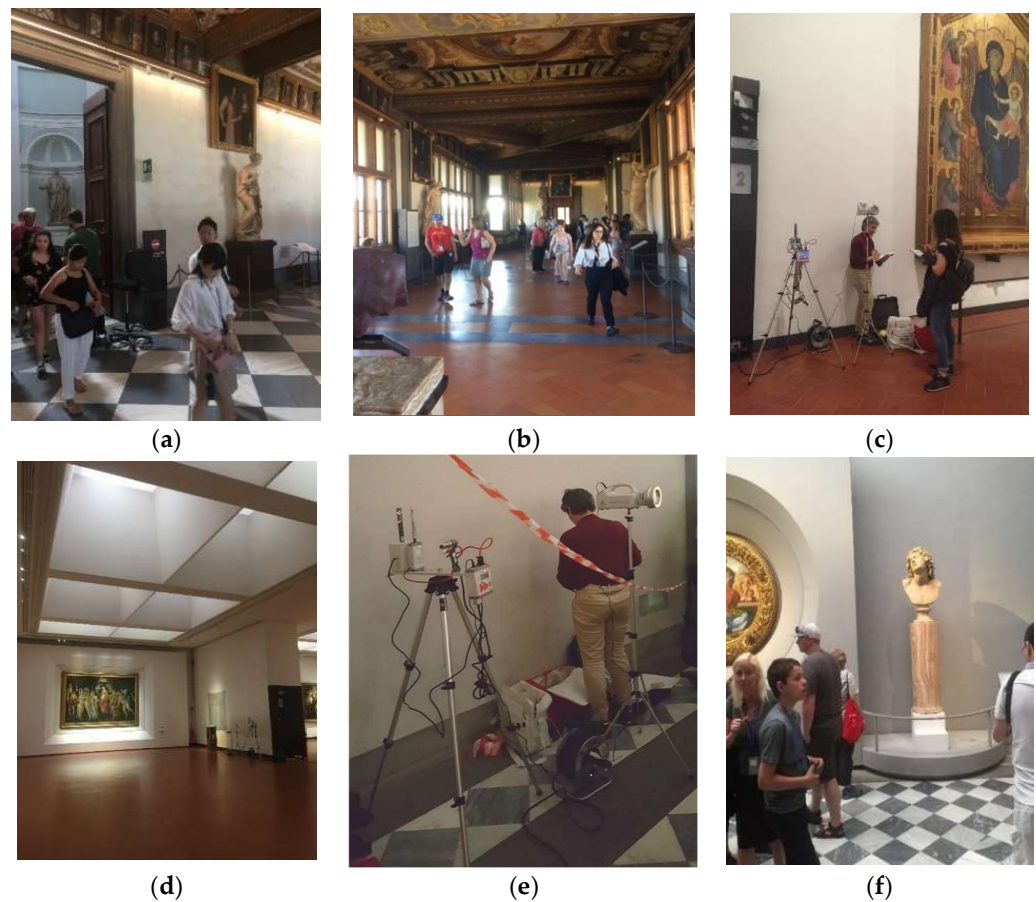
Figure 4. Analyzed rooms on the second floor of the Uffizi Gallery: (a) Entrance, (b) Verone II floor, (c) Room 2, (d) Room 10, (e) Room 35 and (f) Room 41.

The other six rooms analyzed are located on the second floor of the building (Figure 4). The entrance (Figure 4a) of the Uffizi Gallery overlooks a large corridor. It faces west with large windows and mainly hosts marble statues and paintings on canvas. Sampling was performed near the visitor control area. The entrance has a floor area of 317.14 m², a height of 5.68 m and a volume of 1801.35 m³. The space is equipped with nine fan coils placed in the internal wall of the corridor without air exchange. The recirculated indoor air is heated/cooled by the fan coil exchanger and then sent through a duct to the floor air inlets placed on the opposite side of the corridor. Inspection of the equipment is difficult.

The Verone II floor (Figure 4b) is a corridor connected to the entrance of the Gallery. It is north-, south- and west-oriented, with large windows, and mainly hosts marble statues and paintings on canvas. Sampling was performed near the west-facing window, an area without an air conditioning system. It has a floor area of 214.99 m², a height of 5.68 m and a volume of 1221.14 m³.

Room 10 (Figure 4d) has only an east-oriented windowless external wall. Inside the room there is the well-known “Primavera” by Sandro Botticelli, a tempera painting on wood (1478–1482). Samplings were carried out near the painting. The room has a floor area of 146.34 m², a height of 8.93 m and a volume of 1306.82 m³. It is equipped with an HVAC system for the control all year of temperature and relative humidity, managed by a remote monitoring and control system. The AHU, housed in an attic room, allows the centralized air treatment with air recirculation all year, and is equipped with supply and return fans with variable flow (nominal air flow of 8000 m³/h). The air inlet and outlet takes place through linear grids placed under the top skylight.

Room 35 (Figure 4e) has one west-oriented windowless external wall. Inside the room there is the “Adorazione dei Magi” of Leonardo da Vinci, a tempera and oil painting (1481–1482). Samplings were carried out near the painting. It has a floor area of 146.80 m^2 , a height of 6.61 m and a volume of 970.35 m^3 . It is equipped with an HVAC system for the control all year of temperature and relative humidity, managed by a remote monitoring and control system. The AHU, housed in an attic room, allows centralized air treatment with air recirculation all year and is equipped with supply and return fans without variable flow (nominal air flow of $9500 \text{ m}^3/\text{h}$). The air inlet takes place through linear grids placed on the top of the ceiling while the air outlet occurs through floor grids.

Room 41 (Figure 4f) has one west-oriented windowless external wall. Inside the room there is the Sacra Famiglia, called “Tondo Doni”, of Michelangelo Buonarroti, a tempera painting on wood (1503–1504). The room samplings were carried out near the painting. The room has a floor area of 140.91 m^2 , a height of 6.61 m and a volume of 931.41 m^3 . It is equipped with an HVAC system for the control all year of temperature and relative humidity, managed by a remote monitoring and control system. The AHU allows centralized air treatment with air recirculation all year, and is equipped with supply and return fans without variable flow (nominal air flow of $10000 \text{ m}^3/\text{h}$). The air inlet takes place through linear grids placed on the top of the ceiling, near the skylight, while the air outlet occurs through floor grids. The AHU is located in a very narrow attic room, which is particularly difficult to access for maintenance purposes.

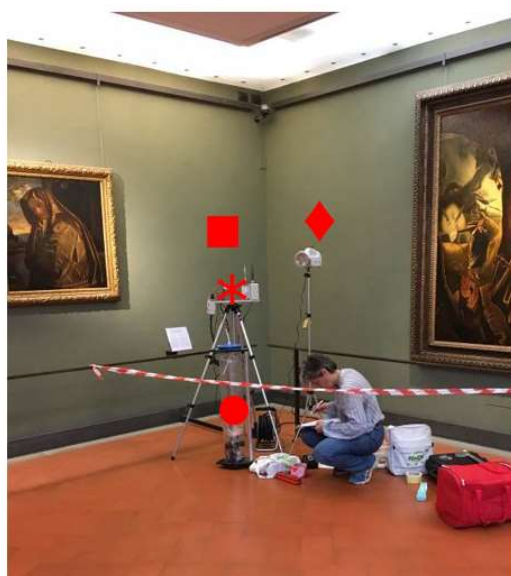
Figure 5 shows the equipment for IAQ monitoring positioned in a representative room of the case study (Room 160).

■ t, RH and CO₂

● VOCs

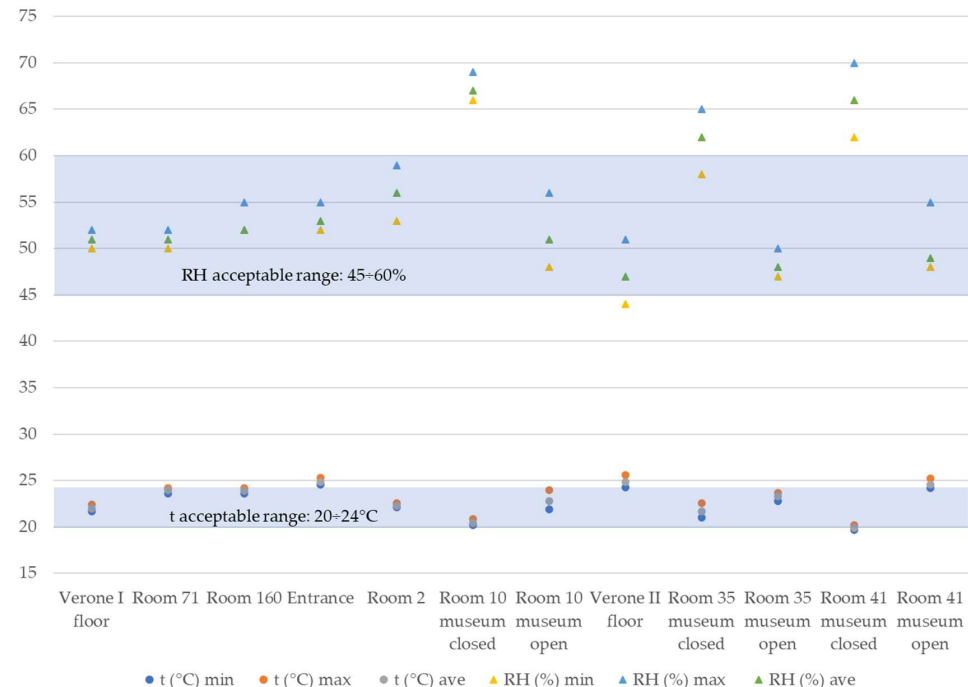
Figure 6 shows, for each analyzed room and monitoring period, the minimum, average, and maximum measured values for air temperature (t) and relative humidity (RH).

The values were compared with narrow ranges considered acceptable for both artwork conservation (paintings— $19 \div 24$ °C for temperature and $45 \div 65\%$ for relative humidity [30]) and for the comfort of people ($20 \div 26$ °C for temperature and $40 \div 60\%$ for relative humidity [20,21]), i.e., $20 \div 24$ °C for temperature and $45 \div 60\%$ for relative humidity.

Figure 6. Minimum, average and maximum measured values for temperature (t [°C]) and relative humidity (RH [%]) compared together with recommended values.

With respect to the microclimatic parameters (Figure 6), the measured values compared with the recommended ranges showed acceptable values for air temperature in the majority of the rooms—in some of them the values were only slightly over the limit value. For relative humidity, the values were above the limits when the museum was closed to the public in Room 10, Room 35, and Room 41. For the temperature values, the environment with the highest values (over 26 °C), which went beyond the conservation levels of the paintings and the comfort of people, was the Verone II floor, which had no HVAC systems. By comparison between data collected in the rooms with the museum closed and when open to the public, it was observed that when the museum was closed, the temperature and relative humidity values were often outside the optimal ranges. In particular, when the museum was closed, the temperature had lower values and the relative humidity higher values, even reaching 70% in Room 10 and Room 41. These data suggest that when the museum was closed, with climatic conditions that were not critical for a lack of sensible heat due to the occupants, the temperature was lower due to the absence of the public; under these conditions, the HVAC system was not able to control the relative humidity as it was not working under standard operating conditions. The fluctuations in the above-mentioned parameters must, therefore, be carefully assessed so that they do not cause damage to the artefacts of the museum.

To guarantee and maintain optimal microclimatic conditions for the correct conservation of the objects displayed, variation in the temperature and relative humidity values must be carefully monitored, in particular, where paintings on wood are exposed. The best conditions are those that address, at the same time, air conditioning requirements, energy saving needs and the architectural constraints of the museum operating in an historic ancient building.

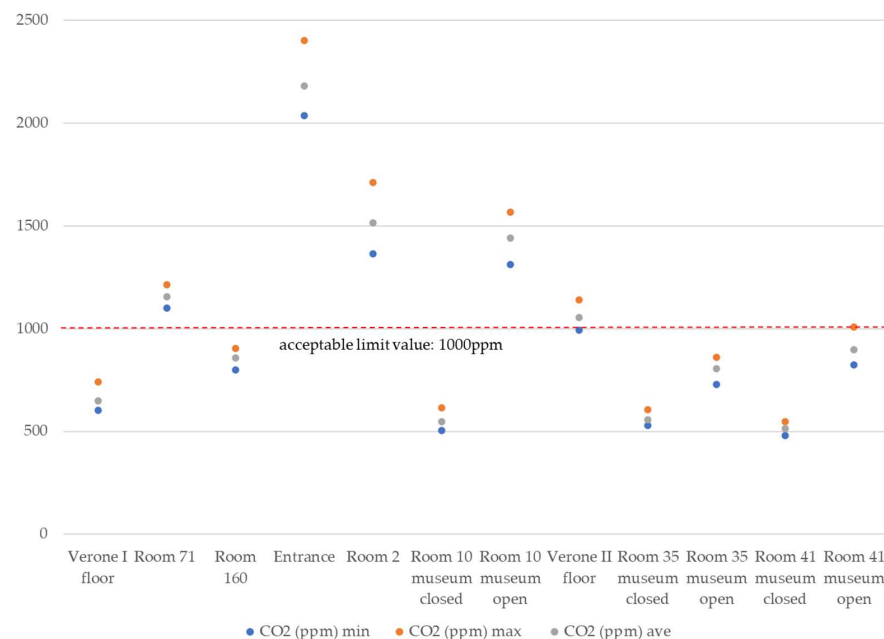
Figure 7 shows, for each analyzed room and monitoring period, the minimum, average and maximum measured values for carbon dioxide concentration, which were compared with value ranges considered acceptable for people, i.e., 1000 ppm [12].

Figure 7. Minimum, average and maximum measured values for carbon dioxide concentration (CO₂ [ppm]) compared together with value ranges considered acceptable for people.

The comparison between the measured values of the CO₂ concentration in the presence of visitors (average concentration in Room 10, Room 35, and Room 41 equal to about 1049 ppm) and when the museum was closed (average concentration in Room 10, Room 35, and Room 41 equal to about 540 ppm) made it possible to evaluate the influence of the presence of the public, which was associated with an approximate doubling of the background concentration of CO₂ in rooms with mechanical ventilation.

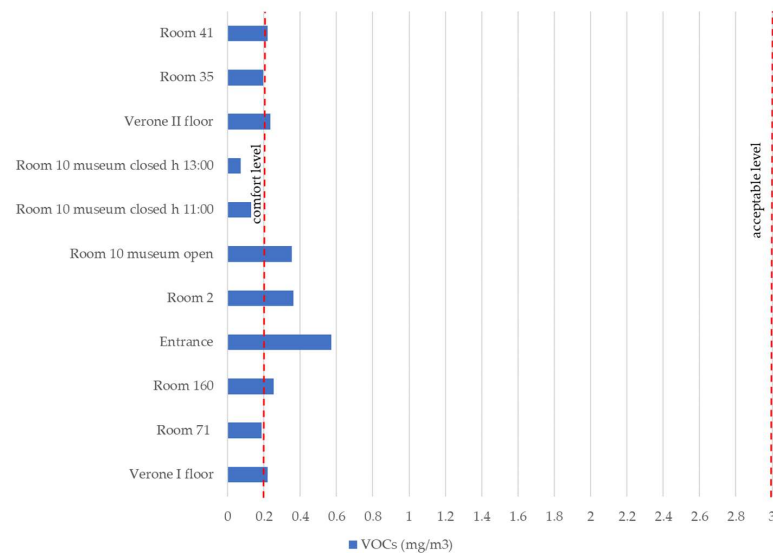
In Figure 8, for each analyzed room, the measured values for VOCs concentration are reported and compared with comfort ($<0.200 \text{ mg/m}^3$) and acceptable ($0.200 \div 3 \text{ mg/m}^3$) values for these pollutants [10,12]. For Room 10, one of the most visited areas, samples were also taken on a closed day of the museum (3 June 2019), during which there was only one guided tour by a small group of visitors at 11:00, while the measurement of 13:00 refers to the museum totally without visitors.

Figure 8. Sampled values for VOCs (mg/m^3) in the analyzed rooms of the Uffizi Gallery compared with comfort ($<0.200 \text{ mg/m}^3$) and acceptable ($0.200 \div 3 \text{ mg/m}^3$) values for people.

Regarding the VOCs concentration (Figure 8), comparison of the values from sampling carried out in Room 10 when the museum was closed with days of high visitor turnout confirmed the hypothesis of human influence on the release of volatile organic compounds. The two VOCs values relating to the first and second sampling in Room 10 on the day of closure to the public provide significant information on the effectiveness and importance of the air exchange provided by the ventilation system: two hours between the passage of the first group of visitors (11:00) and the following group (13:00) were sufficient to reduce the VOCs concentration by 44%.

The values compared with the recommended limits reported in Table 3 showed comfortable (Room 35, Room 41, and Room 71) or acceptable levels for the VOCs concentrations.

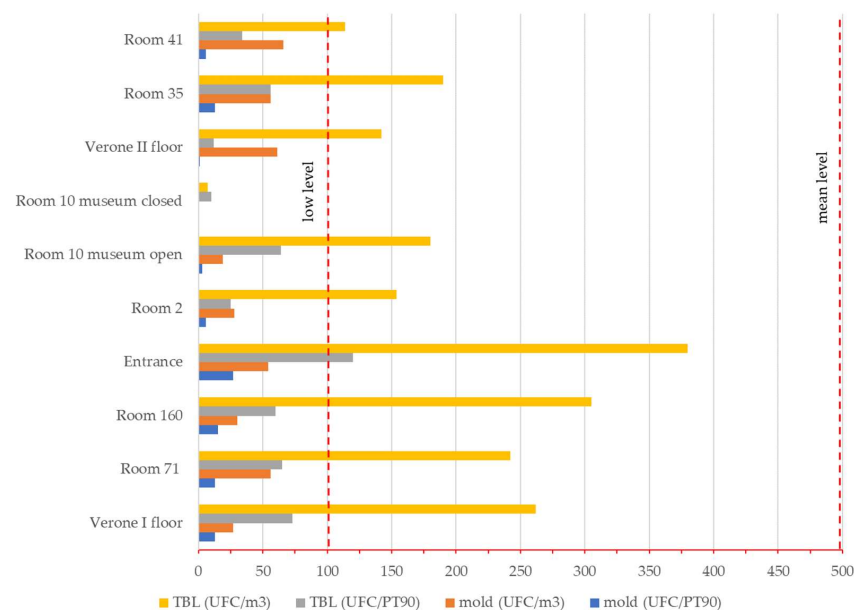
Figure 9 reports, for each analyzed room, the results of the sampling carried out for biological pollutants compared with reference values reported in Table 4. The results expressed in CFU/m^3 were obtained from active sampling, while those expressed in CFU/PT90 refer to passive sampling of TBL and mold. The greater concentration detected by active sampling compared to passive is a natural consequence of the sampling technique: passive sampling does not force the capture of microorganisms and, thus, lower values are expected.

Figure 9. Values for biological pollutant sampling in the analyzed rooms of the Uffizi Gallery compared with reference values for TBL and molds.

The observed environmental molds were of the *Aspergillus* and *Penicillium* genera. The first species is ubiquitous and, therefore, is often monitored in different environments. *Flavus* and *Fumigatus* species (classified in [31] as allergenic molds) were recorded, while *Aspergillus niger* was not identified. *Penicillium* genera can generate respiratory tract disorders in predisposed or immunosuppressed subjects.

- Microbiological pollutants: It is suggested that biological monitoring is extended to investigate the presence of microbiological agents in the airduct, on the air inlet and outlet grids, as well as on the filters, before and after washing/replacement operations;

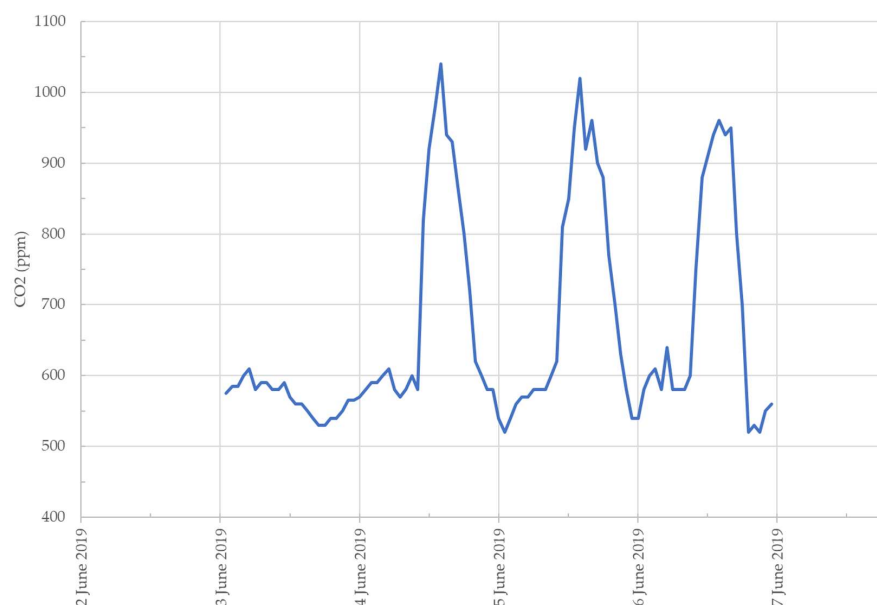
Figure 10 shows the trend in CO₂ concentration measured by the continuous monitoring system owned by the museum and present only in Room 160 from 3 to 6 June 2019; these data are in line with those monitored during the spot campaign (with a difference of about 5%). The CO₂ minimum value measured in Room 160 in this period was 530 ppm (museum closed) while the maximum value was 1040 ppm (museum open). This background concentration of CO₂ is consistent with the average Italian data measured outdoors in 2019 and equal to 410 ppm [38], considering that there were still people present in the museum even during closing hours (staff, restorers, maintenance workers, etc.). The graph also shows that the highest concentration of CO₂ was reached between 10:30 and 16:00, indicating that these times were also those with the greatest turnout of visitors.

Figure 10. Trend of CO₂ values (ppm) for the period from 3 to 6 June 2019 detected by the continuous monitoring system in Room 160 owned by the museum.
