# VIII. THE CUPOLA CHURCH

## An Archaeological Stratigraphic Description

**Abstract** / This paper presents an archaeological analysis of the Cupola Church in Yeghegis, highlighting the distinctive construction features of a building representative of an architectural type widely found in medieval Armenia. Through stratigraphic investigation, the research details the church's construction procedures, the traces of the devotion of the worshippers, and the restoration interventions of the 1970s. By situating the building within the broader framework of sacred architecture in Vayots' Dzor and the neighboring regions, the study narrows the dating of the church to the late thirteenth century and traces architectural continuities and influences that contribute to our understanding of the architectural program promoted by the Örbëlean dynasty in the thirteenth and fourteenth centuries.

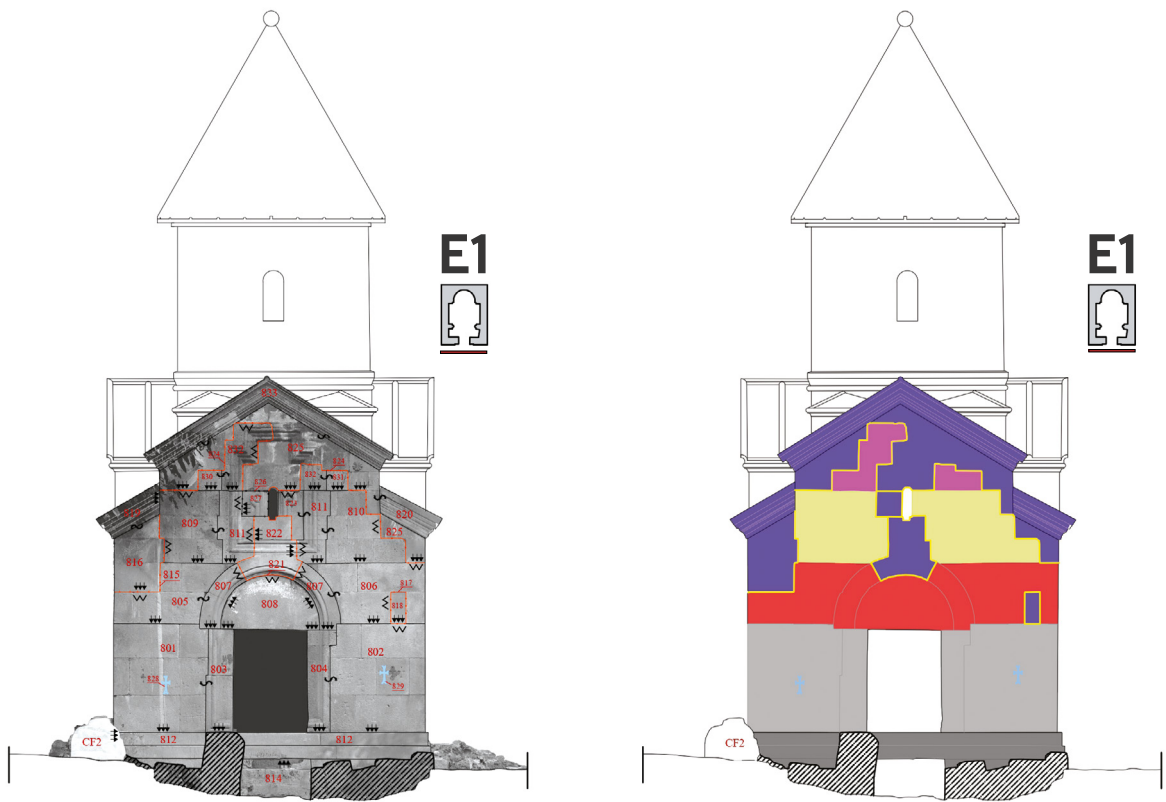
E1: ARCHAEOLOGICAL ANALYSIS

| 813 | Foundation element of B1, visible in the lower part of E1 | | 812 | | |
| 826 | Cut for the replacement of the molded left jamb of the window in E1 | 822, 825 | 827 | | |

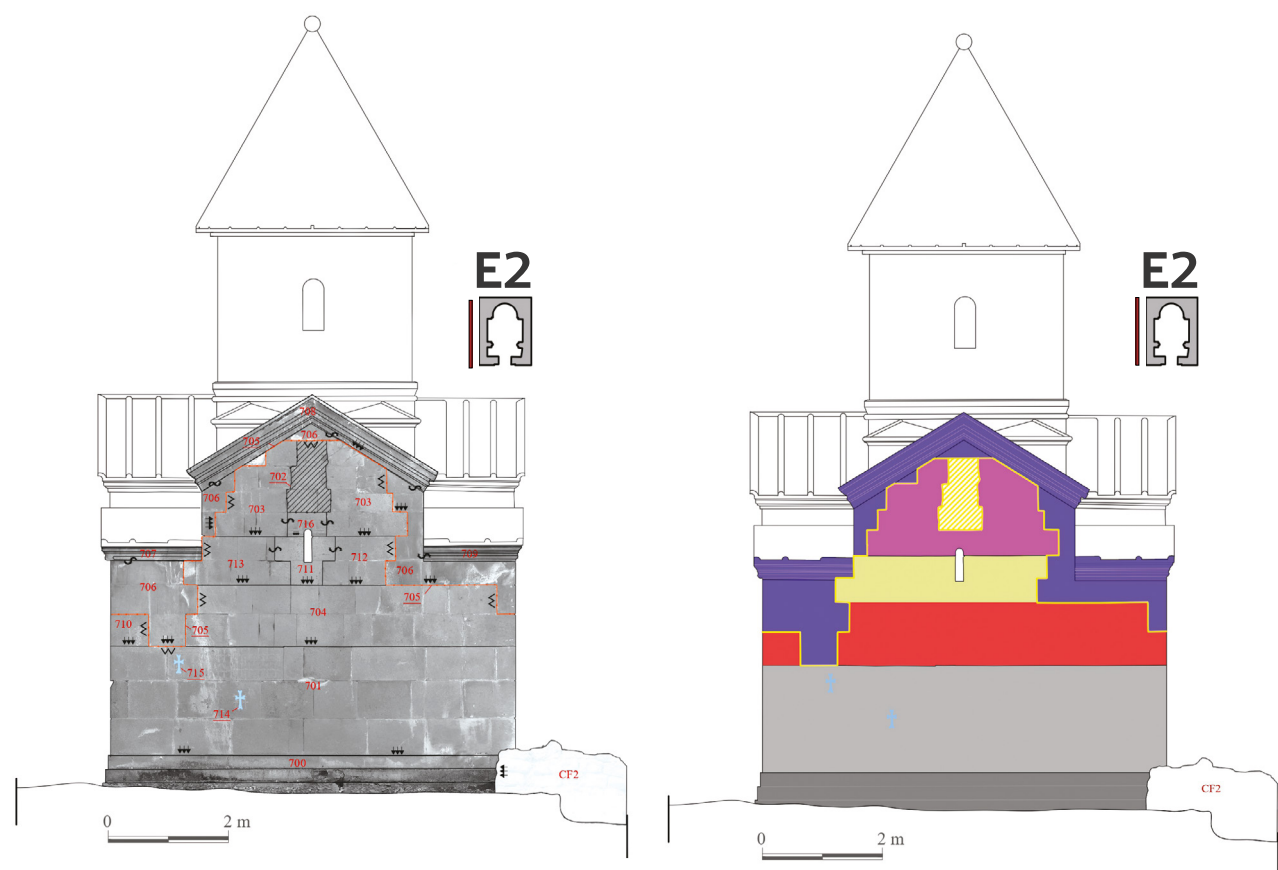
E2: ARCHAEOLOGICAL ANALYSIS

| 716 | Lintel of the window | 711 | 702 | 703 | |

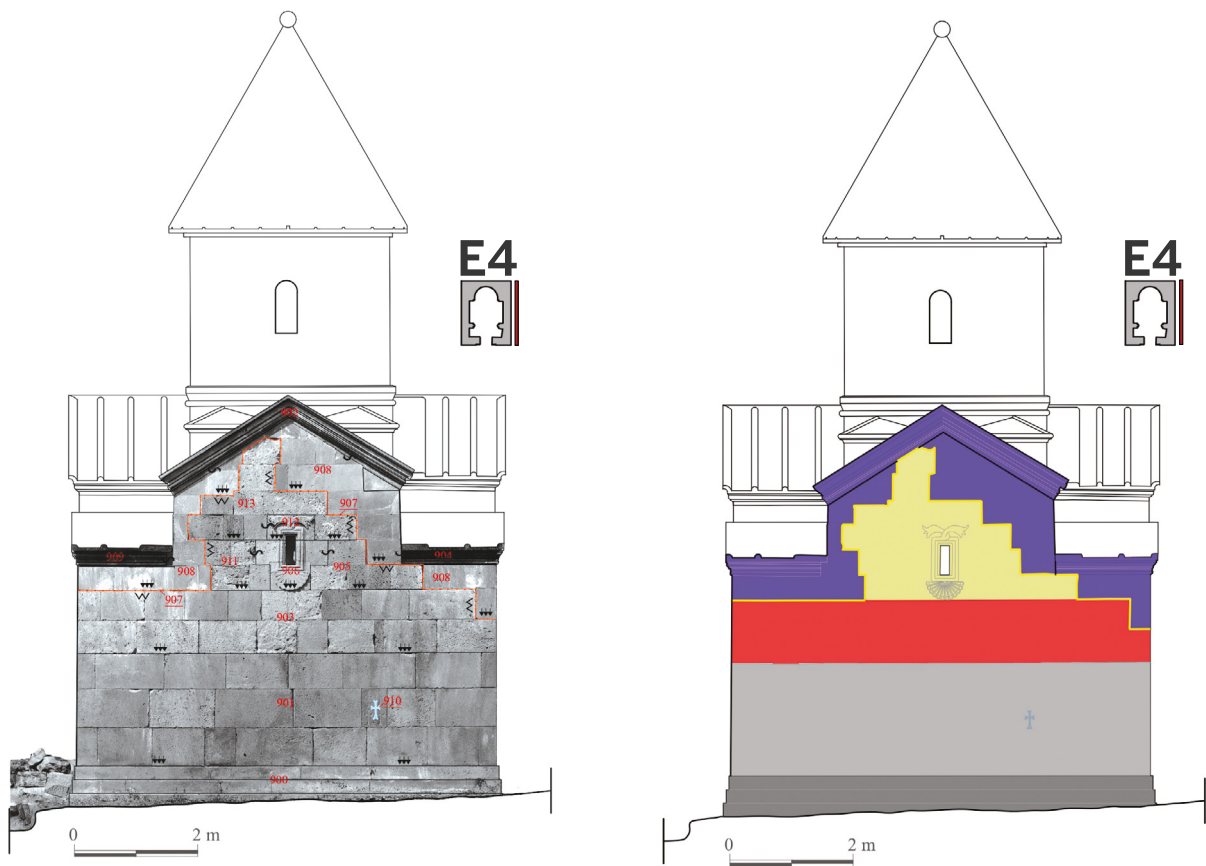
E4: ARCHAEOLOGICAL ANALYSIS

| 913 | Upper portion of the elevation | 905, 906, 911 | 907 | 912 | |
