# IX. THE ZORATS' COMPLEX

## An Archaeological Stratigraphic Description

**Abstract** / The fortified monastic complex of Zorats', located on a hill east of Yeghegis, stands as a significant architectural and historical landmark. This study analyses its evolution over time, focusing on masonry stratigraphy and structural development. The research identifies the church's five major construction phases from the late ninth century through its fourteenth-century construction, later modifications, collapse, and restoration in 1971–1972. Stratigraphic analysis of the Zorats' Church – an exceptional structure built under the patronage of Prince Burt'el Ōrbēlean and Bishop Step'anos-Tarsayich – reveals distinct construction techniques, including methods to achieve stability. This analytic approach, while shedding light on medieval Armenian architectural practices, regional socio-economic dynamics, and the importance of this monastic complex, expands discourse on the conservation of medieval ecclesiastical architecture and heritage.

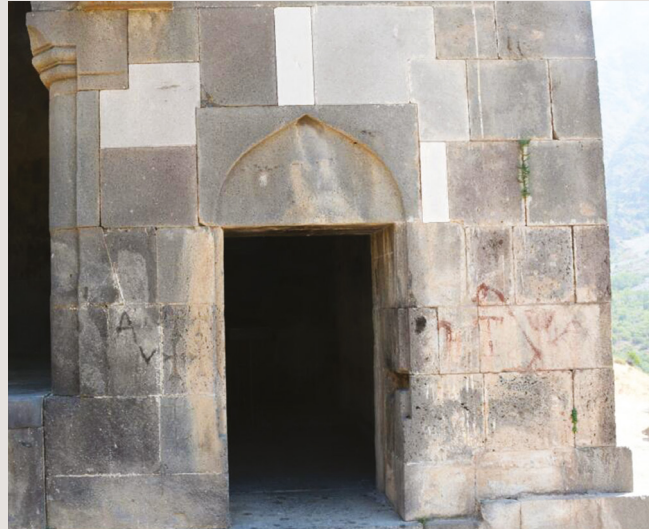
[fig. 10] Example of L-shaped notches and thinner ashlar used for the connection with the architectural elements (a segment of the right and left side of ε4)

some L-shaped notches<sup>30</sup> and the frequent use of smaller or thinner ashlar, with the same height of the course, arranged vertically as wedges.<sup>31</sup> This solution is probably due to the fact that the blocks that constituted the architectural elements were delivered to the building site of the Zorats' Church already molded by skilled workers for the assembly, so the builders had to adapt the masonry to the previously worked ashlar in *loco* [fig. 10]. These kinds of construction techniques were also used in the church walls themselves. It is possible to notice, mostly in E4, the frequent use of L-shaped notches that interrupt the lines of beds with the purpose of giving greater static stability<sup>32</sup> or occasional thinner ashlar, with the same height of the course, arranged vertically.<sup>33</sup> Despite the use of these techniques, there are sporadic aligned joints in the walls that weaken the static stability of the structure.<sup>34</sup> Oblique joints are rare: only one is identified in E4

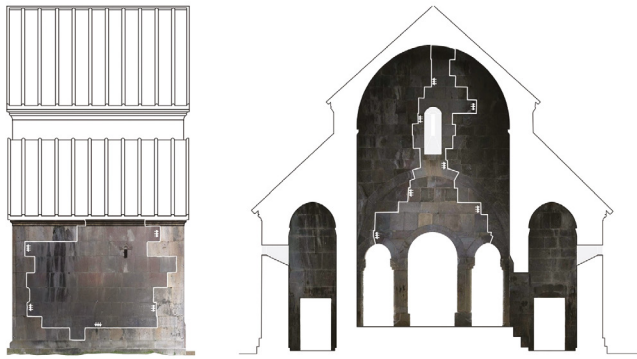
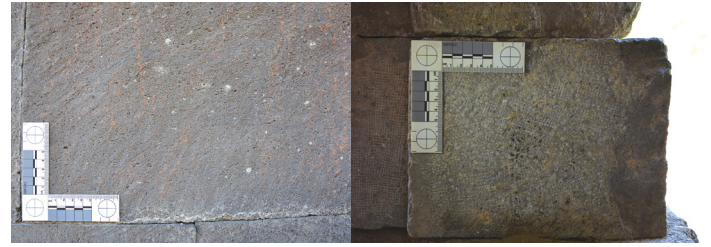
[fig. 17] Left: restoration visible in elevations 1 and 5 (counter-façade); right: the surface dressing of the phase 5: ygv2 (on the left) and ygv3 (on the right)

53 Both YGV2 and YGV3 are associated with the restoration of the 1970s. YGV2 is a surface dressing primarily visible on E1, the presbytery, and the north chapel floor. It was executed with a chisel 3.5 centimeters wide, leaving marks approximately 4.6 millimeters wide and 1.3 millimeters deep. The tool's orientation follows circular segments, with the chord of the arc generally parallel to the vertical side, occasionally parallel to the horizontal side, and rarely intersecting at 90°. The margins have been reworked. This surface dressing is the same as the one found in the restorations of the Cupola Church. YGV3 is visible on some elements of the reconstructed columns. It is characterized by the use of a bush hammer (5×5 teeth; distance between teeth: 2.7 millimeters) and a toothed blade (*gradina*) with 9 teeth (distance between teeth: 3.1 millimeters).

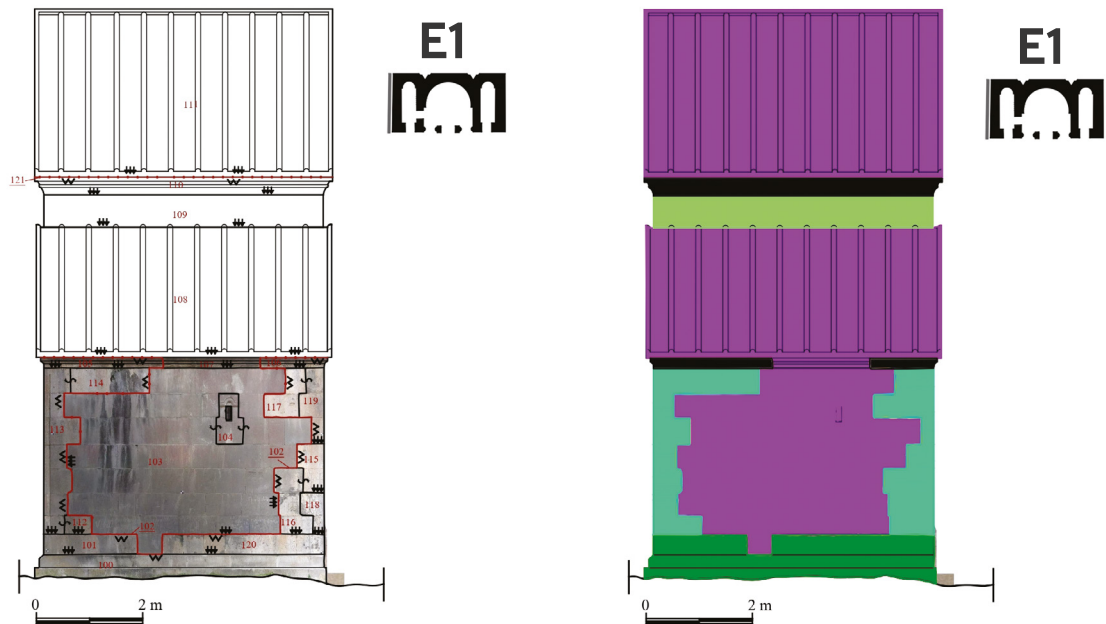
E1: ARCHAEOLOGICAL ANALYSIS

| 121 | Collapse of the upper part of the pitched roof in E1 | 110 | 111 | | 229 (E2),<br>478 (E4) |

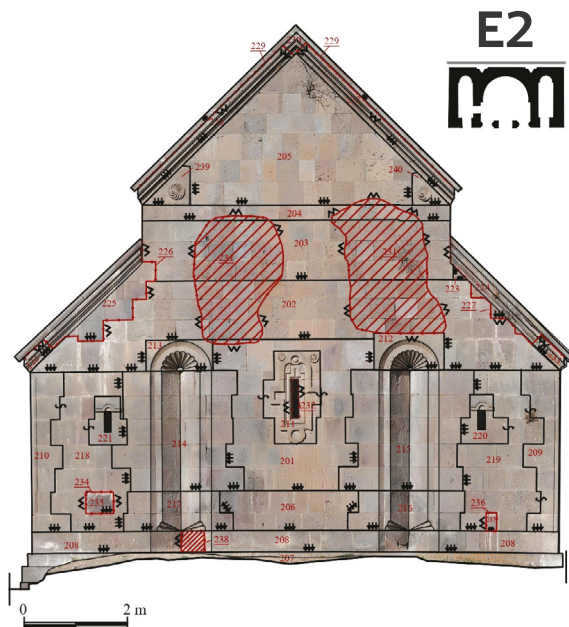
E2: ARCHAEOLOGICAL ANALYSIS

| 231 | Damaged surface in the upper part of E2 | 205 | | | |
| 234 | Cut for the replacement of one ashlar in the left part of E2 | 218 | 235 | | |
| 236 | Cut for the replacement of one ashlar in the left part of E2 | 219 | 237 | | |
| 238 | Damaged surface in the lower left part of E2 | 208 | | | |
| 240 | One triangular carved ashlar (rosette) on the right of MSU 205 | 204 | 205 | | |

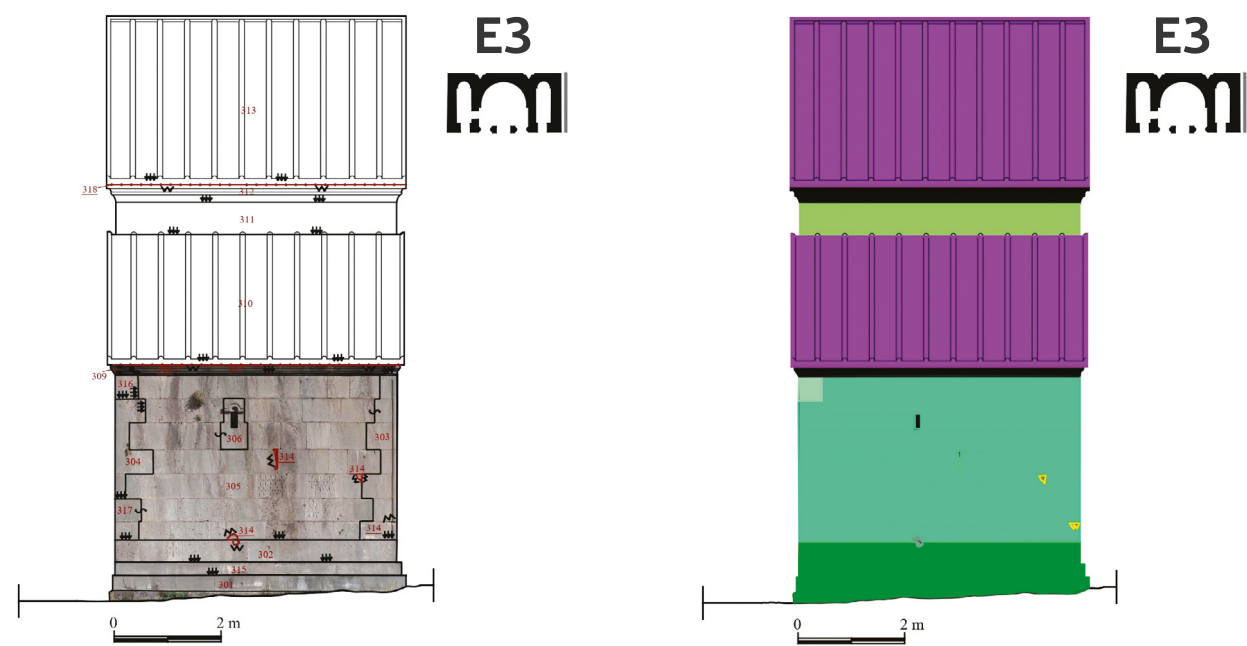
E3: ARCHAEOLOGICAL ANALYSIS

| 318 | Collapse of the upper pitched roof in E3 | 312 | 313 | | 229 (E2), 478 (E4) |

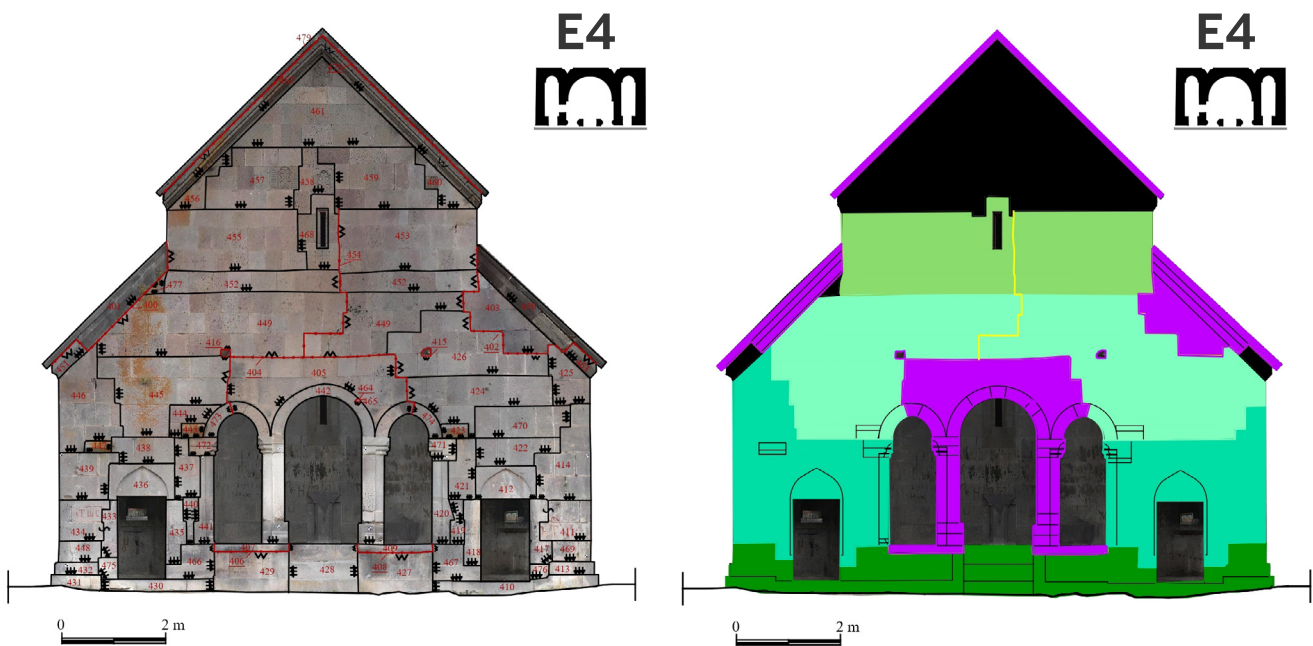
E4: ARCHAEOLOGICAL ANALYSIS

| ID MSU | Definition | Later than | Earlier than | Contemporary with | Equal to |
|---|---|---|---|---|---|
| 406 | Cut for the replacement of the threshold of the left arch and of the inner floor | 428, 466 | 407 | | |
| 408 | Cut for the replacement of the threshold of the right arch and of the inner floor | 428, 467 | 409 | | |

| 454 | Vertical crack in the middle of the elevation | 459 | | | |
| 479 | Restoration of the upper pitched roof in E4 | 478 | | | 111 (E1), 313 (E3) |
