### The Cupola Church. An Archaeological Stratigraphic Description

The Cupola Church. An Archaeological Stratigraphic Description / Marianna de Falco, Leonardo Squilloni. - STAMPA. - 16:(2025), pp. 160-196. [10.1484/m.convisup-eb.5.154161]

# VIII. THE CUPOLA CHURCH

## An Archaeological Stratigraphic Description

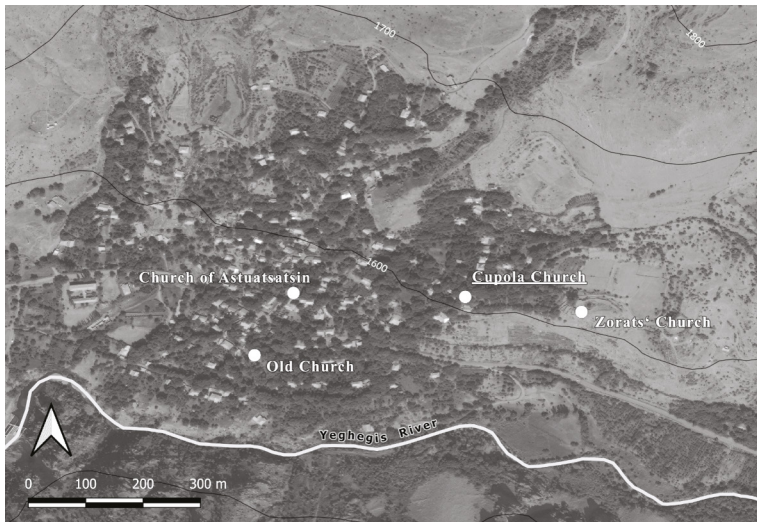
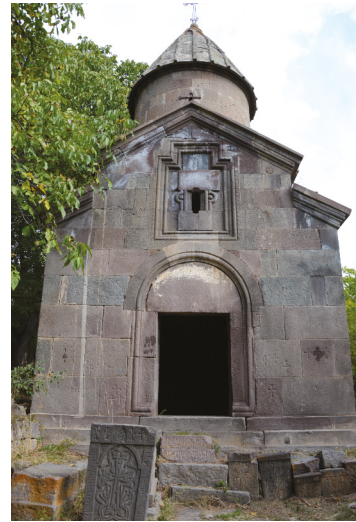
[fig. 1] Left: the localization of the Cupola Church in Yeghegis Village; right: a view of the façade

This church is known in the scholarly literature as the Cupola Church. Various other denominations have been applied to it, such as Surb Karapet (Holy Precursor), Surb Nshan (Holy Sign), or St Grigor, but there does not seem to be corroborating evidence for any of these dedications in the sources.<sup>1</sup> The main building is a domed-hall church with a semi-dome covered apse (embedded in the straight wall on the exterior), a gable roof, and a central dome standing on a high tambour covered by a conical roof [fig. 1]. The building is roughly oriented east–west (a few degrees NE–SW).

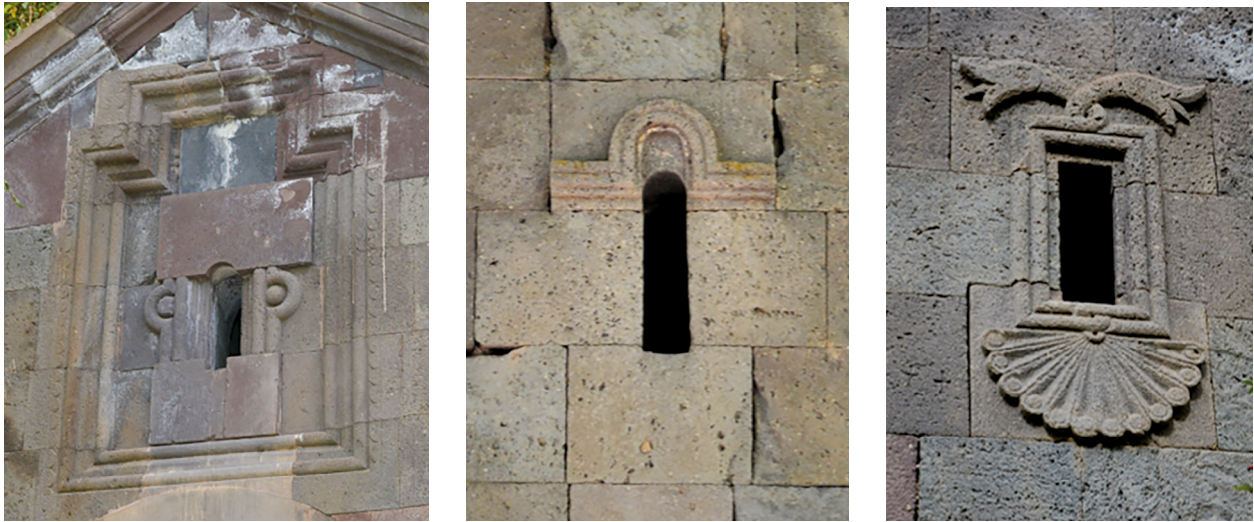
[fig. 2] Left: the molded lintel of the northern window;  
right: a bas-relief sundial and snakes framing the southern window

framed by a double bead molding and a continuous semicircles motif [fig. 2].

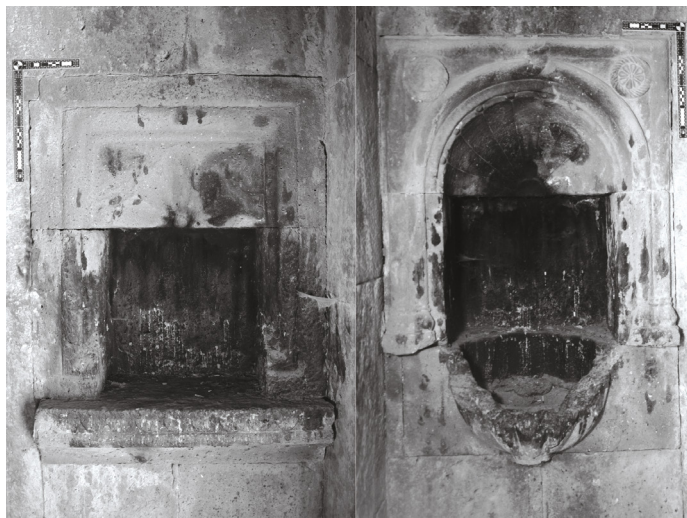
[fig. 3] Niche on the southern (on the left) and northern (on the right) side of the vestibule

The barrel-vaulted vestibule is separated from the hall by two semi-column pilasters, each bearing a double rounded arch, which is part of the central ceiling system. On the south side (E8), a niche with a deeply carved shell vault is framed by a bead molding; opposite (E6), a stoup, shell-shaped and painted outside in red and black, juts from a niche with a bas-relief *intradox* showing a radiant motif. The cornice is richly decorated with a double bead molding and a rosette on both sides [fig. 3]. The south wall of

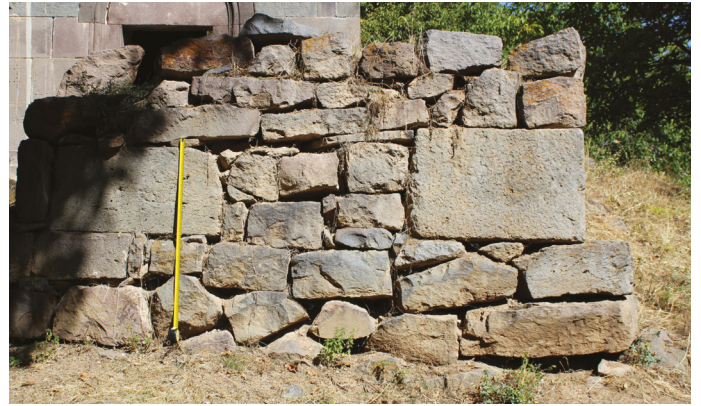
[fig. 5] B2 southern masonry with squared and smoothed re-used basalt ashlar and broken and roughly squared basalt blocks

Access to the enclosure is on the west side, aligned with the portal of B1. The threshold, a single basalt block shaped into an inverted T by removing the upper edges of the short sides, is 0.80 meters above the actual external ground level. The access (1.15 meters wide) is flanked by big basalt squared and smoothed blocks (probably re-used ones, since their dressing is completely different from that of the stones that compose the walls), representing the remains of the jambs [fig. 5].

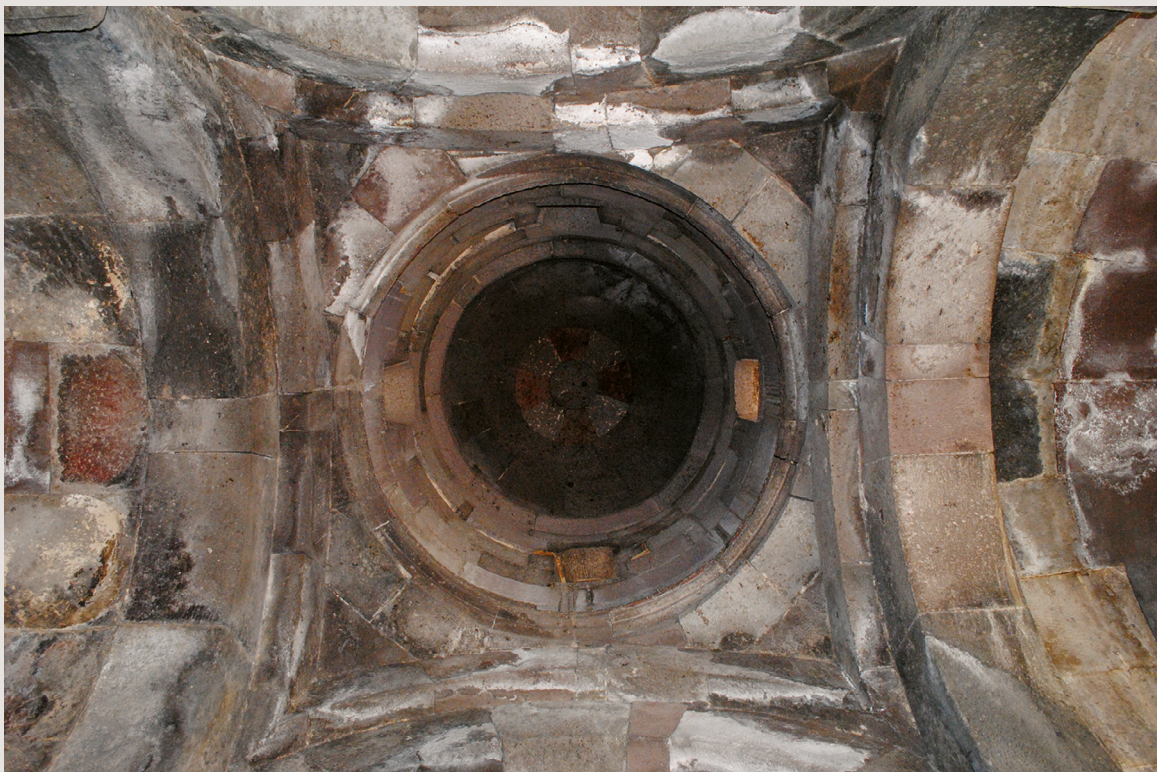
[fig. 6] The supporting system (double rounded arches and squinches) of the tambour and central dome

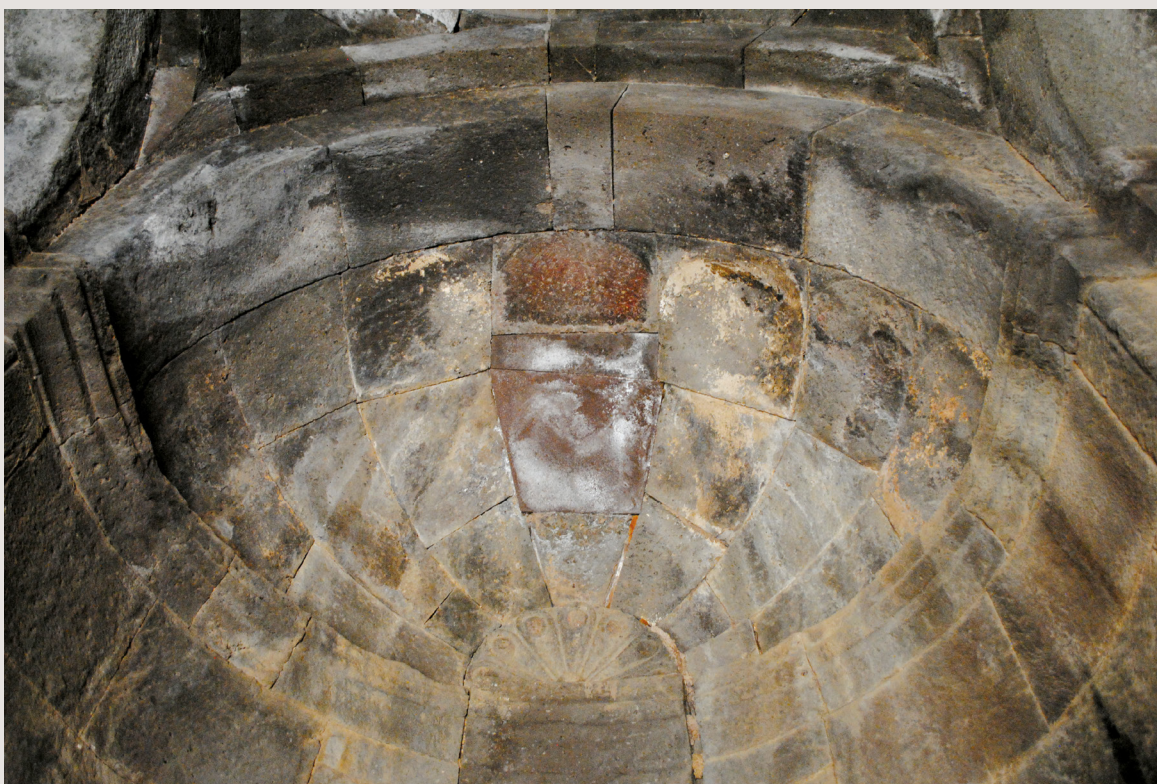
[fig. 10] In the picture, sub-phase 1g is split to highlight the construction of the upper portion of the walls

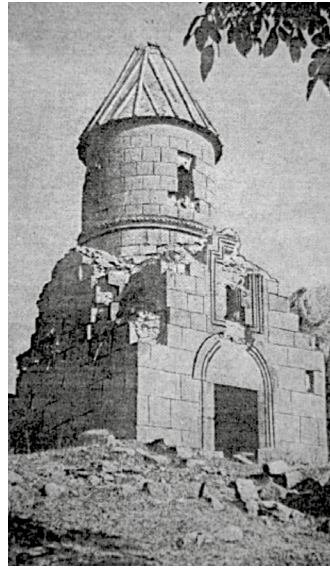
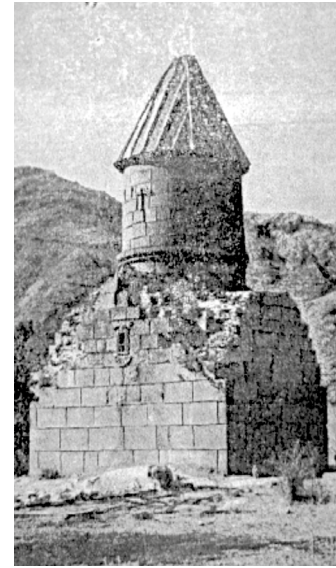
[fig. 8] The western and northern sides (on the left) and the southern and eastern sides (on the right) before the restorations of 1970

tambour in good static conditions, although affected by the outward displacement of some ashlar.

- 3 Collapses of the upper portions of external elevations (MSUs 815, 824, 705, 1008, 907), part of the vestibule's vault (MSU 1118=1233=1436) and of the apsidal semi-dome (MSU 1317) and cracks (MSUs 1004, 1005 in E3; 1311, 1341 in E7; 1508, 1509, 1510, 1511 in E9) [fig. 8].

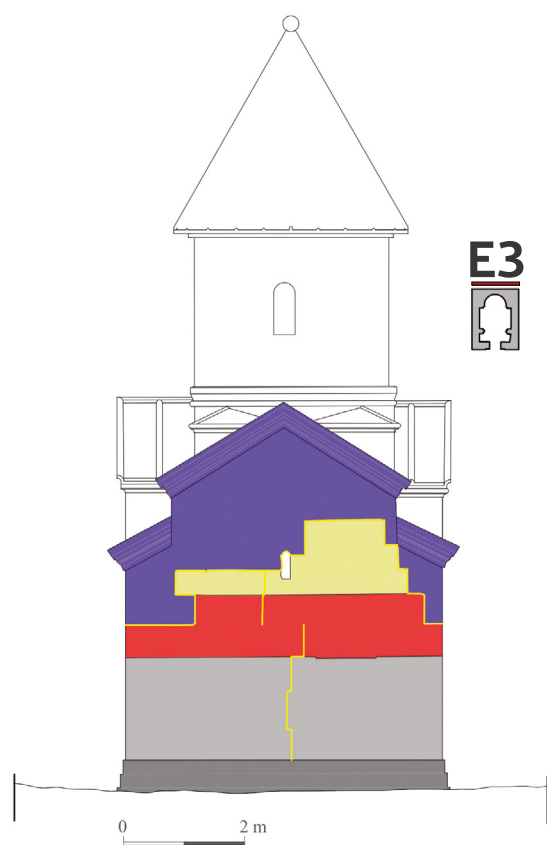
E3: ARCHAEOLOGICAL ANALYSIS

| ID MSU | Definition | Later than | Earlier than | Contemporary with | Equal to |
|---|---|---|---|---|---|
| 1004 | Vertical crack in the center of E3 | 1003 | | | |
| 1005 | Vertical crack near the window MSU 1007, in E3 | 1006 | | | |

The outer eastern elevation (E3) shows a vertical crack (MSUs 1004, 1005), a structural dislocation due to a seismic event or to ground instability, loosening the joints of sub-phase 1b (MSU 1002), 1d (MSU 1003), and 1e (MSUs 1006, 1007) masonries. Traces of this dislocation (MSUs 1311, 1341) may also be found inside the apse (E7), in the broken corners and edges of some ashlar of sub-phase 1c (MSU 1307), 1d (MSU 1310), and 1e (MSUs 1316, 1339).
