New technologies for surveying buildings ruins / G.Tucci; V. Bonora; N.Crocetto; A.Nobile. - In: THE INTERNATIONAL ARCHIVES OF THE PHOTOGRAMMETRY, REMOTE SENSING AND SPATIAL INFORMATION SCIENCES. - ISSN 1682-1777. - ELETTRONICO. - (2009), pp. 0-0. (XXII CIPA International Symposium "Digital Documentation, Interpretation & Presentation of Cultural Heritage" Kyoto 11-15 ottobre 2009).

NEW TECHNOLOGIES FOR SURVEYING BUILDING RUINS

3. BIVONA CASTLE

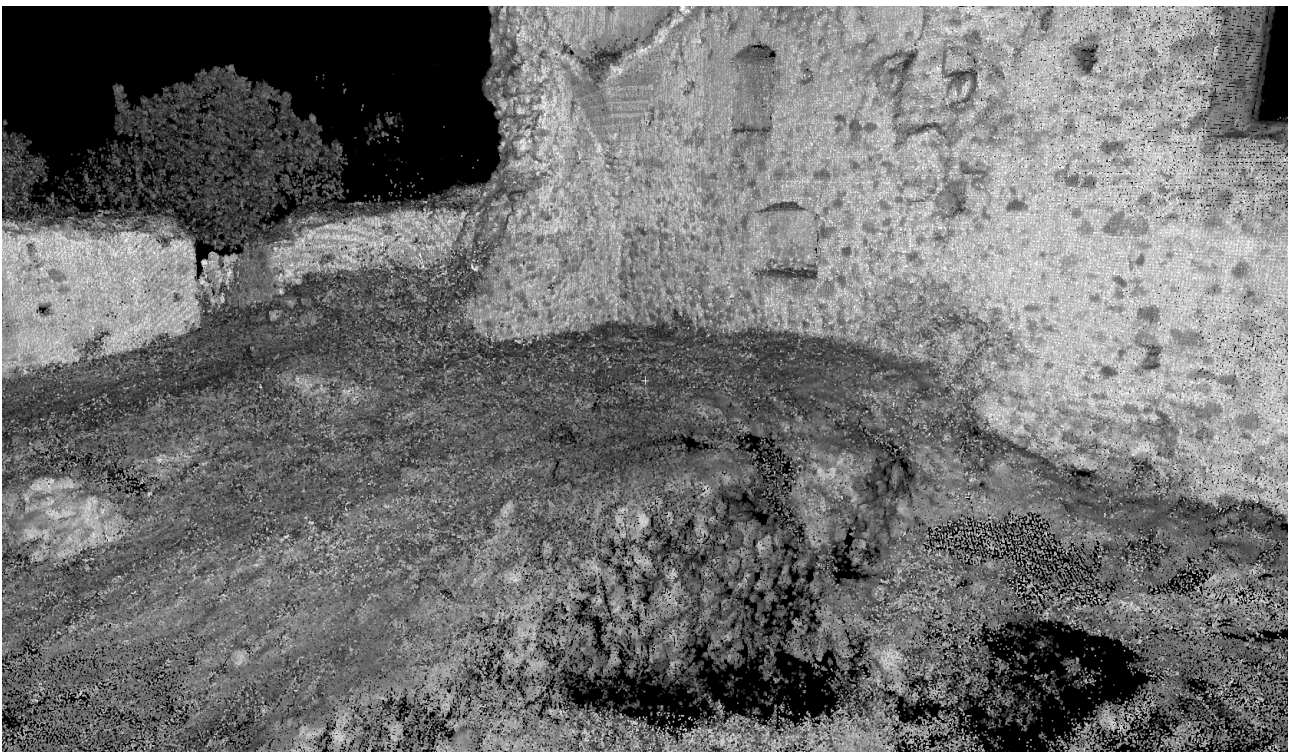
Figure 2. The rooms inside the castle are not accessible at present as they are entirely obstructed by fallen building material (view from the points model surveyed using a laser scanner)

Both the lower level of the building and the level immediately above are internally divided by a partition that runs longitudinally; on the ground floor this partition created a long corridor that led to a barrel-vaulted hall and to two cross-vaulted rooms. Fallen

building material has filled the two large subterranean rooms that used to be accessed through a door on the southeastern side of the keep: the first step to this door was found during the work carried out in 1969.

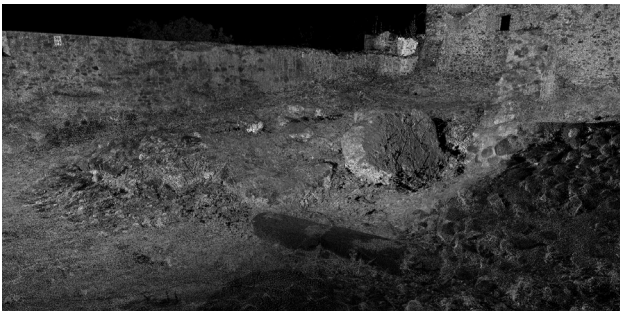
Figure 3. View of the inside of the castle (3D points model)

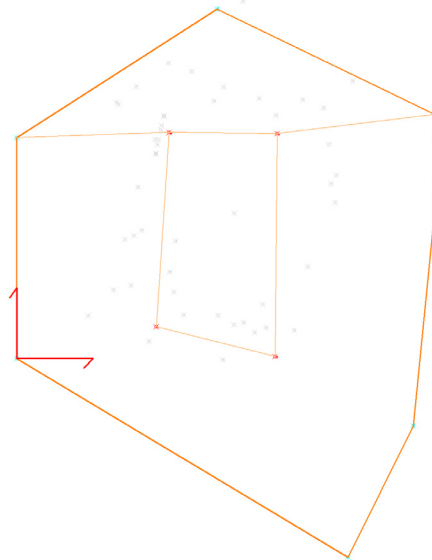
Figure 4. Diagram of the topographic network: the local reference system used, the transverse network, the targets

The transverse network is the back-bone of the entire survey because it defines the local reference system; it is made up of a non-oriented closed polygon to which an other transverse is attached. The geometry of the transverses was designed as regularly as possible, keeping the lengths of the sides as homogeneous as possible, to ensure that the vertices required for surveying the targets would be available in all areas of the structure both inside and out. The transverse network has 9 vertices the coordinates of which were calculated and compensated empirically.

48 targets, distributed throughout the entire structure, were measured from the vertices of the network and used for aligning the scans.

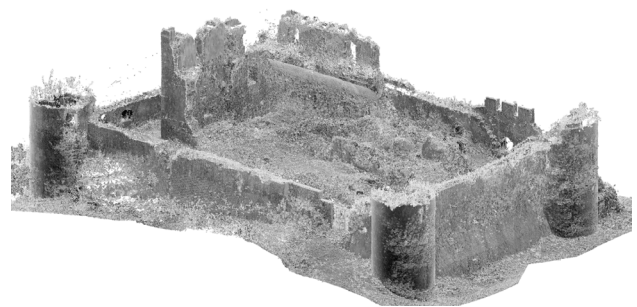
Figure 5. View of the points model surveyed using three-dimensional scanning

Three-dimensional scans were used to realise the detailed survey. The acquisition from different positions made it possible to reciprocally integrate the shadow zones and to obtain an almost complete points model of the castle. 14 scans were taken outside the castle and 19 inside.

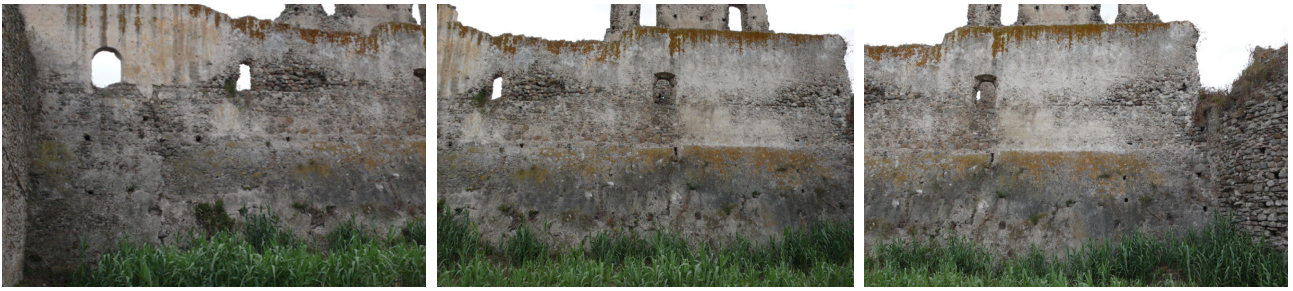
Figure 6. Photographic survey of the elevations

The photograms were taken under “pseudo-normal” shooting conditions, with the shooting axis as nearly as possible to being perpendicular to the building elevations, to ensure that the scale

of the image was more or less uniform over the entire photogram. The elevations of both sides of all the walls were documented. The photograms were shot as flight strips thereby ensuring that adjacent photograms were sufficiently superimposed.

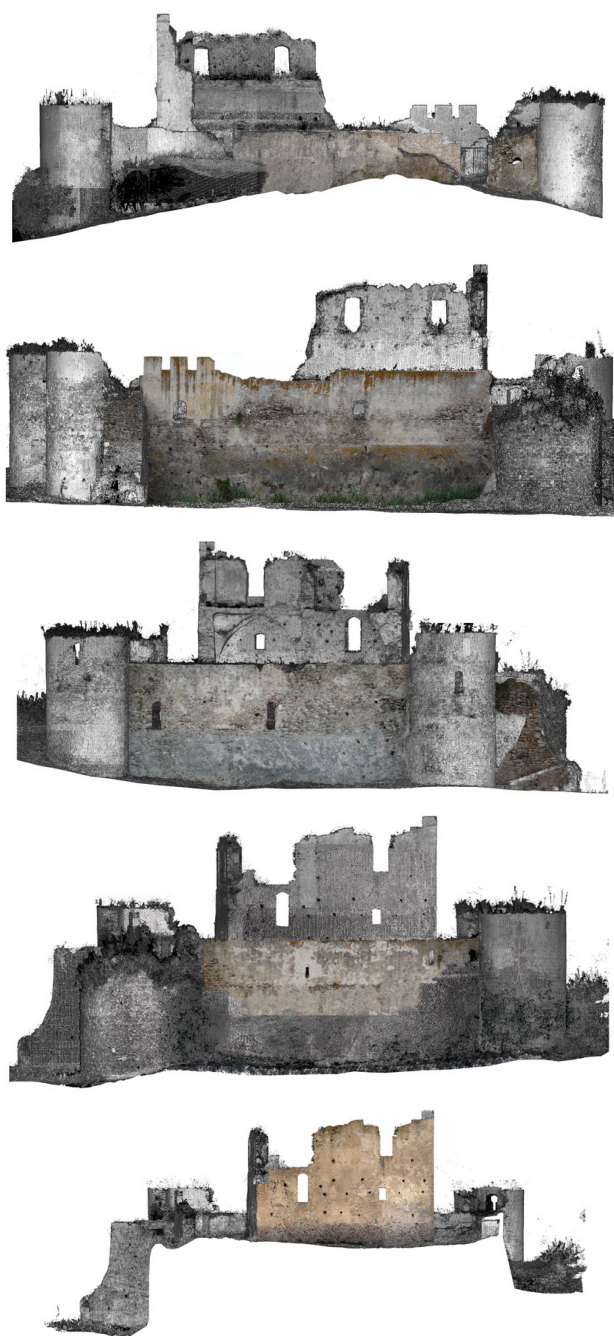
Figure 10. Example of the graphic restitution of the survey: the elevations integrate rectified digital images for the flat parts and the orthogonal view of the range maps

Vectorial restitution in the elevations and sections was integrated by the rectified images realised for every portion of flat wall whilst raster images obtained from the points cloud, exploiting the analogy between the rendered reflectivity data and the photographic image, integrated the representation of curved or strongly three-dimensional elements. For each point measured during scanning, the intensity of the signal reflected which depends, albeit not exclusively, on the colouring of the surface being analysed, was memorised. This information makes it possible to obtain images that strongly evoke the corresponding photos, obviously corrected beforehand to remove all perspective distortion.
