XVIIth World Congress of the International Commission of Agricultural and Biosystems Engineering (CIGR)

FLUSH SYSTEMS FOR DAIRY MANURE REMOVAL: THE ALLEY ROUGHNESS VALUE

CSBE100442 – Presented at Section II: Farm Buildings, Equipment, Structures and Livestock Environment Conference

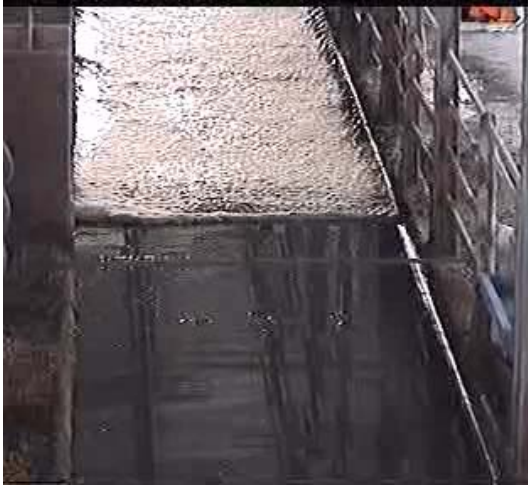
Figure 1. Flush wave on the clean freestall alley (barn 2).

Figures 1 and 2 show the movement of the flush wave on the freestall alley flooring, for the barn 2. It clearly appears how the front wave is moving regularly on the clean floor compared with the wave flow along the dirty floor of the alleys. The roughness obtained values justify this behavior.

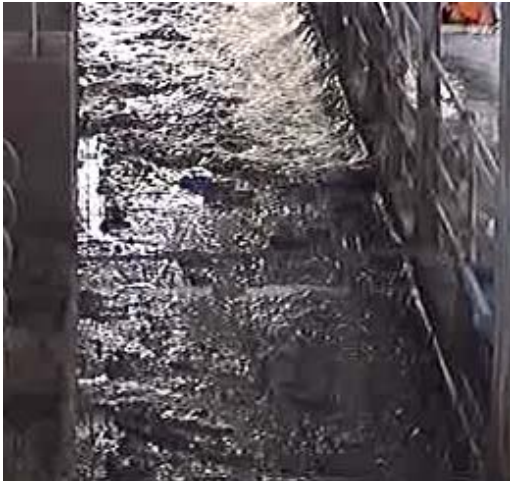
Figure 2. Flush wave on the dirty freestall alley (barn 2).

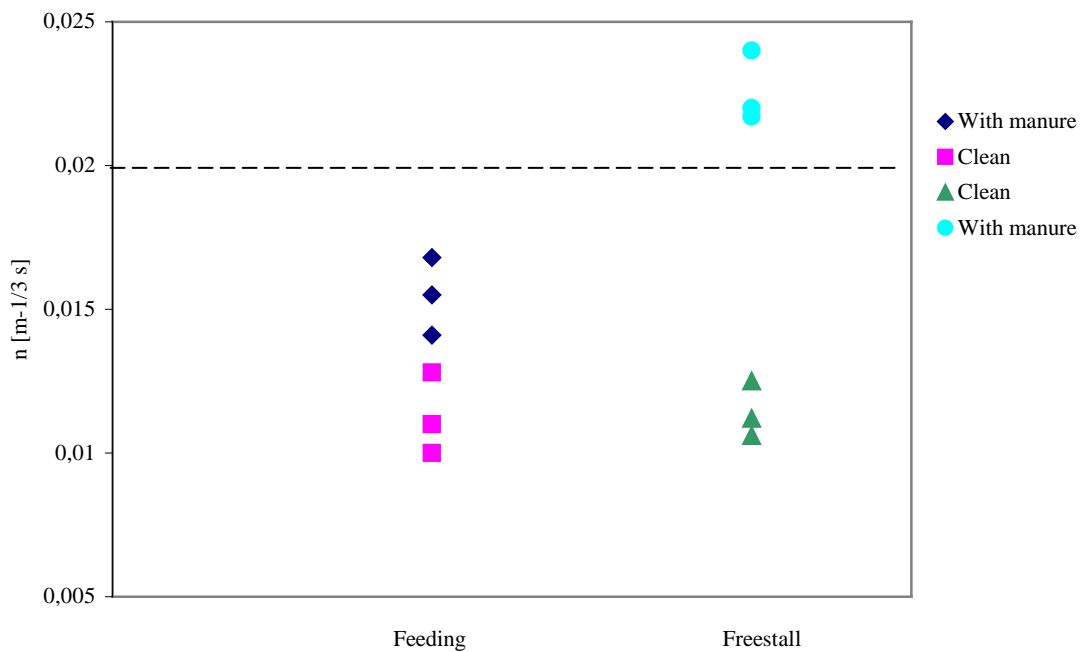
Figure 3. Manning coefficient (n) for the different alleys under normal and clean conditions for the freestall barn 1 (dash line represents the n value equal to 0.02 as suggested in literature).

RESULTS AND DISCUSSION The values of the Manning coefficient n are obtained from the Chezy formula substituting the measured velocity and the surveyed flow depth for each trial. Data elaboration has been made both separately for each freestall barn and then grouped for alley type. The barn 1 and 2 have in fact the same alley grooves. In figure 3, n values for the barn 1 are shown, with the reference value of 0.02 as suggested in literature, separated between feeding and freestall alley types. The repeated trials on the clean alley of both types show comparable values included in the interval 0.010-0.013, thus a value of 0.01 (cut at the third digit) may be considered as the typical roughness number for an alley made of concrete with longitudinal grooves, 0.02 m wide and deep and 0.1 m spaced. As regards the feeding alley, the range is 0.014-0.017, showing an increase of 27% compared with the n value for the clean alley. The freestall alley presents values in the interval 0.022-0.024, showing an increase of 46% compared with n value for the clean alley. The higher value calculated for the freestall alley, compared with the value obtained for the feeding alley, may be justified by the presence on the alley of both manure and litter material. From the graph, it is clear how all the values are under the 0.02 line with the exception of values for the freestall alley.

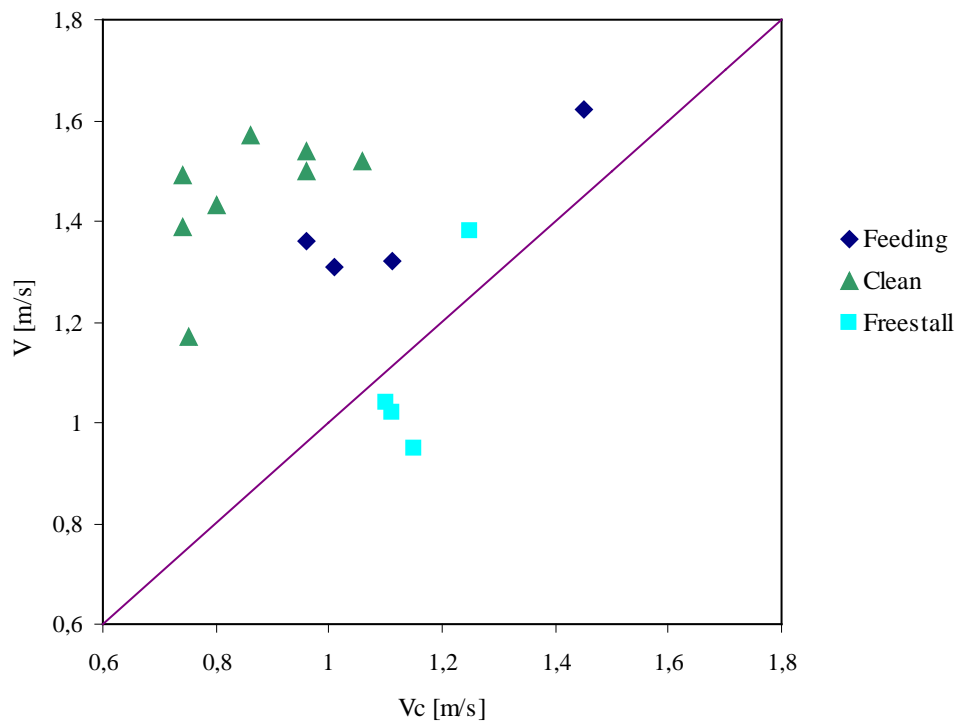
Figure 4. Measured velocities (V) and calculated velocities (Vc) for different alleys.

In figure 4, the velocity values, calculated with the Chezy formula using a n value equal to 0.02 and the measured ones, are reported for all the investigated barns. Points close or on the straight line are those whose calculated and measured velocity values are similar, resulting in n values close or equal to 0.02. All the points are above the line with the exception of those corresponding to the freestall alley for barn 1. For those points, the n value equal to 0.02 would result into a weak over estimation of the velocity. The value of n equal to 0.02 may be considered representative for a situation which is not the current one in the surveyed barns. The only point belonging to the freestall alley over the straight line is for the barn 2 and this may be justified by observing that the freestall alley may be strongly influenced by the litter type and quantity. In this case, the obtained n value is less than 0.02. For the other freestall points, the obtained n value is bigger than 0.02.

As regards the feeding alley, it clearly appears that the n value equal to 0.02 involves an under-estimation of the velocity value. The value far from the other three corresponds to the barn 3, which was characterized by a different type of grooves compared to the other two, thus influencing the roughness value both for the clean and the dirty conditions.

As regards the clean alley case, all the points are far from the line resulting in higher measured velocity than those calculated with the 0.02 n value. The under estimation may be strong for this situation and n value equal to 0.02 is too high for that situation.
