## The Church of Meryem Ana in Göreme, Cappadocia

### Correct documentation for a meaningful heritage at risk

Maria ANDALORO<sup>1</sup> | Tatiana PIGNATALE<sup>2</sup> | Giorgio VERDIANI<sup>2</sup>

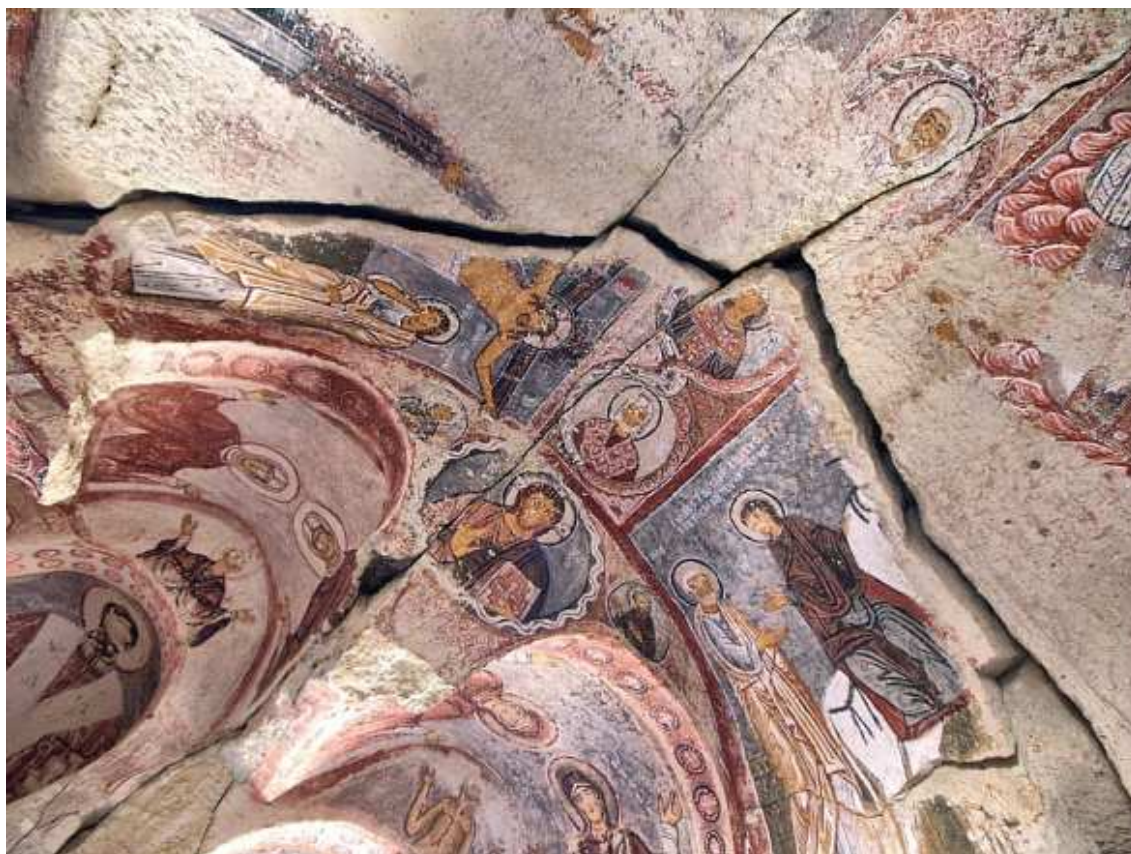
Fig. 2 – The great crack passing all over the vaults

The Meryemana church, commonly defined as Göreme 33, is carved, together with a small monastic complex, in an emerging peak overlooking the valley of Kiliçlar – the Turkish name means the “valley of the swords”- from a 25 meters of high over the area where the valley becomes narrow. Here the fertile area rich of cultivations leaves the space to hard stones and high natural walls, where a feeble river has sculpted this valley. The path to reach the church is not easy, the only available passage crosses some rupestrian rooms with ruined fronts, where the visitor sometimes has to pass crawling on his knees because of the small size of the openings, and then reaches the plan space containing the entrance of the Church. Commonly the passage is not open to the public; a small gate closes one of the narrow openings leaving no possibility to continue the visit. The rooms giving the access to the church were separated by numerous rooms connected one another, and there are still the remains of a millstone door. Arrived at the entrance it is possible to notice that it is characterized by the typical horseshoe arch, which was once enriched with wall paintings. The paints are mainly dedicated to the narration of the life of St. Mary and all the biblical events connected to her figure. The architectural typology of the church is different from the other monuments of the area for the presence of a transverse nave blanket of two barrel vaults of different sizes, without support in between. The sequence of spaces shows clearly the complex development of the church across time, with some quite aggressive intervention, like the connection with the room of the tombs which has altered and destroyed a part of the original mural paints. The whole space is dimensioned in small proportions, but it has a very impressive effect on the visitor (fig. 1), the rich colours, the articulated shapes, the sequence of levels and a certain “sense of drama” capture the eyes and generate a strong sense of admiration. The bema is elevated on three steps, and it was originally separated through a carved iconostasis with six arches and five columns, but two columns get lost and so the large missing part creates an asymmetric perception of the church emphasizing the value of the remains. Besides this partially fallen and destroyed colonnade there are a cross-corridor and apses. Only two of the three original apses are preserved, the one on the South side is almost completely disappeared and a large opening toward the valley allows an impressive view toward the opposite peaks. Beneath the right part of the bema, there are other two main rooms excavated down the peak, they are structured one over the other, probably they were carved in different phases and were connected with wooden staircases which now is lost. For this reason the two lower rooms are accessible only “jumping” down, but they are not that tall and they can be easily accessed. The real risk is due to the fact that all the bema and its lower rooms are beyond the crack dividing the church in two parts, the whole crack develops all along the vaults and the vertical walls, and interests the pavement too (fig. 2). Only a

length of half a meter separates the two extremes of the crack on the floor. So any walk done on this side can be considered dangerous for the structure as well for a visitor.

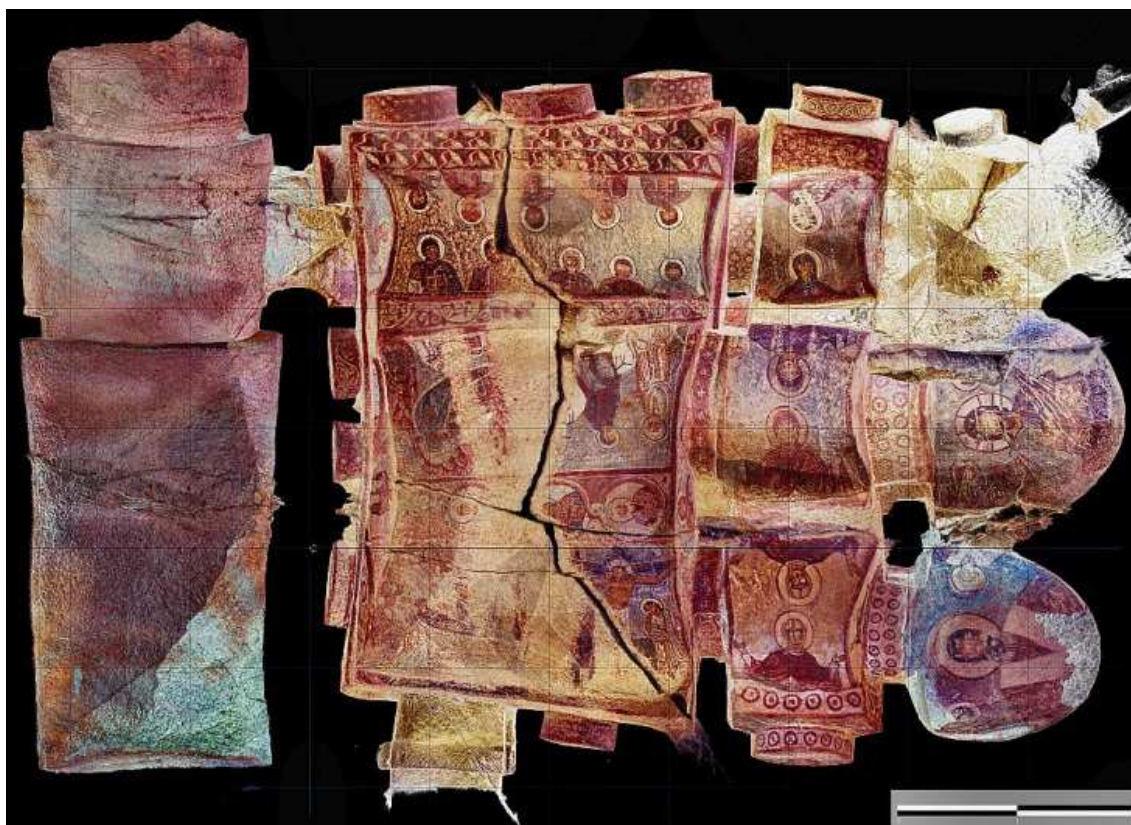
Fig. 3 – Horizontal section toward the vaults of the Meryemana Church (reference scale in meters)
