Environmental monitoring and microclimatic control strategies in “La Specola” museum of Florence

Abstract This work presents the results of the environmental monitoring of some rooms of the “La Specola” Museum in Florence, affected by significant overheating problem in summer mainly due to the absence of efficient solar shadings. The elaboration and analysis of the microclimatic data have been carried out according to the Italian Standard UNI 10829 and the Performance Index of the most important thermo hygrometric parameters has been calculated and assessed. This analysis shows that temperature and RH conditions were not reasonably acceptable for the preservation of the kind of objects exhibited. In order to reduce this problem, solar gain control solutions (shadings and solar control glasses) has been analysed with a dynamic thermal simulation tool for two sample rooms, as a possible solution to improve architectural integration with the historical context. In order to reduce the risk of damage, the evaluation of different strategies has been expressed in terms of the reduction of energy need for space cooling and in terms of the ability to control dry bulb temperature values. Th

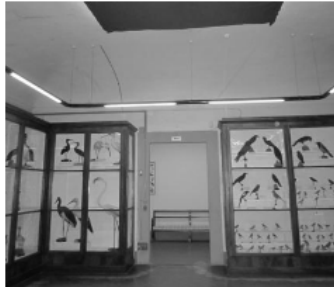
Room XVI

Objects exposed: Italian birds stuffed Room dimensions: Plant surface (m ²): 54 Volume (m ³): 224	Technical systems: - No HVAC system - Direct artificial lighting of the room with tubular fluorescent lamps - No light inside showcases Architectural features: - One skylight without external solar shading - Two external walls (SW and NE oriented) and not insulated pitched roof
Room XIX

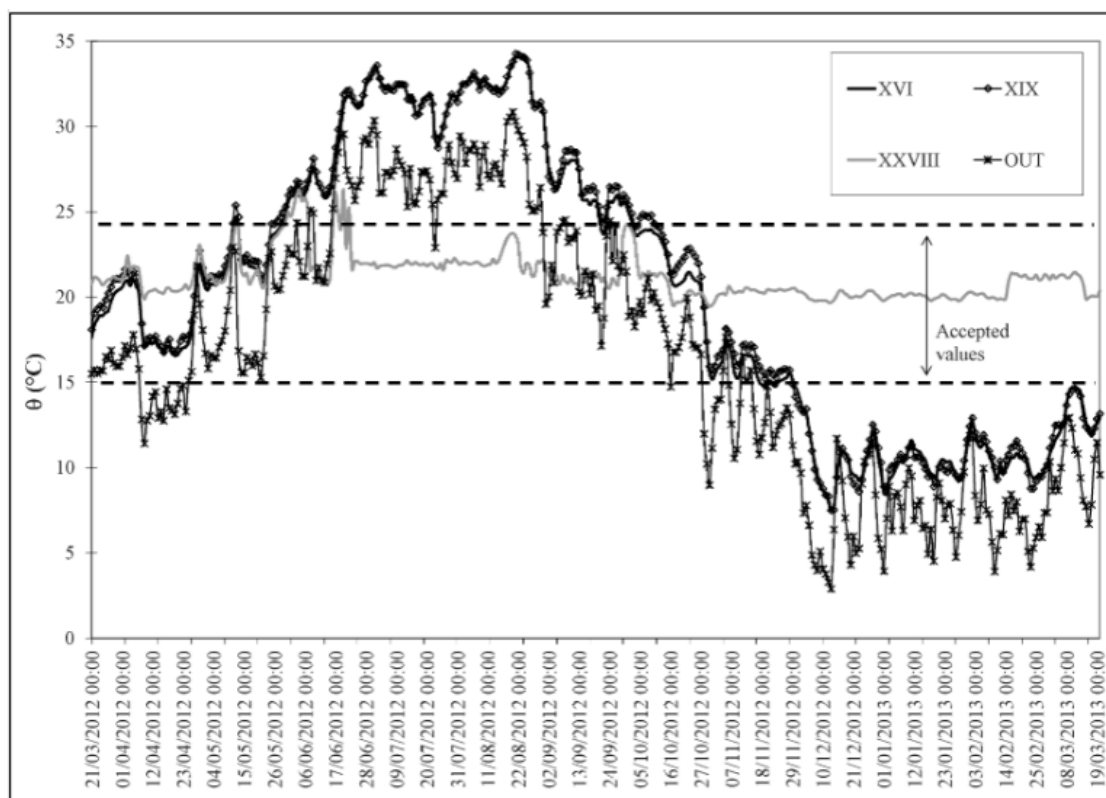
Figure 2 – Time profile of mean daily temperature values for one year monitoring period.

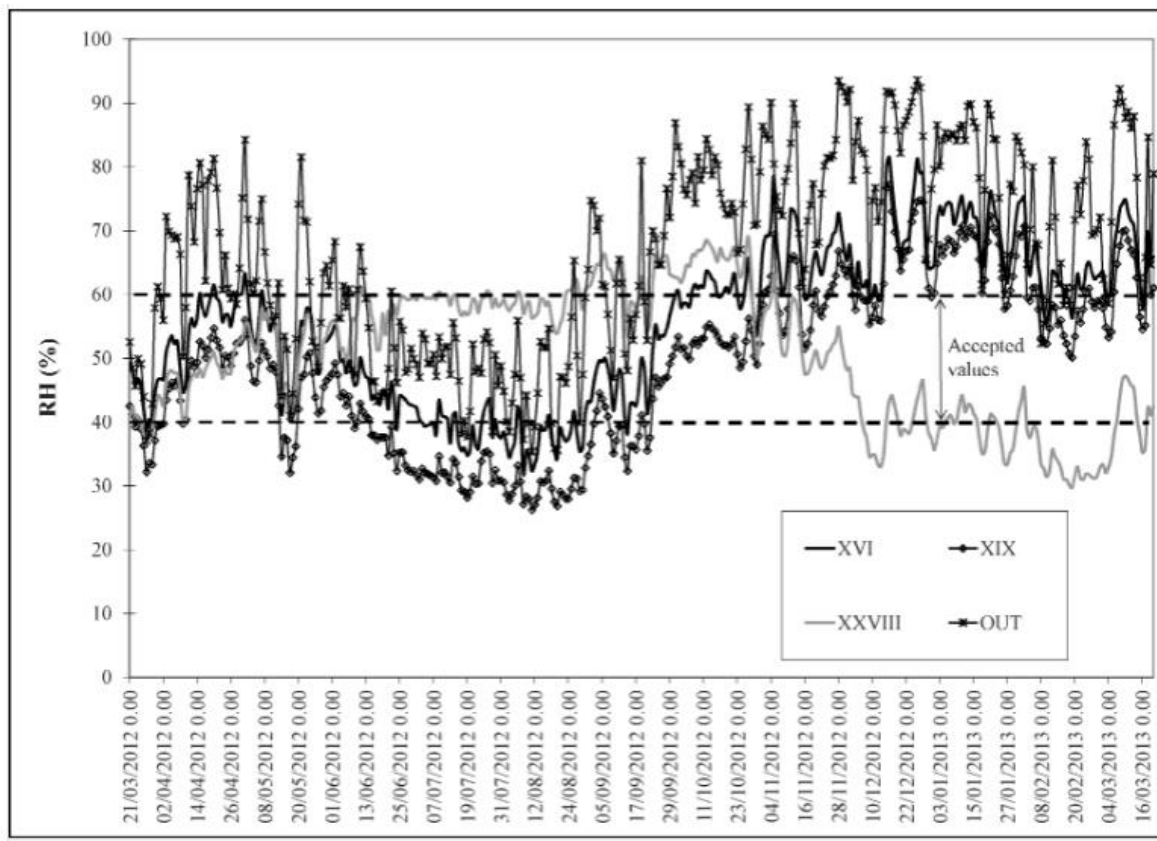
Figure 3 – Time profile of mean daily RH values for one year monitoring period.

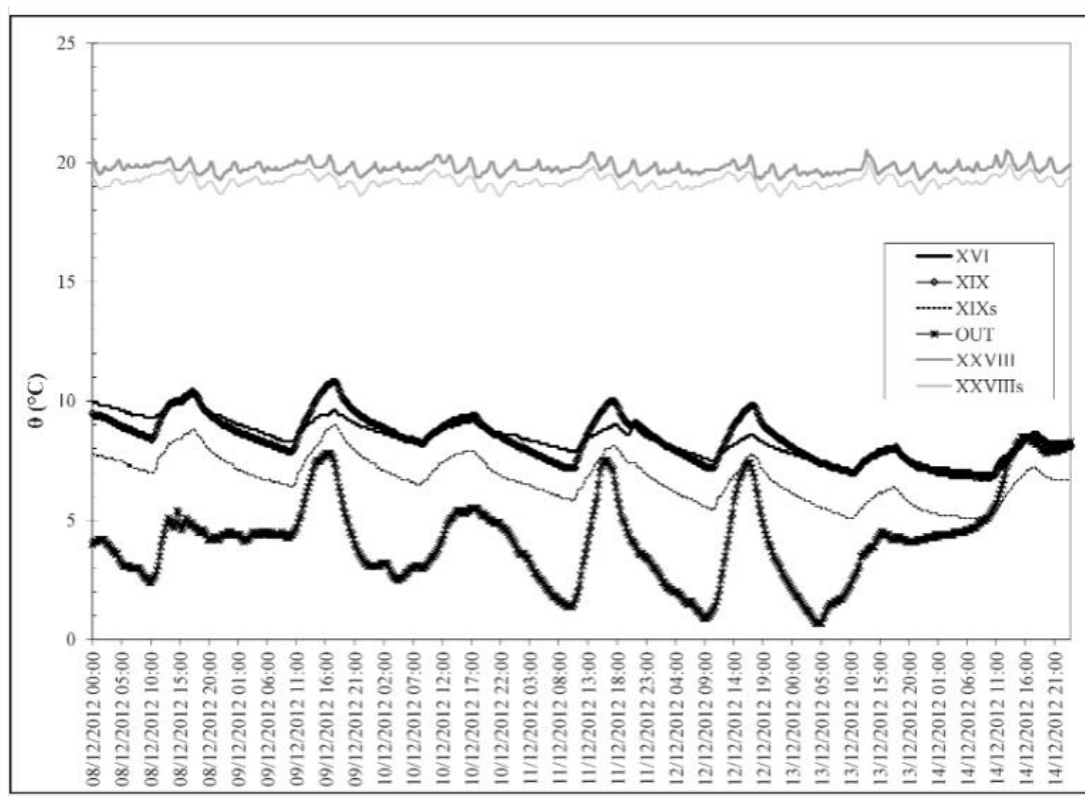
Figure 4 – Time profile of temperature values for the coldest week of the year monitored.

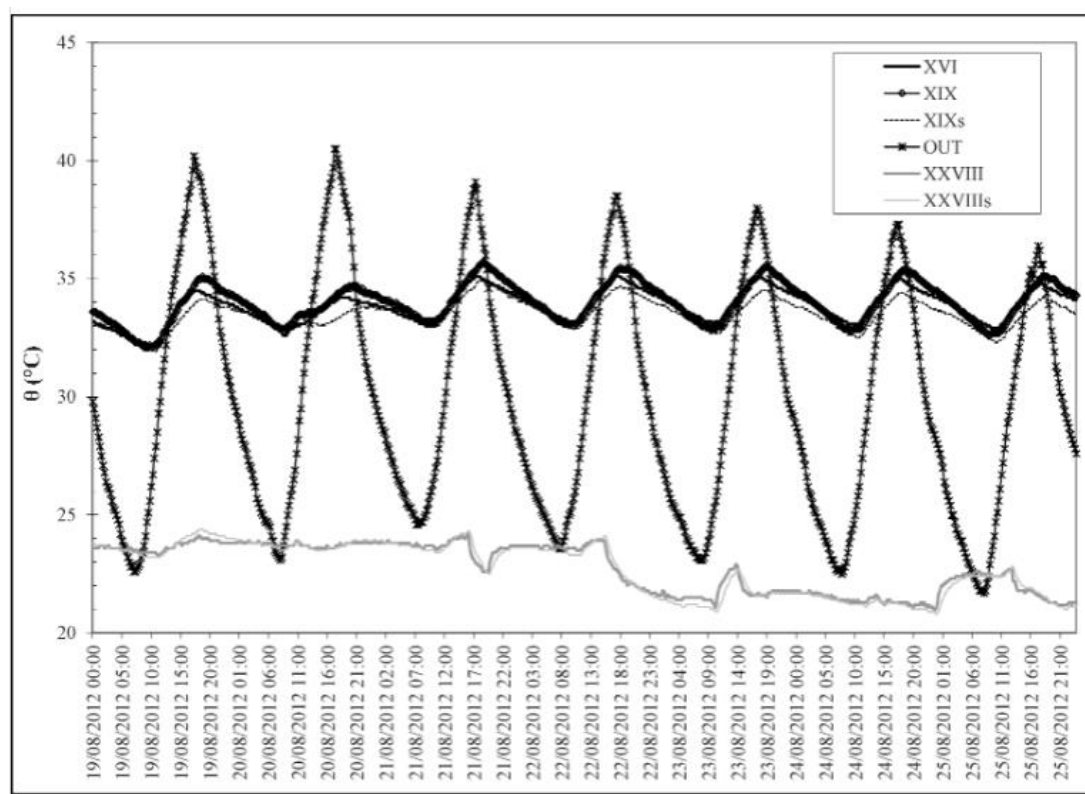
Figure 5 – Time profile of temperature values for the hottest week of the year monitored.

conservation of the artifacts in room XVI and XIX due to the daily temperature variations, especially during summer period, than can cause important and permanent damages.

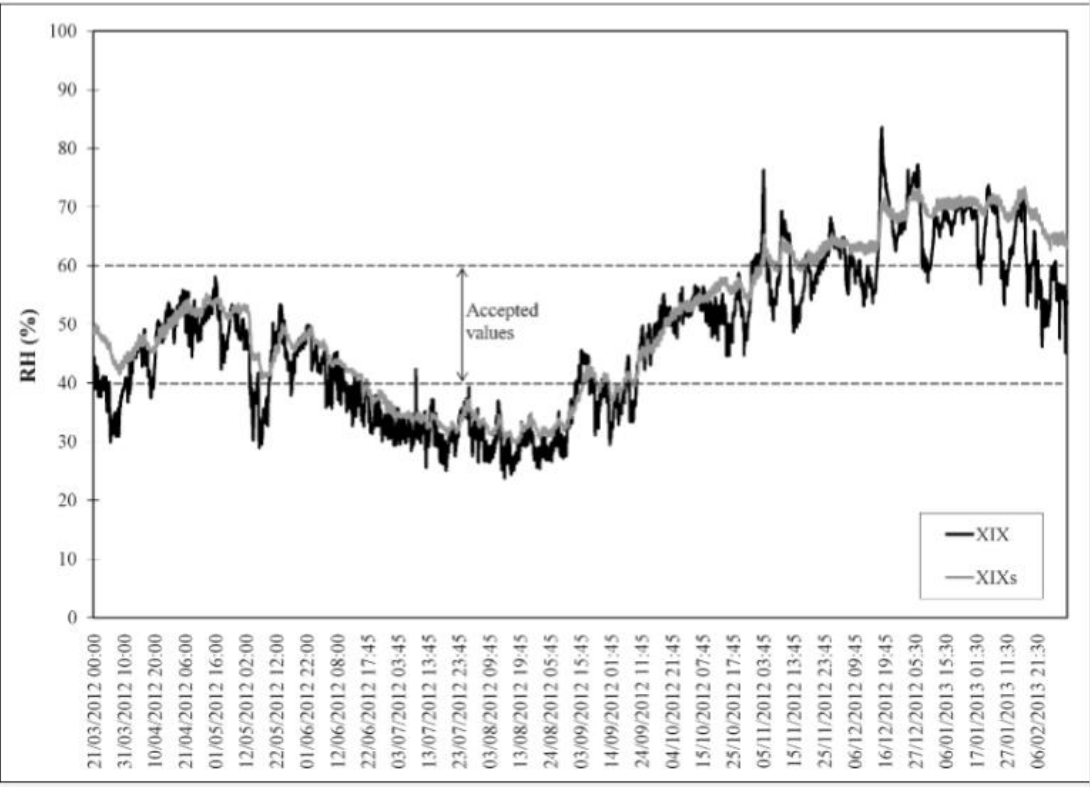
Figure 6 – Time profile of RH values of the year monitored for the room XIX and the showcase XIXs

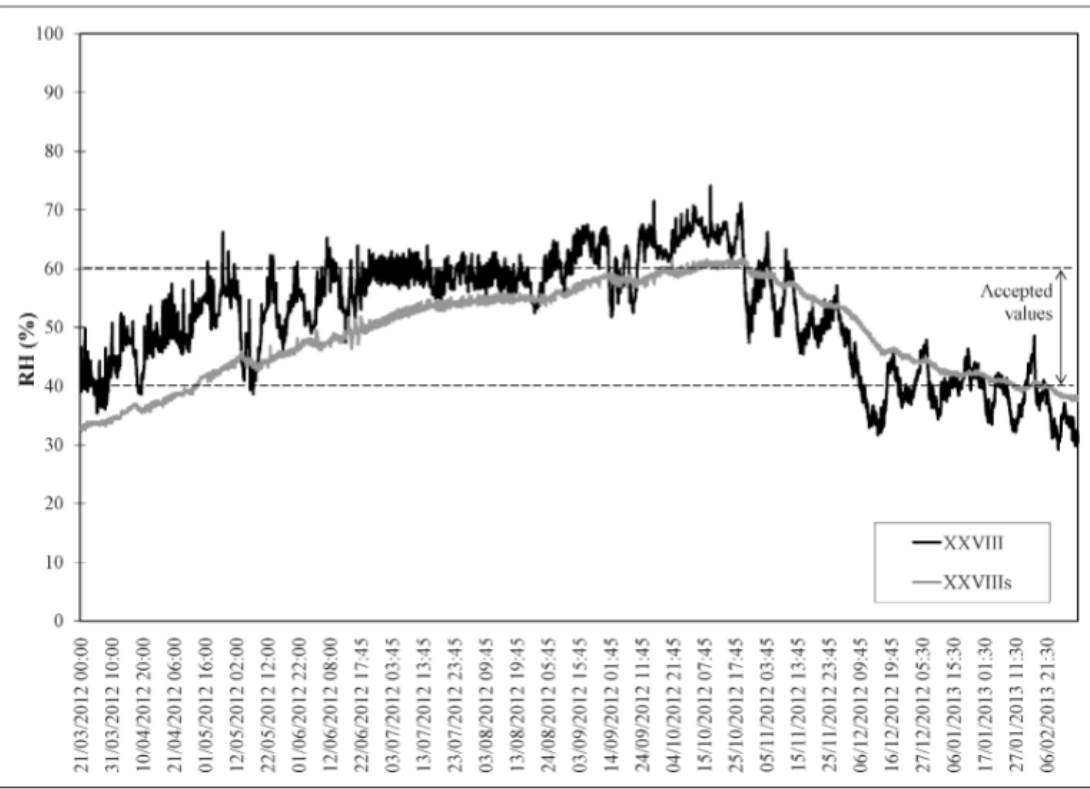
Figure 7 – Time profile of RH values of the year monitored for the room XXVIII and the showcase XXVIIIs

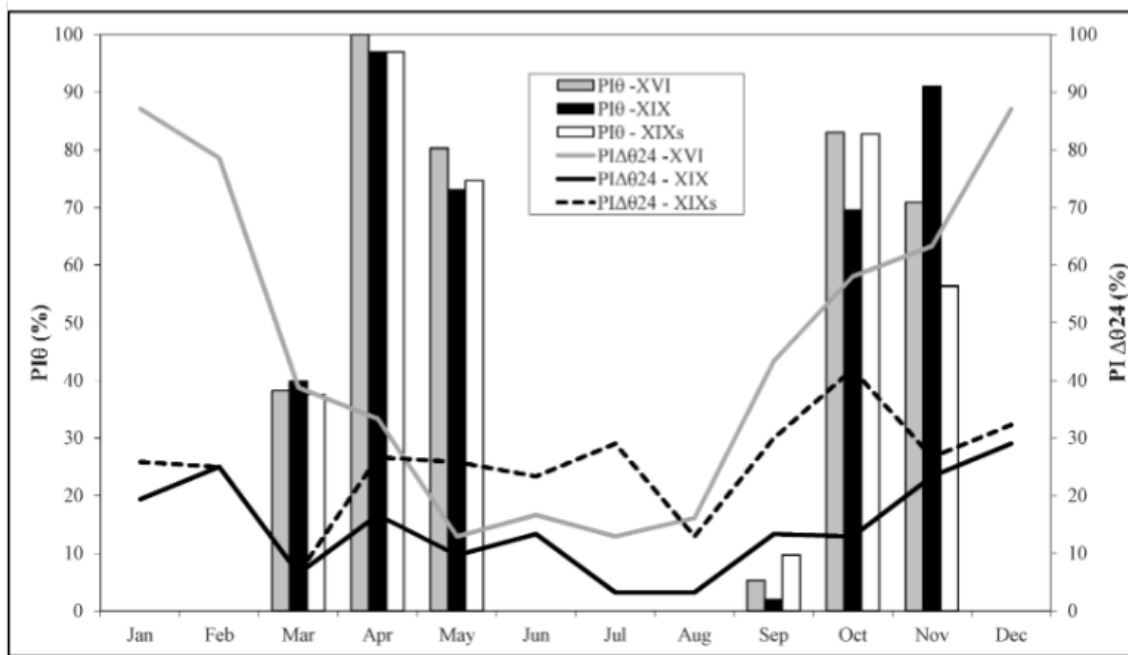
Figure 8 – Monthly $PI\theta$ and $PI\Delta\theta_{24}$ calculated values of rooms without temperature control system (XVI, XIX, XIXs)

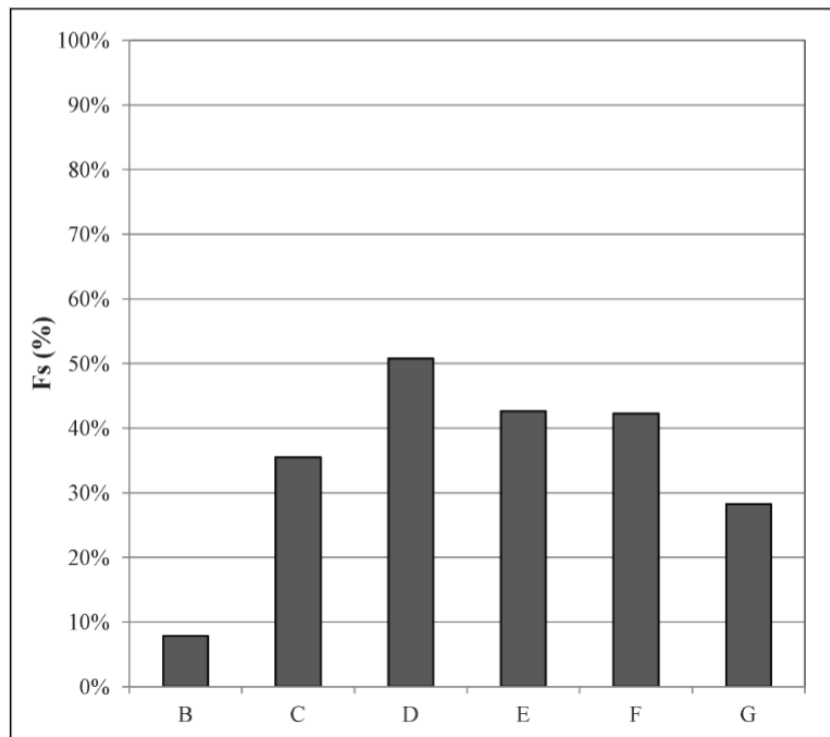
Figure 10 - Reduction of summer thermal loads F_s for room XVI.

The effects on the reduction of summer thermal loads F_s resulting from the solutions adopted are shown in Figure 10 and 11 respectively for the rooms XVI and XIX. For room XVI, the following observations based on the value F_s can be made: D, E and F solutions are the most effective ones as reduce summer loads from 51% (D) to 42% (F). When a double glazing is set, an external solar shading, such as venetian blind (D) or roller shade (F), greatly reduce summer solar radiation; an effective alternative is the combination of solar control glazing with internal roller shade (E). Regarding room XIX, the most effective shadings are P, M and I that combine solar control glazing (I) to internal shadings, such as venetian blind (M) or roller shade (P), and reduce F_s from 51% (I) to 57% (P). Regarding the effectiveness in terms of F_s of external venetian blind (tilting 0°), for room XVI this solution (D) is the most effective, otherwise in room XIX the effectiveness of this solution (L) is not excellent because of the different orientation of the three windows that varies from SE to

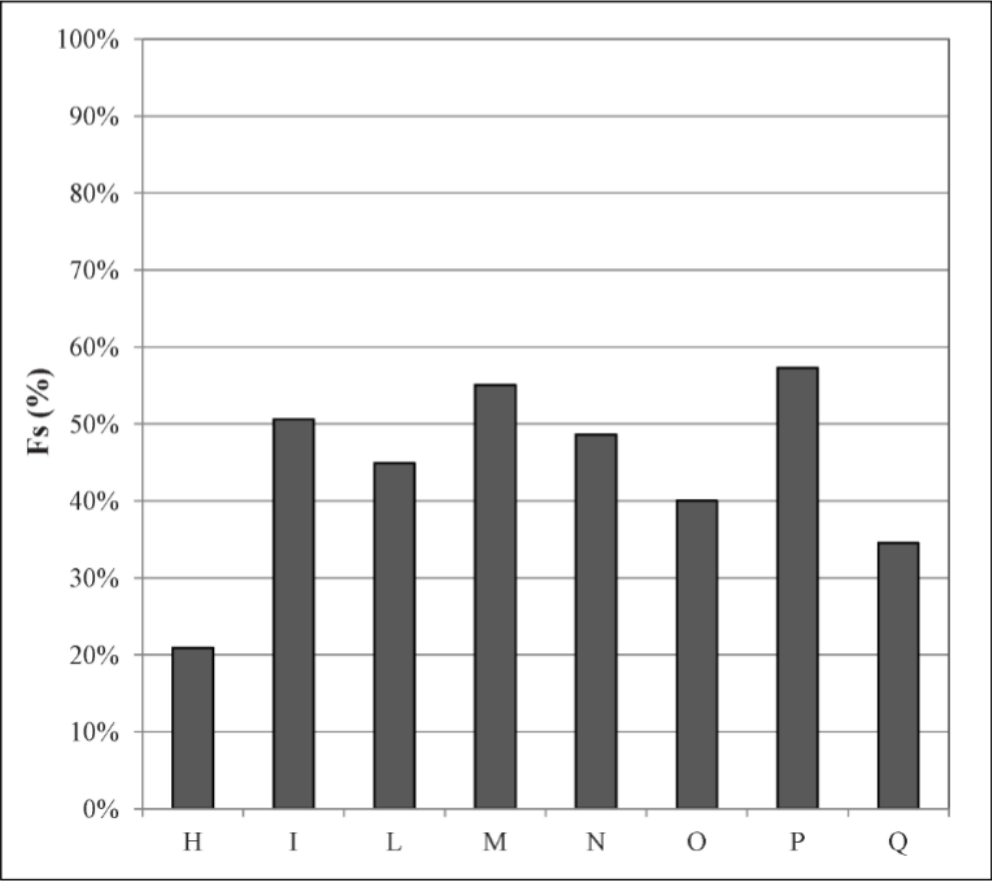
Figure 11 - Reduction of summer thermal loads F_s for room XIX.

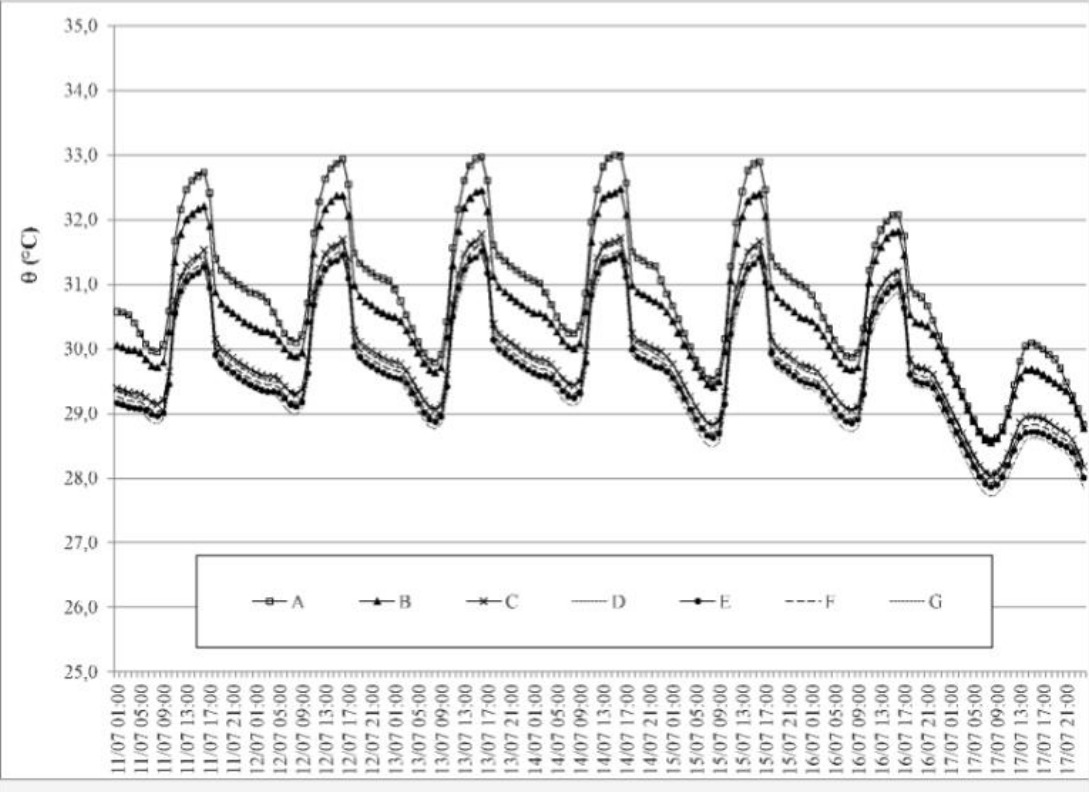
Figure 12 - Variation of internal dry bulb temperature from 11 to 17 July in room XVI.

NW. In general, in the choice of a proper external solar shading devices has to take into account also costs and maintenance problems of the device itself (both on the roof skylights as well as on the façade) related for example to the highness of the building itself and its poor accessibility. Regarding these aspects, important especially for historical buildings, some consideration can be pointed out: the effectiveness of solar control glazing (C and I), easy to install, varies from 36% (room XVI) to 51% (room XIX) while the effectiveness of double glazing combined with internal roller drape (G and O) varies from 28% (room XVI) to 40% (room XIX). These strategies, besides a good technical feasibility, guarantee a good reduction of energy need for space cooling. Figures 12 and 13, respectively for the room XVI and XIX, show the effects of the different simulated solutions on the variation of internal dry bulb temperature in one of the hottest week in the summer period (from 11 to 17 July). The following observations, based on Figure 12, can be made for room XVI: all the analysed shading devices and solar control glazing (C, D, E, F and G) are able to reduce the maximum dry bulb temperature values respect the base case A; the maximum reduction varies from 0.5°C obtained with double glazing (B) to 1.5°C obtained with all the other solutions; solar control glasses (C) are able to reduce the maximum dry bulb temperature of 1.3°C. As shown in Figure 13, for the room XIX the most effective solutions are those which combine a solar control glass with internal venetian blind (M) or internal roller shade (P); these solutions reduce the maximum dry bulb temperature values of up to 3°C respect the base case A. Double glazing (H) is able to reduce the maximum dry bulb temperature values of 1°C, while for the solar control glass (I) this reduction arises to 2.5°C.

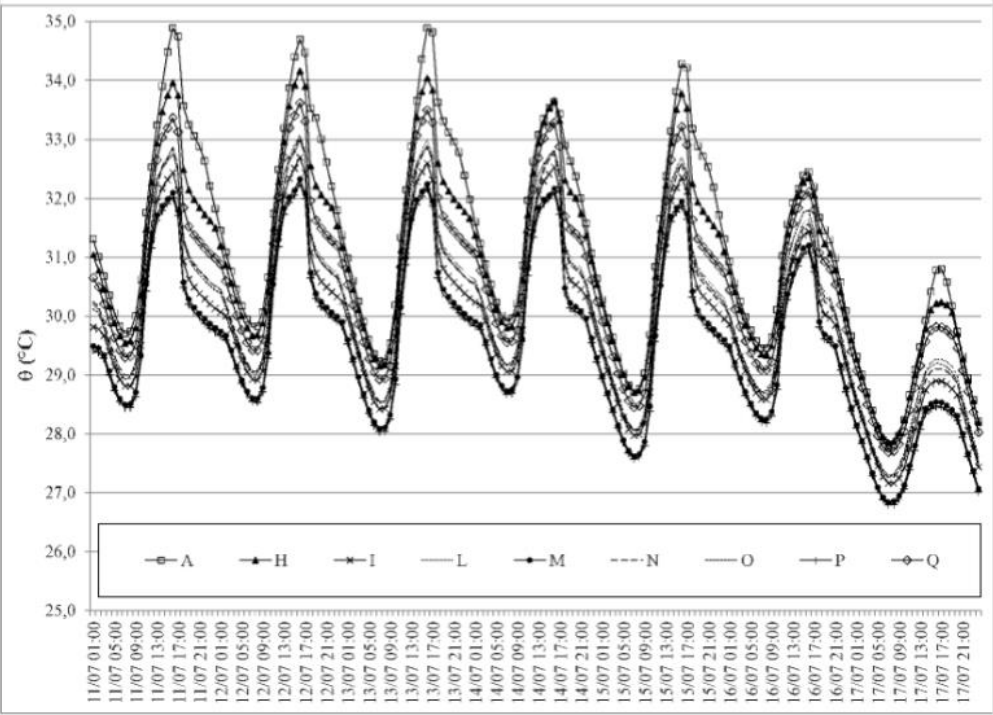
Figure 13 - Variation of internal dry bulb temperature from 11 to 17 July in room XIX
