# A Multidisciplinary Methodology for Technological Knowledge, Characterization and Diagnostics: Sandstone Facades in Florentine Architectural Heritage

**Keywords:** built cultural heritage; diagnostics; architectural survey; NDT; pietraforte

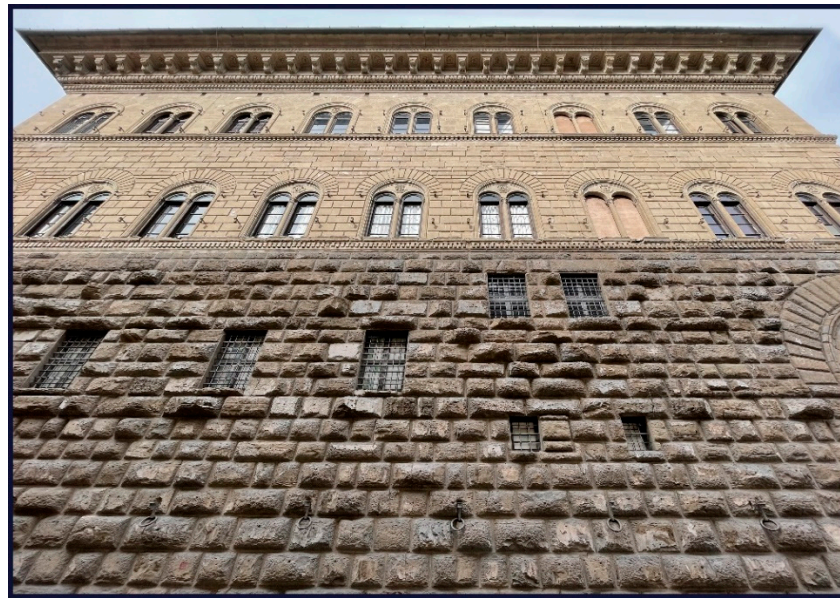
Figure 4. Facade of Palazzo Medici-Riccardi on Via Gori.

The facade of the Palazzo Medici Riccardi is set on three overlapping registers, separated by string-course cornices. The lower one consists of large, rusticated blocks. The second register is characterized by a smooth-faced rustication, with less pronounced and more regular volumes, with which the mullioned windows are also made [22]. In the third register, with another set of windows identical to the lower one, the facing is flat.

The facade ends above with a large cornice with sandstone shelves, composed of a sequence of classic moldings [23] (Figure 4).
