## LONG-TERM MONITORING OF A MASONRY TOWER WITH WIRELESS ACCELEROMETERS

## 2 THE MATILDE TOWER

### 3 THE STRUCTURAL HEALTH MONITORING SYSTEM

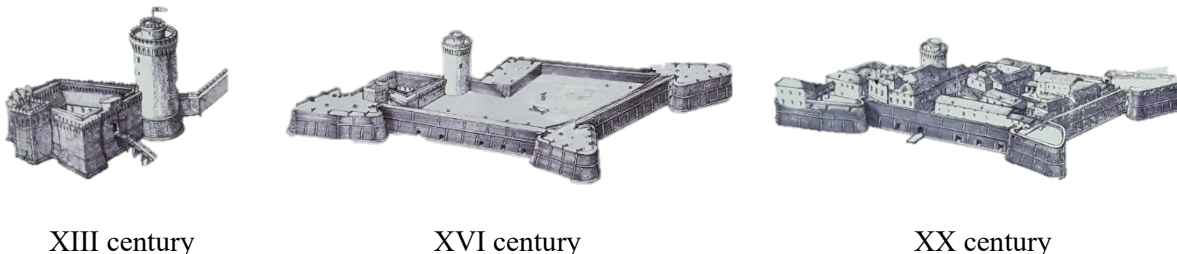
Figure 1: The evolution of the buildings around the tower over the centuries.

The structure underwent several modifications over the centuries, as showed in Figure 1. In the XIII century, the tower was part of a minor, squared fortification under the control of the

Pisa Republic. Then, under the Medici's domain, the defensive structure was further enhanced to a larger fortress with three bastions ("Ampolletta", "Canaviglia" and "Capitana") and two main gates by Antonio da Sangallo the Elder and Antonio da Sangallo the Younger. Lately, the structure was converted into a palace by Cosimo I de' Medici, and in the XX century, the fort became a prison. During the WWII, the complex sustained extensive damage, and most of the buildings were destroyed apart from the Matilde tower.
