# Enhancing cultural and natural heritage as a lever for the regeneration of rural areas

The village of Bënjë, Southern Albania, as a case study

3.3 Necessary constructions as a landscape paradigm <i>Pietro Matracchi</i>	118
PART II. RESULTS	
Chapter 4	
The project proposal	141
4.1 The design strategy <i>Antonio Lauria</i>	141

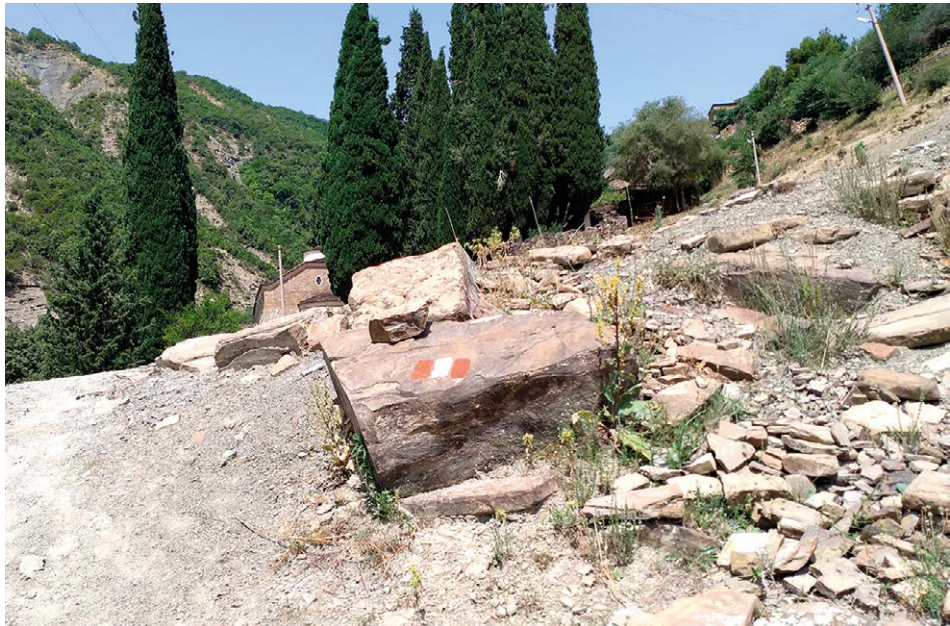
Figure 3.15 – The landscape in Section 5 of the path, in the vicinity of St Mary's Architectural Complex, on the side of the village most affected by the spread of rocky detritus outcrops and its degraded appearance.

In continuation of Sections 4 and 4a, from an elevation of approximately 410 metres a.s.l, the route continues as far as the village at an elevation of approximately 497 metres a.s.l, with a section on the hydrographic right of the Bënjë Stream, characterised by semi-natural forest formations with a predominance of deciduous broad-leaved trees. Slightly further up they border extensive areas where plant life has disappeared due to widespread soil erosion and the consequent emergence of evolving scree formations. [Fig. 3.15] The path has a pronounced slope with stretches of traditional cobblestones (*kalldrëm*) which are still quite recognisable, albeit deteriorating (see § 3.3). The section is also characterised by the gradual appearance of elements that testify to the human presence in the area, such as dry stone walls, small buildings and rural tree formations (see § 3.3). Close to the village, the visual field of the path opens up higher up due to the absence of forest vegetation as a result of the aforementioned soil erosion and the emergence of eroding scree slopes. In this final section of the path, the anthropogenic plant presence of cypress trees in the cemetery of St Mary's Architectural Complex is a significant landscape landmark (see Chapter 2).

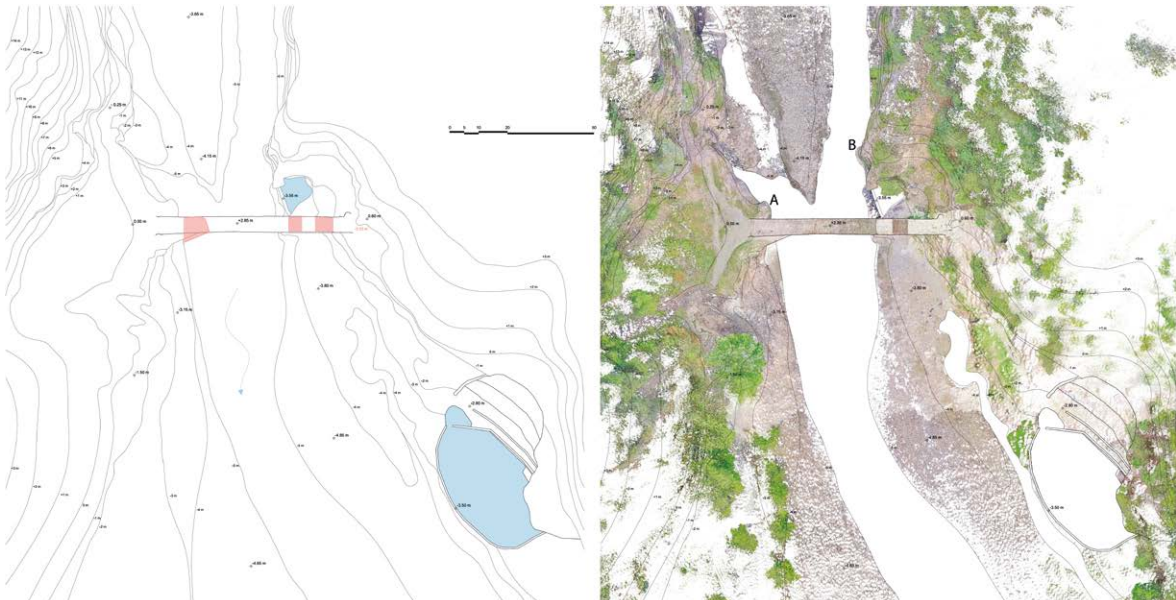
Figure 3.16 –  
Left, Plan of the Kadiu Bridge highlighting the piers (in orange), the contour lines of the area, and the thermal pools (in light blue). Right, plan view of the point cloud of the laser scanner survey, indicating the rock outcrops (A and B) protecting the bridge abutments.

The positioning of the Kadiu Bridge in relation to the particular orography of the Lëngarica River's route was not accidental. The bridge is preceded by a long gorge that snakes between high cliffs. Right on the last sloping offshoot of the rocks that cling to the riverbed, the abutments supporting the arch of the bridge found a powerful foothold, which are preceded by rock outcrops that help mitigate the impetuosity of floods [Fig. 3.16]. The change in orography before and after the bridge is evidenced by the sudden reduction in the steepness of the slopes at the river's edge. Beyond the bridge, the valley floor widens considerably, leaving more space for the Lëngarica riverbed and the gradual extension of the fields. [Fig. 3.17]

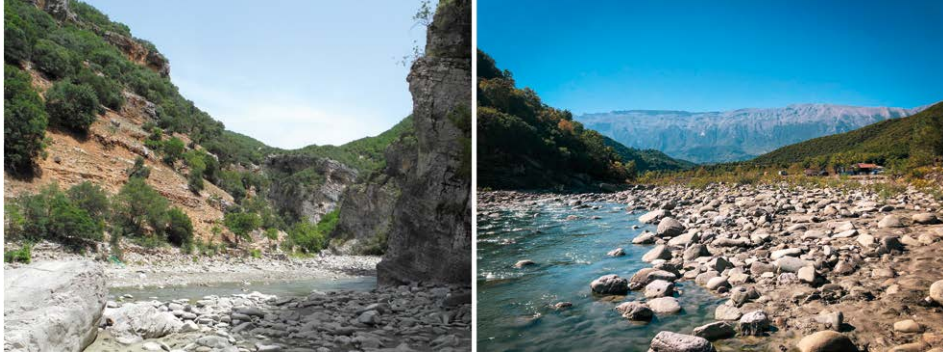
Figure 3.17 – Orographic context of the Lëngarica River upstream (*left*) and downstream (*right*) of the Kadiu Bridge.

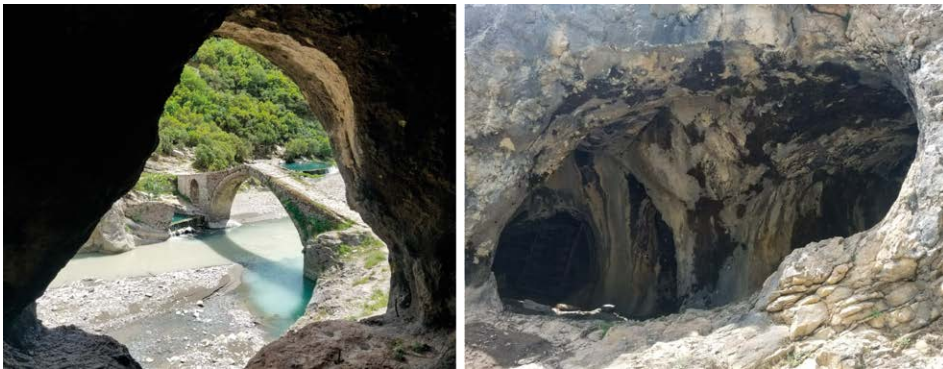
Figure 3.18 – The Bënjë Cave, on the right side of the river, with the Kadiu Bridge in the background.

The relevance of the bridge area is also linked to some caves that testify to human presence in times necessarily much earlier than the construction of the bridge, dating back to the period between the 18th and 19th centuries during the reign of Ali Pasha of Ioännina (Shtylla, 2013; Lauria *et al.*, 2020). [Fig. 3.18] The presence of thermal waters that could have had a religious or curative value may also have been considered when deciding the location of such rock dwellings (Melillo, 1995). The specific location of the bridge can therefore be explained by several factors, with the orography of the context seemingly the most significant.

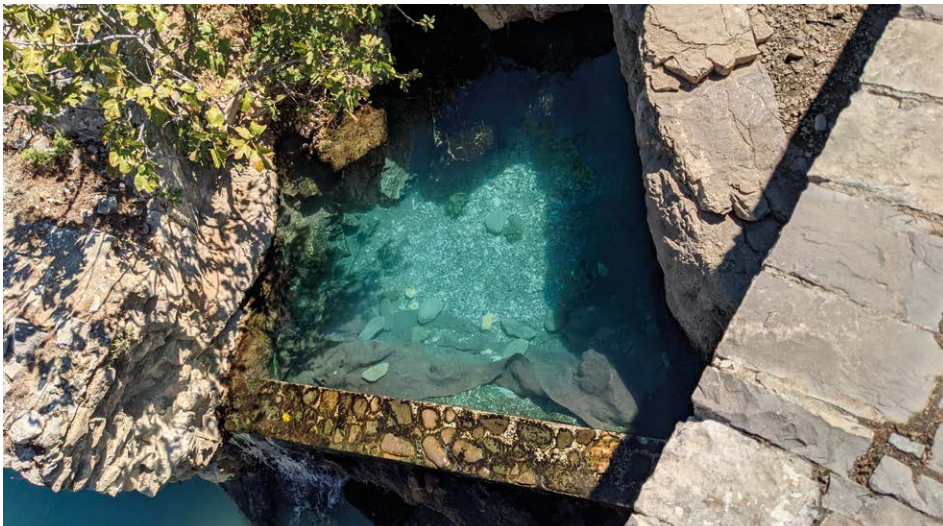
Figure 3.19 – Thermal pool on the edge of the Kadiu Bridge.

From a more general point of view, according to Kola (2002) the thermal baths, together with the Kadiu Bridge, constitute a strategic junction because several roads connecting two large provinces intersect here [Fig. 3.19]. They served as a permanent guidepost. «In fact, one of the first military trigonometric points was built on the highest hill to the north-east of the village (*Kryqëzë*), which also served as a stationary landmark» (Kola, 2002: 10).<sup>7</sup>

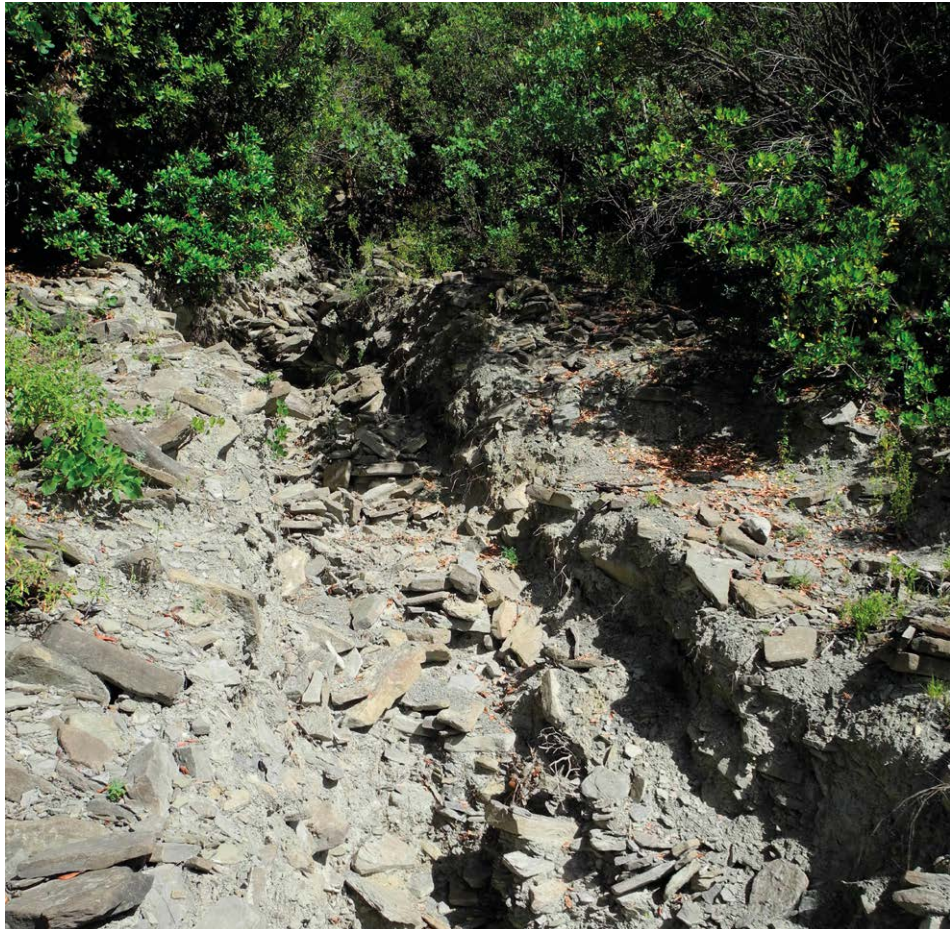
Figure 3.20 – Compluvial area between slopes where the path that led to the Kadiu Bridge is interrupted.

From the Kadiu Bridge, the path towards Bënjë continues to climb until, having overcome a difference in height of approximately 100 metres from the bridge,<sup>8</sup> it does not go beyond the hilly promontory between the confluent valleys of the Lëngarica River and the Bënjë Stream. In this short portion of the path, neglect of the land has already led to the almost obliteration of an initial section. The interruption, which was not accidental, is in a compluvial area between rather steep slopes, where a torrent forms when there is heavy rainfall, as evidenced by the area devoid of vegetation due to intense erosion by water runoff. On the same site, the disordered accumulation of slabstones would suggest the remains of a walled construction connecting the two slopes, dismantled by the impetuosity of the waters, which likely became more forceful when use of the path became increasingly sporadic, until it was completely abandoned. [Fig. 3.20]

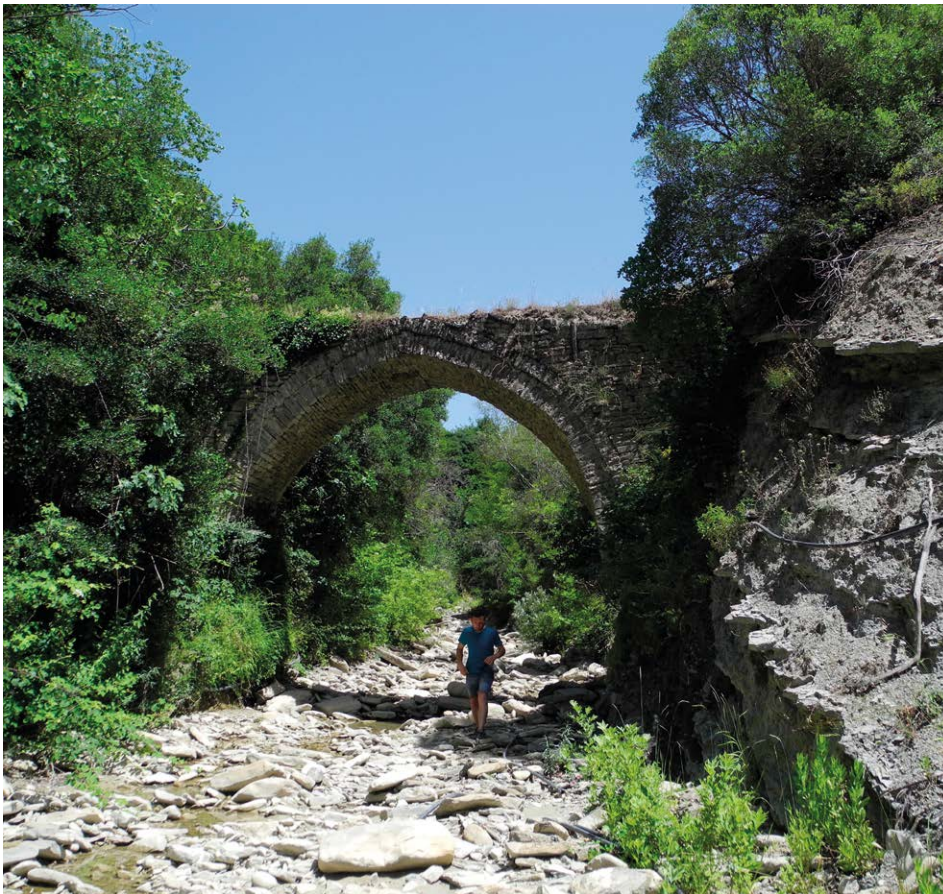
Figure 3.21 –  
Běnjě Bridge.

Just upstream of this crossing rises an excavated rock face with thin sandstone layers alternating with silty-clayey marl layers with extensive, highly fractured flakes. [Fig. 3.22] This is probably a quarry face, rather than a slope cut for the path to pass through it. In fact, the thin layers of compact sandstone were most likely used to construct the adjacent bridge. The choice of such a position for the bridge was also due to the fact that creating a passage a little further downstream, where the conpluvial area between the slopes widens, would have required the construction of a bridge with a much more imposing and therefore much more costly arch.

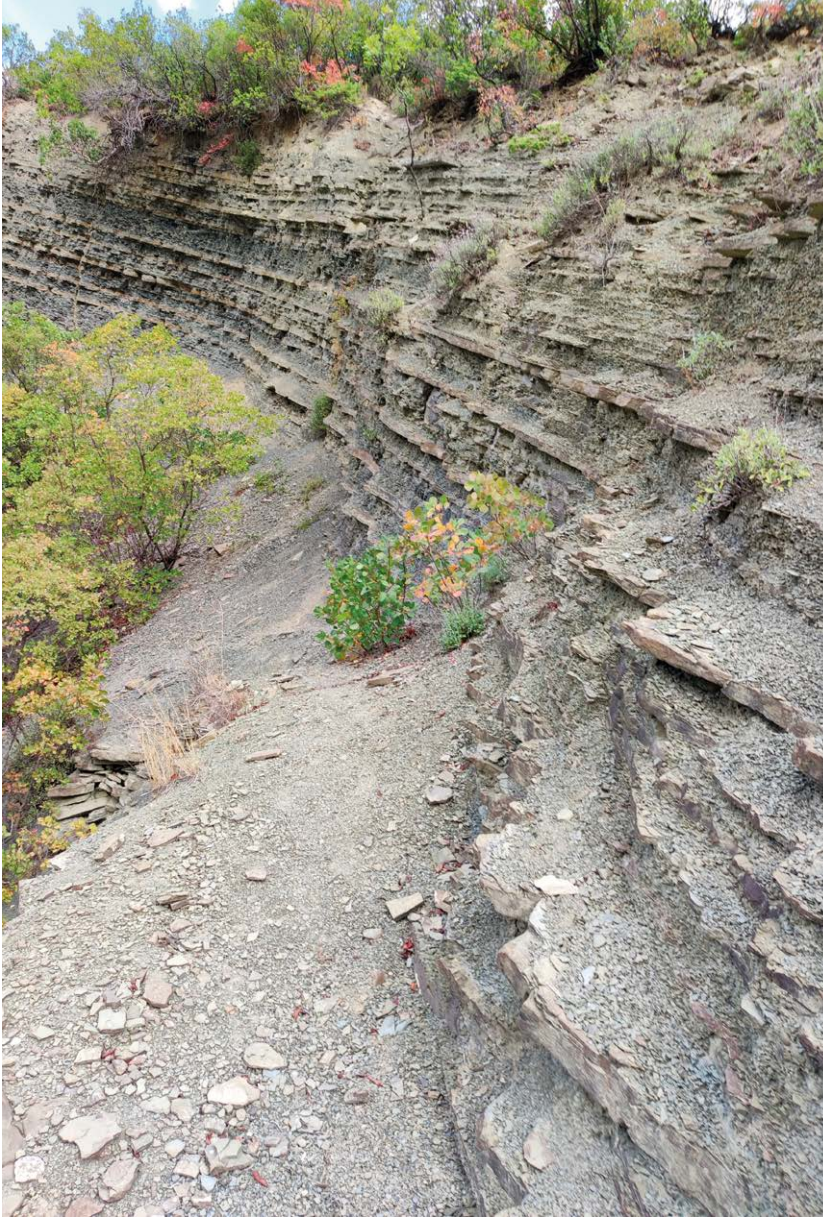
Figure 3.22 –  
Rock face near  
Bënjë Bridge.

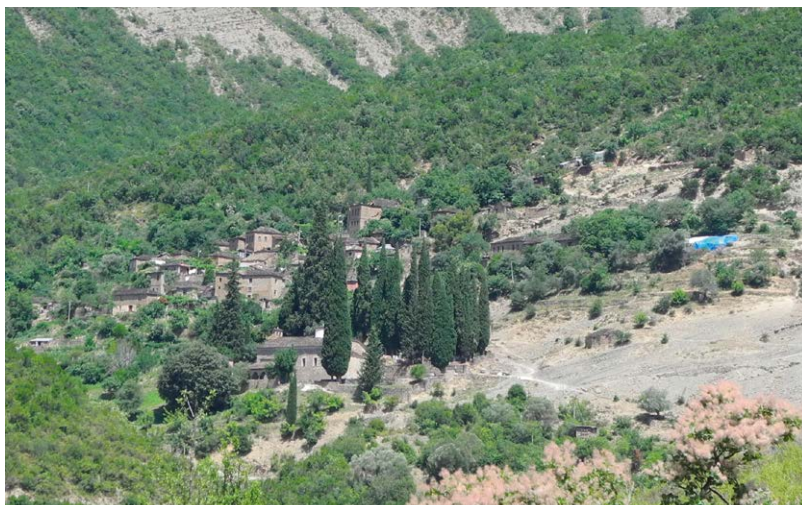
Figure 3.23 – To the right of the monumental cypresses, the last section of the path crosses the bare slope and reaches the Church of St Mary and the village of Bënjë.

After crossing the Bënjë Stream, the village is reached by following a rather short but steep section of the path, with a challenging change in height of more than eighty metres, which initially runs orthogonally to the contour lines, unlike the previous part which tends to cut diagonally across them, mitigating the steepness. The orography of the slope means that as one ascends from the bridge, only in the final stretch does one first glimpse the cypress trees marking the Church of St Mary and the adjacent cemetery, then the apsidal building and the village of Bënjë, now only a few dozen metres away. [Fig. 3.23]

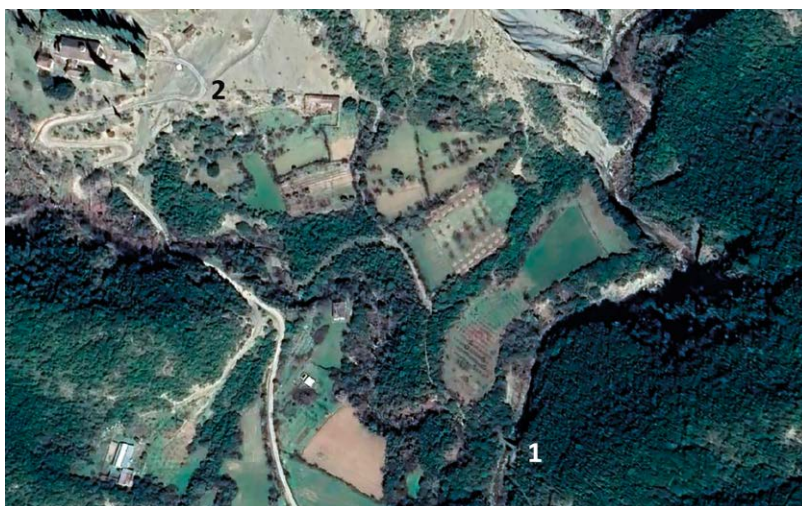
Figure 3.24 – View of the cultivated area on the slope down from the Church of St Mary showing the Bënjë Bridge (1) and the last section of the path before reaching the church (2).

The section of the path between the bridge and the village also has the distinctive trait of crossing a cultivated area organised into fields delimited by wooded borders. [Fig. 3.24] These mostly follow the contour lines and form a kind of extensive tree line that stabilises the soil in cultivated areas and slows down the runoff of surface water, thereby safeguarding the cultivated land, which is made regular and only slightly sloped. The tree-

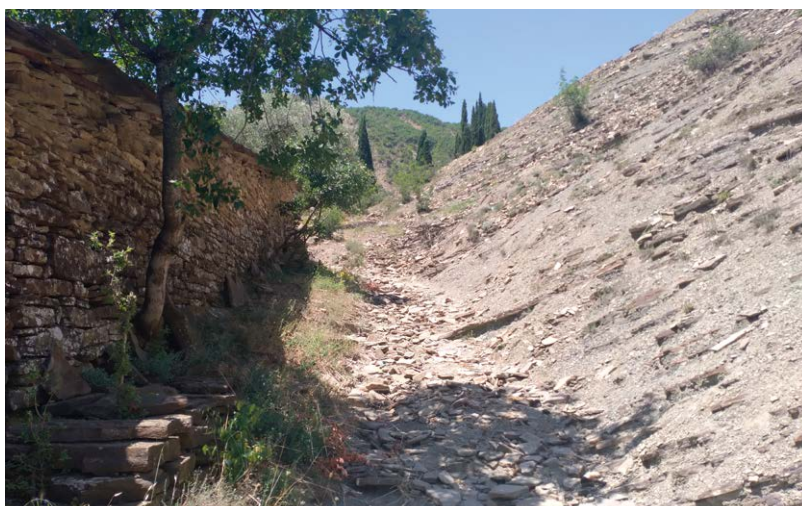
Figure 3.25 – Cypress trees at the end of the path mark the proximity of the village of Bënjë.

The path that climbs up from the stream for an initial stretch is between the cultivated area and the wooded area; it is then flanked on both sides by fields, while in the upper part the vegetation completely disappears due to extensive rock outcrops with fragmentary sandstone and particularly fine materials. [Fig. 3.25]

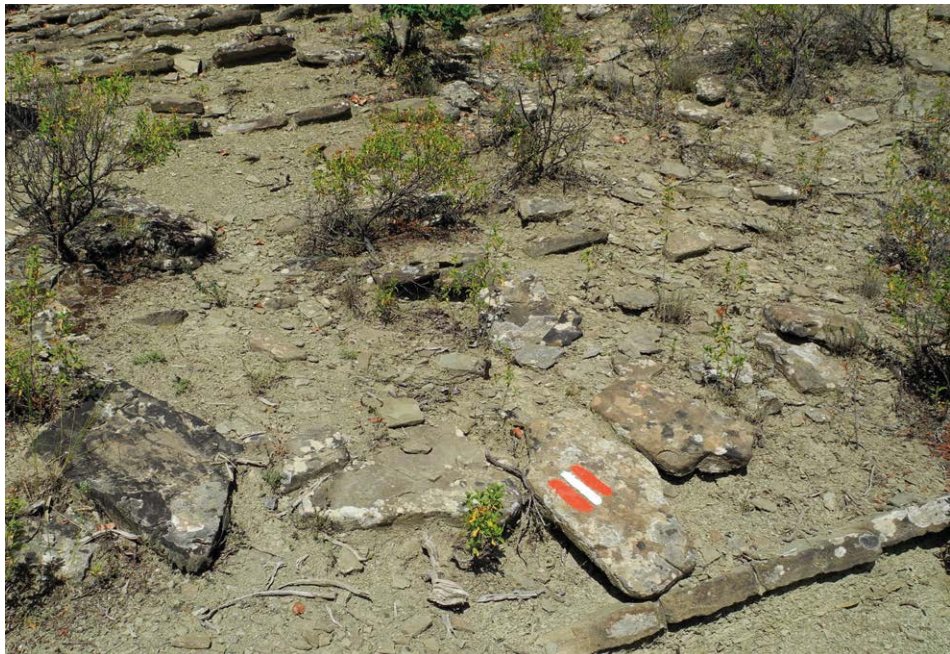
Figure 3.26 –  
Outcrops of rock  
and erratic boulders  
on the path.

For long stretches, the path seems to be marked merely by the removal of the sparse vegetation that manages to grow in areas of rocky outcrops or that are covered by a very thin layer of soil, removed by the continuous passage of people and animals. This was enough to create a sort of natural cobblestone and should not be considered a coincidence, but the result of profound knowledge of the places and of the ability to grasp their virtues and vocations, avoiding modifications, when possible, that would prove onerous and not very long-lasting or effective over time. In some sections, the route is orthogonal to the sandstone formation layers, which thereby create a system of natural steps, albeit uneven and irregular, that make it easier to walk along. [Fig. 3.26] This characteristic has ensured that the path has lasted over time, making it still legible for long stretches today despite its enduring non-use. In addition, it is likely that only small connection works were carried out at the most difficult points, as the small messy accumulations of slabs that are sometimes encountered would seem to indicate. Where the vegetation thickens, the path becomes a dirt track, at times almost indistinguishable among the spontaneous forest regrowth, no longer obstructed by the regular passage of people and animals.

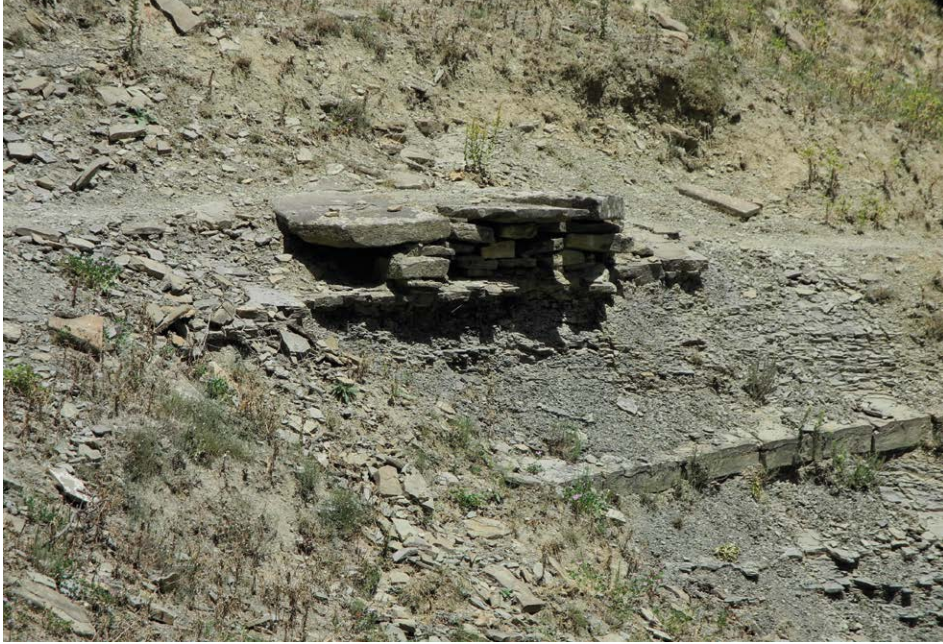
Figure 3.27 –  
Traces of the  
paving of the path  
near the village.

relic survives in the original position of the path and there is a further small portion of wall slightly downstream and blocked by a shrub. These traces show that the pathway here consisted of drystone masonry, which rose from the outer face resting on a narrow levelled strip. From the foot of the facing, a masonry wall with a mostly triangular cross-section rose up, gradually filling in the area between the facing and the slope profile with rubble; the top walking surface was finished off with slabstone, which still exists among the surviving wall fragments. [Fig. 3.28]

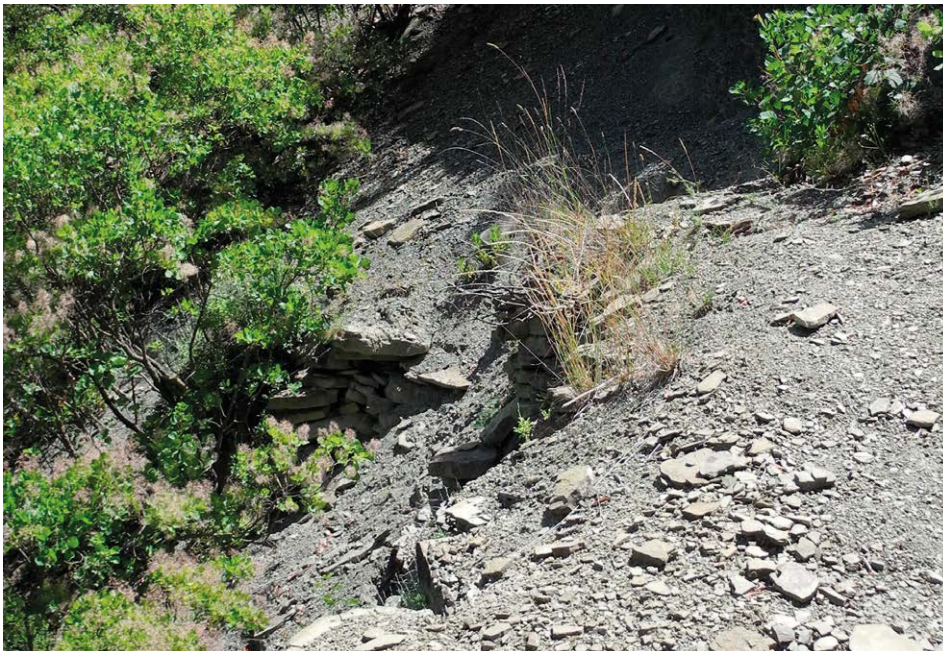
Figure 3.28 –  
Surviving wall  
fragments of the  
path section on the  
left side of the Běnjě  
Bridge.

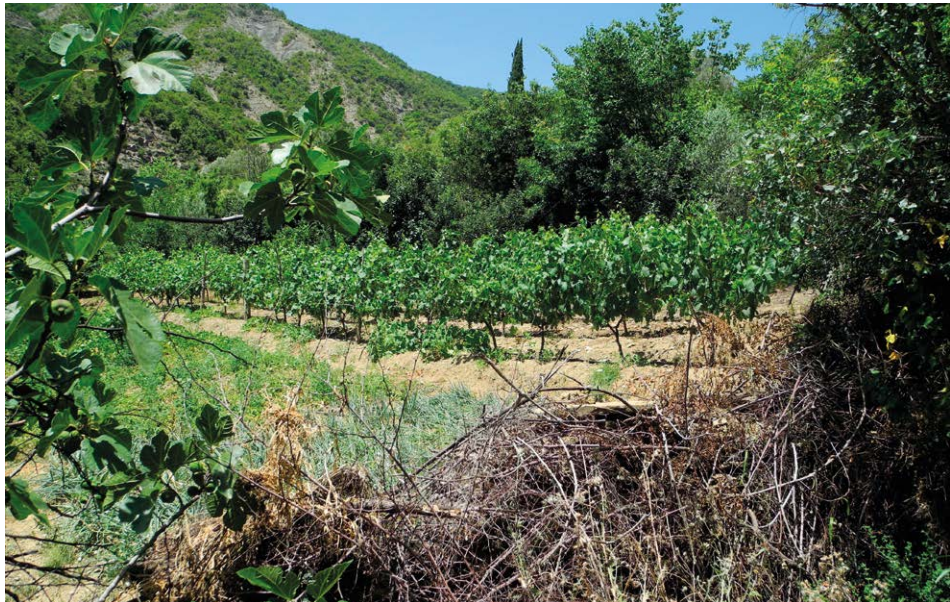
Figure 3.29 –  
Cultivated fields  
on the edge of the  
path.

Nowadays, the path is almost completely screened on the sides by trees and bushes, concealing its close relationship with the adjacent terraced cultivations. [Fig. 3.29] The path is wedged into the ground at times like a slight crevice. In some places one of its edges borders steep slopes, whereas in others it is flanked by portions of masonry of different widths, made necessary by the adjacent terracing. [Fig. 3.30]

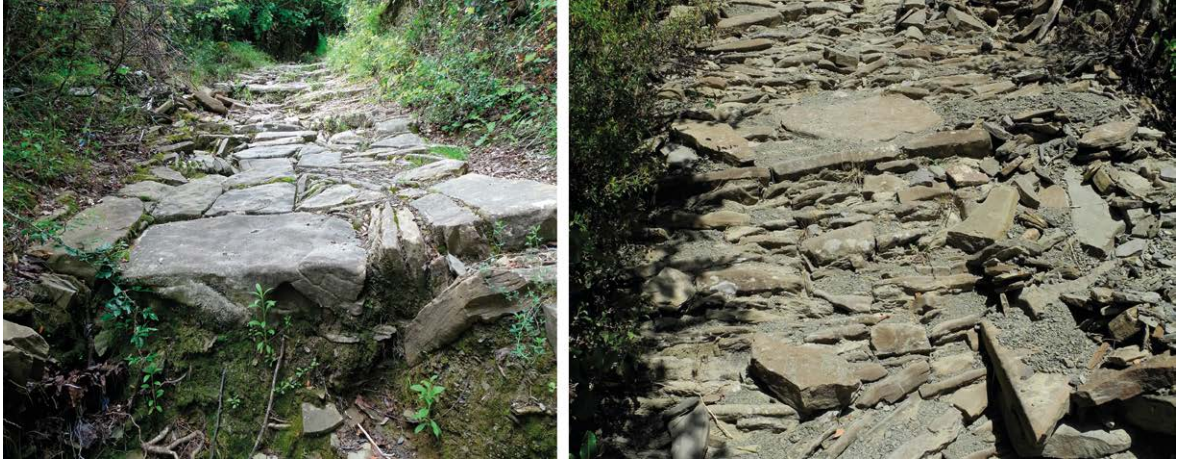
Figure 3.31 – Details of the laying of the *kalldrēm*.

The *kalldrēm* consists of slabs laid with the thinner edge exposed, filled with earth or minute fragments of rock. [Fig. 3.31] The rows tend to be transverse, but rarely continuous over the entire width of the path. The irregularities are due to the fact that there was a tendency to accommodate the unevenness of the ground, corrected in part by the use of slabs of different sizes, sometimes laid on small volumes of soil that uniform the surface. The pattern of the slabs frequently adapts to the rocky outcrops, the top of which becomes part of the walking surface, in some cases after having been levelled. At the same time, the outcrops are particularly strong points of adhesion to which the slab can connect. More rarely, large-format slabs arranged as continuous transverse planking are used. Sometimes such slabs are used to create connecting steps between parts of the walking surface with significant height differences.

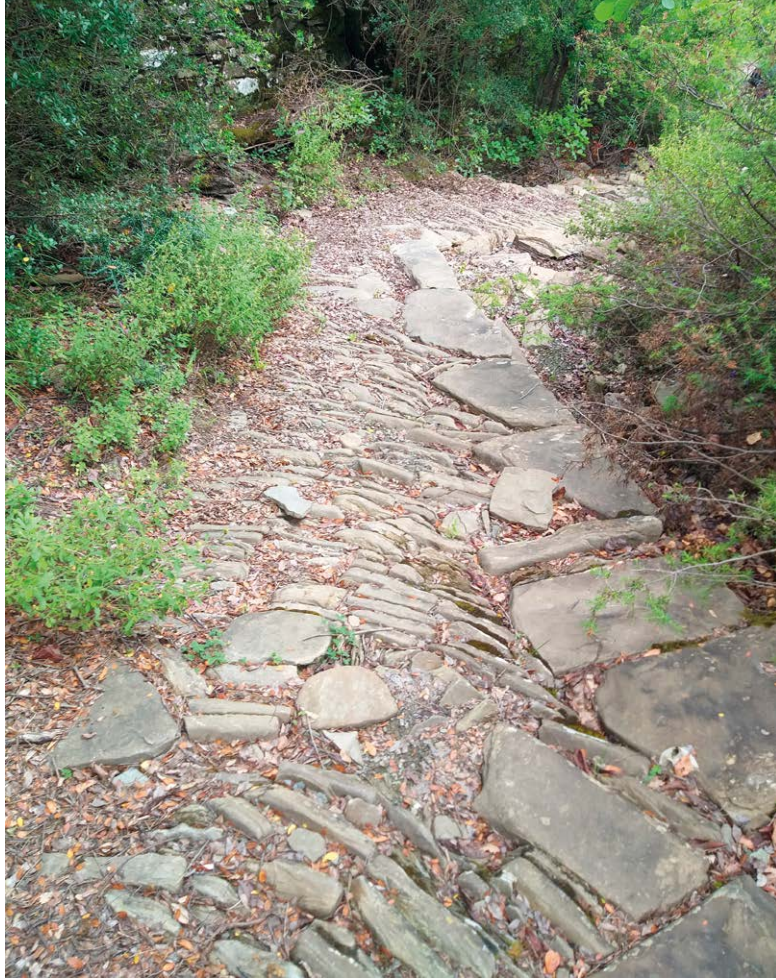
Figure 3.32 –  
Section in *kalldrëm*  
with the edges  
blocked by large  
slabs.

The overall stability of the paving is ensured by the deep insertion of the slabs and the lateral confinement, achieved with walls, or with the ground surface slightly raised at the edges. When the ground tends to slope at the side of the path, the *kalldrēm* is blocked with an edge made of massive polygonal slabs. [Fig. 3.32] The use of large slabs in the remaining parts appears to be episodic. Despite the humble means employed, attention to detail is evident even in the care taken in the gaps between the path and the fields: despite the small differences in height between the two parts, even here there is no lack of stone elements alongside the paving stone.

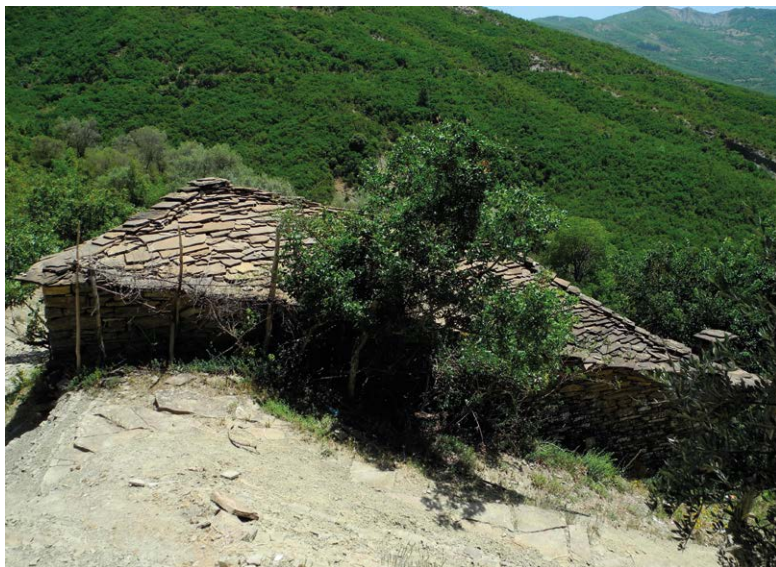
Figure 3.33 –  
Roofing of a  
building made of  
the same slabstone  
used for the path.

As further confirmation of the symbiosis between materials, environment and measured construction actions, a rural building bordering the last section of the path towards the village has a slabstone roof whose pattern is in continuity with the same type of slabstone dispersed on the adjacent slope. [Fig. 3.33]

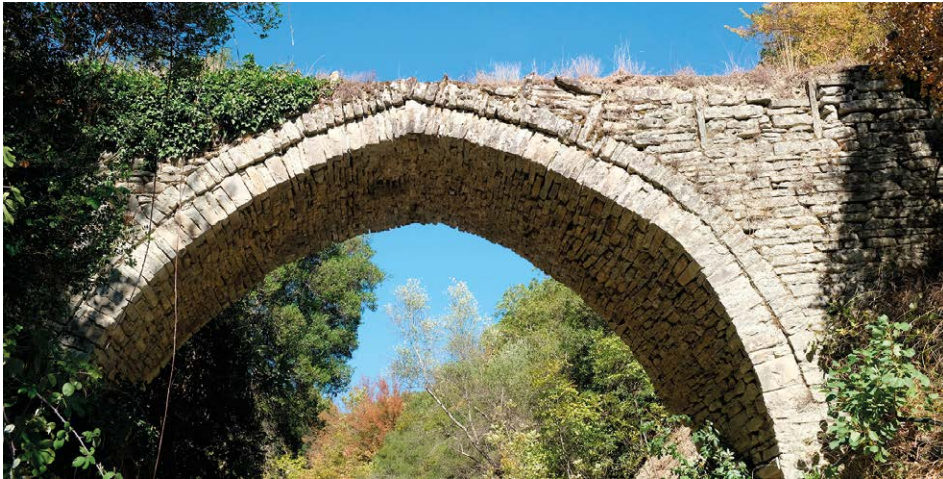
Figure 3.34 –  
Detail of the arch of  
Bënjë Bridge.

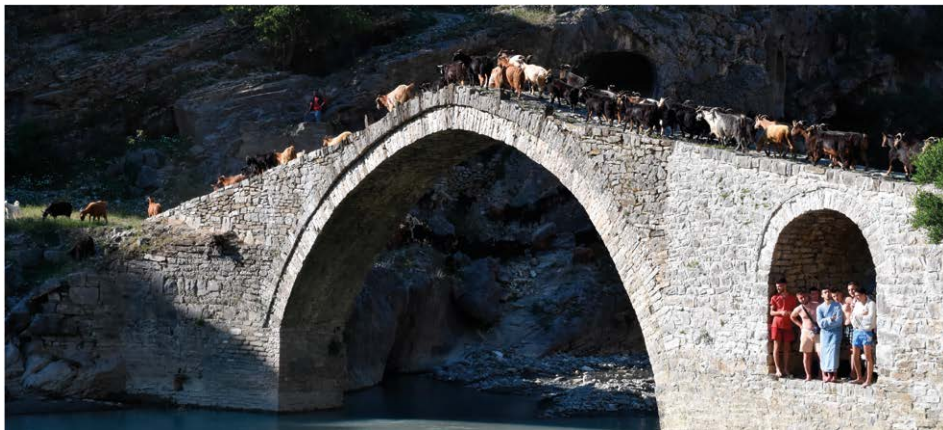
Figure 3.35 –  
The Kadiu Bridge  
crossed by a flock.

The fate of the Kadiu Bridge was different due to its monumental size and its particular location close to the entrance to the canyon of the Lëngarica River; no less important is its function as a connection to the adjacent thermal baths on the left bank, which in recent years have become a destination for an increasing number of tourists. During the *Albania dei Piccoli Borghi* Thematic Workshop,<sup>9</sup> held in May and June 2019, it was possible to appreciate the temporary continuity in the use of the bridge with traditional activities, when it was crossed by a compact and numerous flock of sheep stretching from one bank to the other. [Fig. 3.25]

Information on the restoration of the Kadiu Bridge is limited to more recent years (Lauria *et al.*, 2020). The right pier, probably also due to its position in the riverbed always below the water level, suffered a collapse in the masonry on the downstream side, which was rebuilt in 1982. On the other hand, hydrogeological conditions are considered one of the primary factors of bridge damage in Albania (Gega & Bozo, 2017). Nowadays, the Kadiu Bridge is in an overall good state of preservation; recent work involving the pointing of parts of the wall facing and the complete resurfacing of the paving can be seen. Such works are not always appropriate in the choice of materials and quality of execution. One problem that is certainly open is the safe use of the bridge, as it does not have side guards.

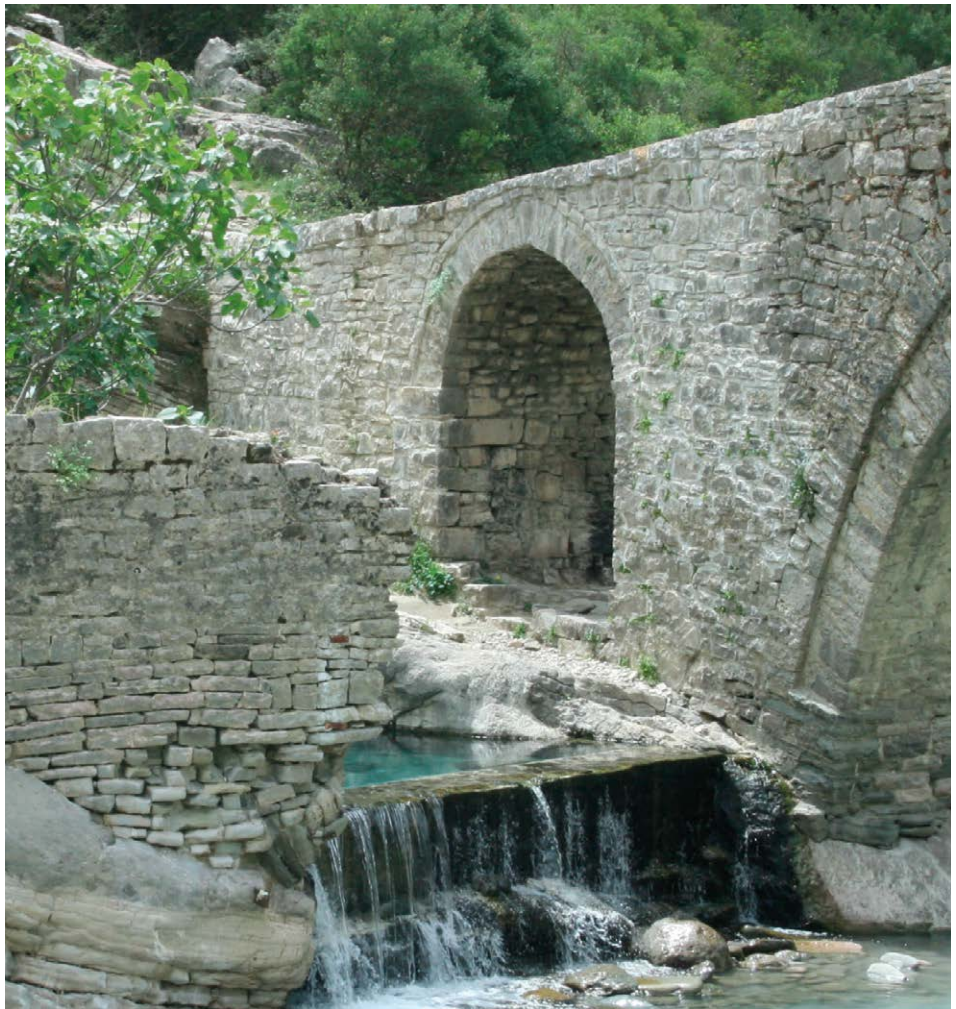
Figure 3.37 –  
Abutment of the  
Kadiu Bridge and  
thermal pool, detail  
of the archway  
springer and the  
side archway.

The characteristics of the Kadiu Bridge piers reflect the deliberate adaptation to the orography of the context. The one on the right rises up from the riverbed with a particularly irregular planimetric arrangement, due in particular to the downstream slanted side that widens, in two misaligned sections, to encompass part of the high ridge of supporting rock. [Fig. 3.16] In addition, the wall underneath the bridge arch, in turn, has been significantly rotated, increasing the span on the upstream side, thereby accommodating the outflow of water. Due to this slanted position of the inner side of the pier, the bridge arch has an upstream span of 15.10 m, which is reduced by approximately 0.80 m on the opposite. [Fig. 3.36] The more gradual steepness of the left bank of the river made it possible to set the pier on a footing on the rock, which for long periods of the year is above the water level. The bridge then continues, with a constant width, resting on the prominent rock, which gradually reduces the height of the wall mass. This section, more extensive than the other side, has an arch for releasing water pressure so that pressure on the flank is reduced in the event of major flooding, which generates a small water collection basin in this part. [Fig. 3.37]

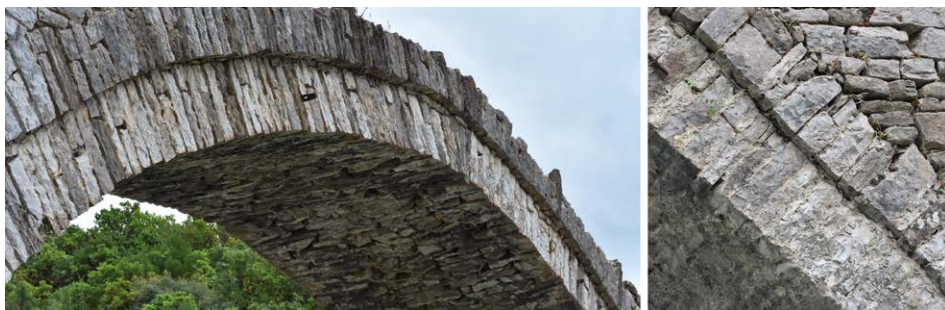
Figure 3.38 –  
Kadiu Bridge,  
details of the stone  
archivolts.

The arch of the bridge has edges delimited by square stone ashlar, usually extending the full height of the stone archivolt which is approximately 50 cm. In the intrados of the barrel vault, in the internal parts, on the other hand, the use of smaller stones in a considerable variety of sizes can be seen, sometimes laid with a certain approximation. [Fig. 3.38] Adequate toothing between such inhomogeneous parts was achieved by using rather large ashlars on the intrados, sometimes exceeding the height of the stone archivolt itself. Given this constructional arrangement, it is reasonable to assume that the thickness of the barrel vault is reduced in the inner part between the edge arches.

At about half the height of the stone archivolts, small eyelets of metal ties, which do not always have an anchor bar, emerge from the mortar joints, comparable to those observed in the ties of the pronaos of the Church of St Mary. The position of the ties indicates that they were put in place when the bridge arch was under construction. Aside from the fact that there were not many anchor bars, the small size of the existing ones should be emphasised, from which it can be deduced that friction between the bars and the masonry of the vault was relied upon in order to reduce the risk of the formation of cracks parallel to the directrix, i.e. the side arches.

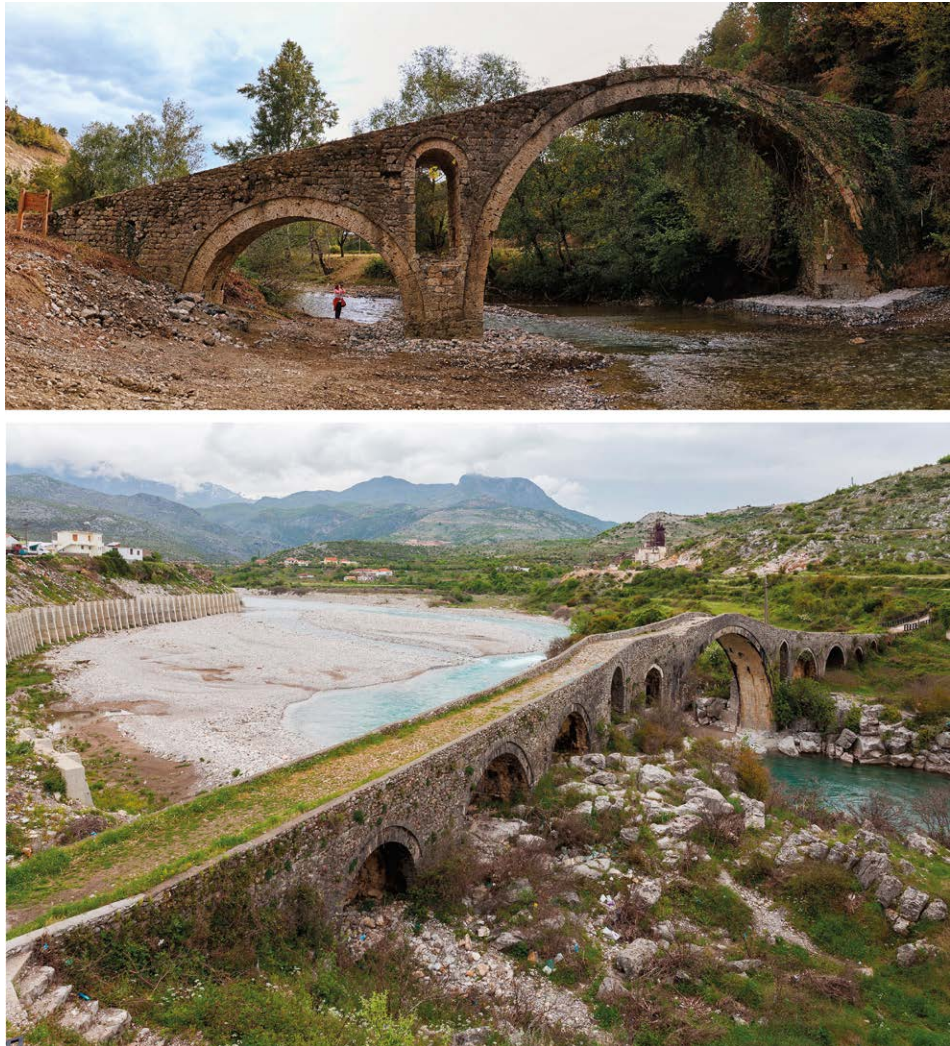
Figure 3.39 –  
Above. Goliku  
Bridge. Bottom.  
Mes Bridge.

chivolts) of Kamare (1715) in Librazhd (in Elbasan County), with evident remains of walls on the sides, and Mes (1768) near Shkodër, featuring protective walls, seem to prove (Maiellaro, 2006). [Fig. 3.39]

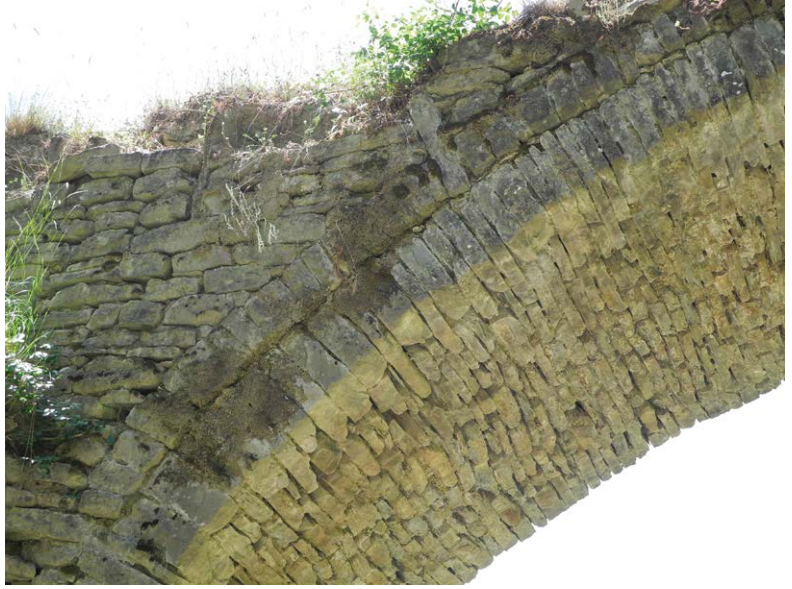
Figure 3.40 – Bënjë Bridge, the stone archivolts and the intrados.

Bënjë Bridge is modest in size, but it has similar characteristics to the Kadiu Bridge in that it has a pointed arch with a double stone archivolt, with the upper one slightly projecting. Differences can be seen in the size of the ashlars of the main arch, which here have thicknesses that decrease from the haunches to the most central area of the arch, where a kind of slab is used that is in continuity with that of the remaining part of the barrel vault. [Fig. 3.40]

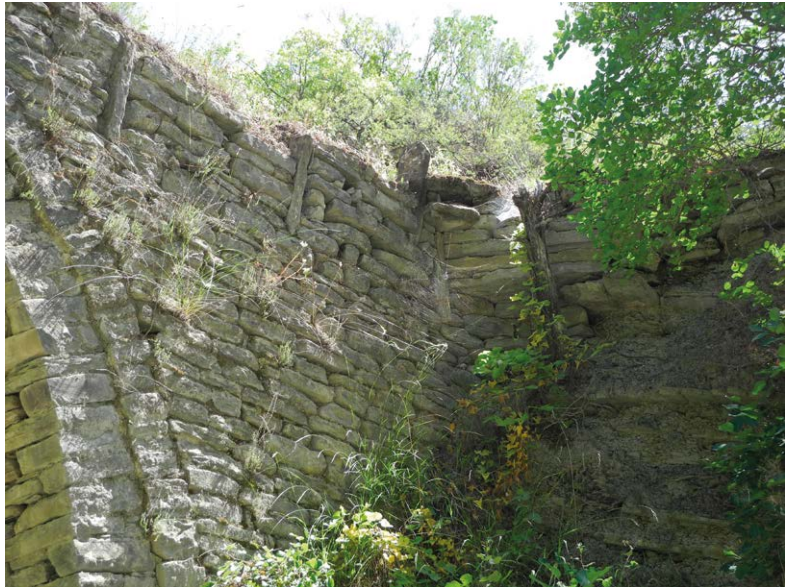
Figure 3.41 – Bënjë Bridge, the masonry joined by vertical stone elements, connected to a section of wall on overhanging slabs.

A further similarity is due to the upper arch, which also uses some longer stone elements; here they are also inserted into a section of masonry delimiting the sides of the bridge. But Bënjë Bridge provides a further important piece of information. In the section of masonry to the side of the archway, the use of vertical stone elements juxtaposed with a horizontal row masonry continues. [Fig. 3.41] When it comes close to the slope, the masonry continues with an overhanging slab. In fact, with this device, the short section of the connecting wall (to the left of the stream) between the bridge and the slope was built as an overhang on the rock escarpment, dem-

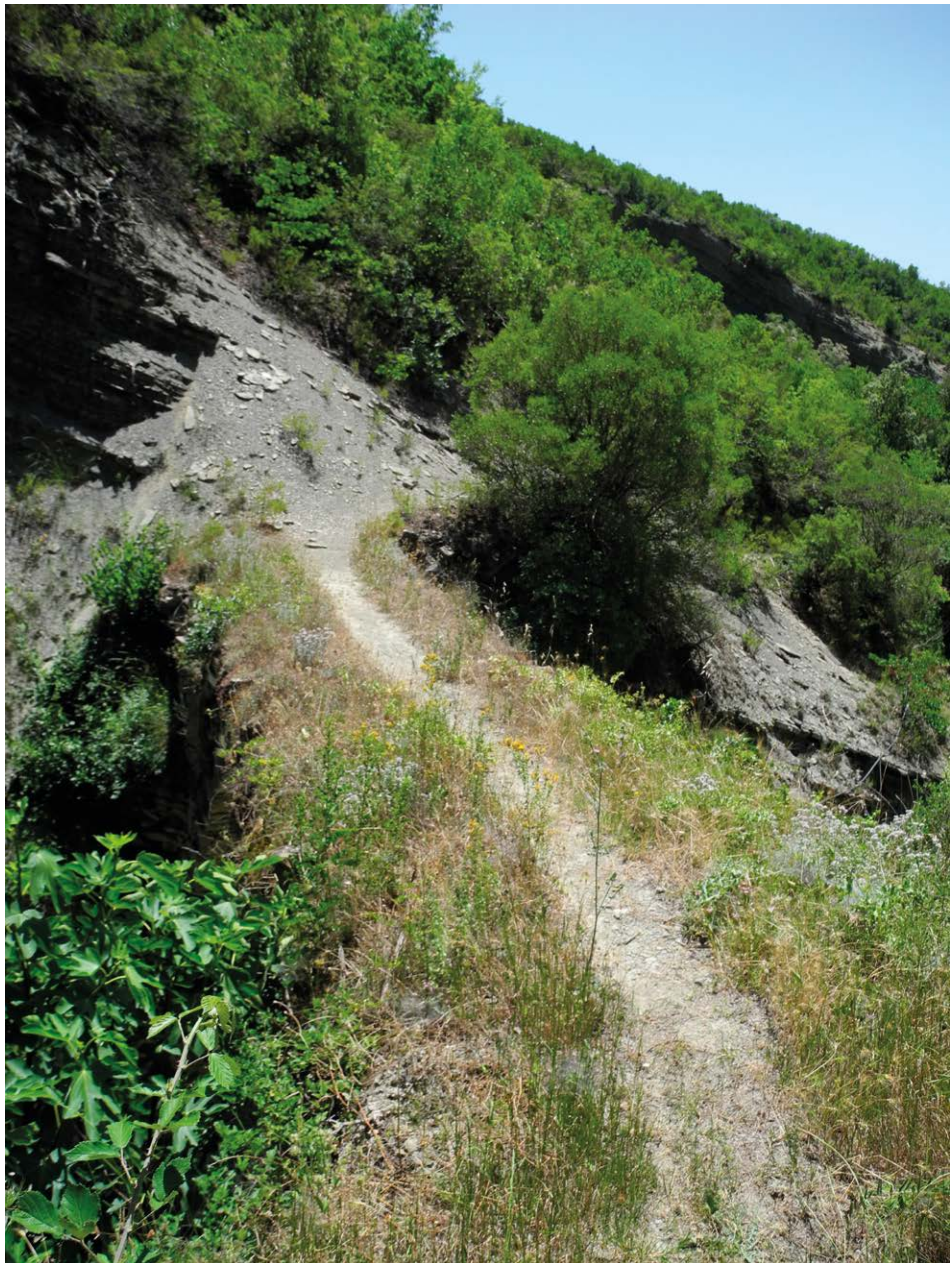
Figure 3.42 –  
Walkway over the  
Bënjë Bridge.

onstrating the incumbency of the slope in the passage area and the desire not to alter it with excavations, however modest. Nowadays, these wall sections are surmounted by a ground crossing, with a walking surface for the most part horizontal. [Fig. 3.42]

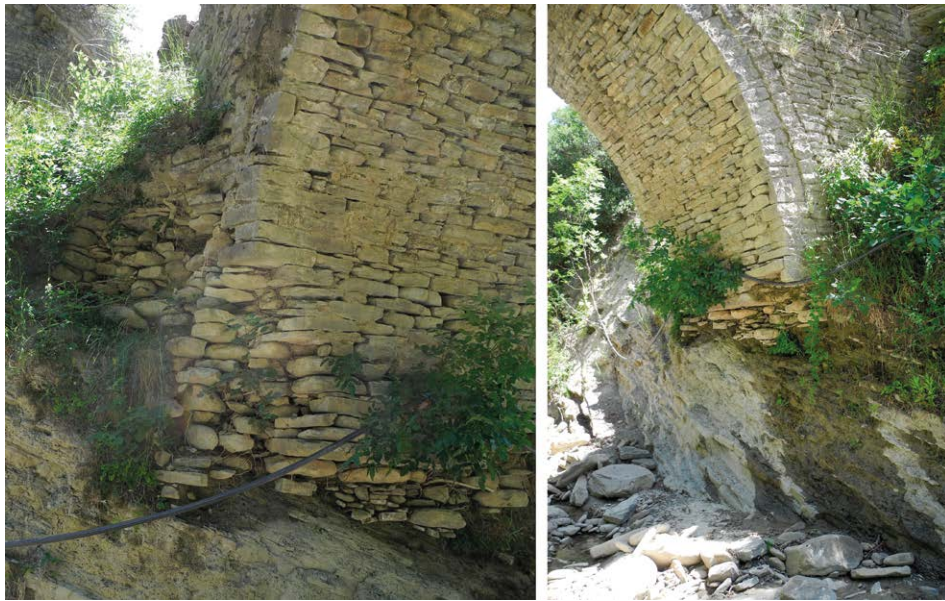
Figure 3.43 – Details of the left abutment of the Běnjě Bridge.

The left side of the bridge arch, placed up against a vertical, heavily stratified rock face, fell on a narrow abutment now completely demolished by floods. The modest thickness of the masonry abutment must have favoured this outcome; the prevailing part of the bridge abutment consisting of rock, however, has conferred stability to the arch to date [Fig. 3.43]. Due to the slight overhang in relation to the rock below, a corbel-like arrangement was created at the base of the arch, which partly compensated for the lack of an abutment. In such a condition of obvious vulnerability, the gradual disintegration of the masonry beyond the support of the arch is in any case occurring, which on the upstream side has already affected a section of the stone archivolt of the arch and the masonry of the side. This makes it all the more urgent to restore the missing parts, ensuring that the pillar to be rebuilt, being of modest masonry mass, has the appropriate anchorage with the adjacent rock wall, which was not provided for in the original structure characterised by this probable genetic factor of structural weakness.
