To cite this article: M Martelli *et al* 2020 *IOP Conf. Ser.: Mater. Sci. Eng.* **949** 012022

Assessment of residual effectiveness for Water-Repellent treatments for building stones. Water absorption tests on the monumental complex Cathedral of San Zeno and the Baptistery of San Giovanni in Corte in Pistoia

M Martelli¹, T Salvatici², C A Garzonio², M De Vita¹

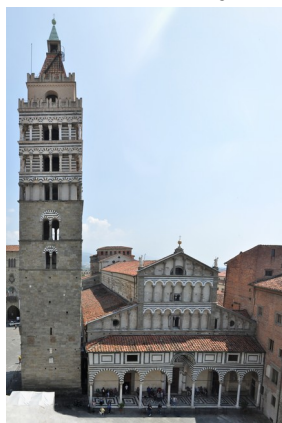
Figure 1. Cathedral of San Zeno and the bell tower.

For this purpose, some stone monuments that had undergone conservative interventions in recent years needed to be chosen. The Cathedral of San Zeno, its bell tower, figure 1, and the Baptistery of San Giovanni in Corte in Pistoia, figure 2, suited the aim for several reasons: the same lithotypes, the same environmental conditions, the different state of preservation, the fair number of documented restorations performed at different times.

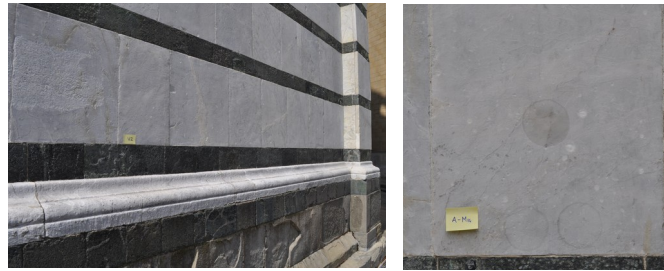
Figure 5. White marbles; detail of point AM14

3.1 *General consideration - white marbles.* White marbles (figure 5), has been taken as a touchstone for the entire research. On them, the different responses due to stone superficial grain size or origin of the lithotypes have been tested, for example, AM7-AM14 and AM4-AM5 [2]. Given the big gap of the results, in the overall evaluation of the treatments, we, therefore, tried to select slabs that had similar characteristics (in particular grain size, state of conservation/decay) to have more reliable results in terms of effectiveness of the water-repellent treatment.

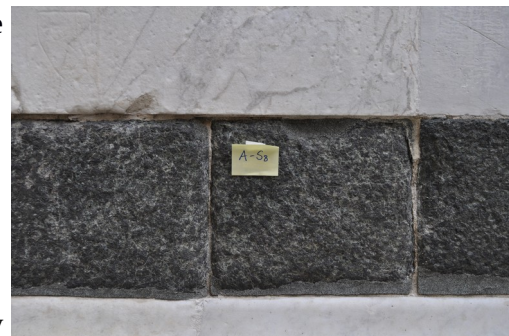
Figure 6. Serpentines; detail of point AS8.

3.2 *General consideration - serpentines.* In this case (figure 9), the distribution of the highest absorption peaks appears more tied to the state of conservation of the surfaces than to the age of the treatment. In any case, the decidedly lower absorption is still that of the last treatment carried out in 2017 with Fluoline HY hexafluoropropene-vinylidene fluoride used as anti-writing in the base part of the Sides 3 and 4 prospectuses (point AS8, figure 6).

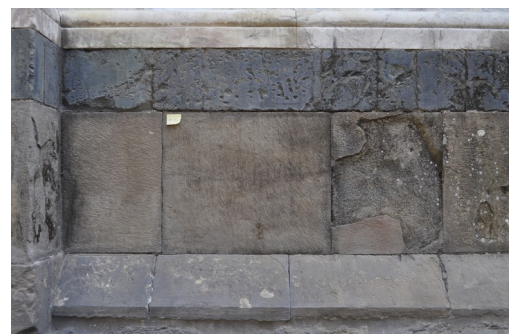
Figure 7. Gray sandstone; detail of point AA5

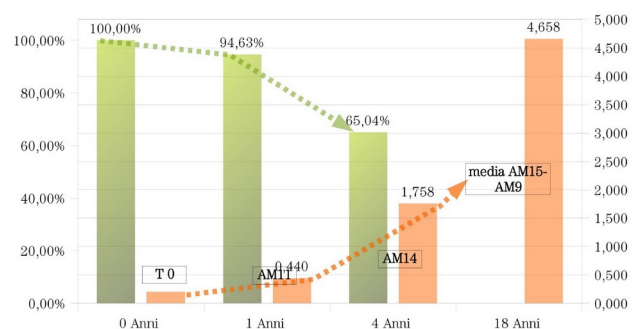
Figure 12: White marble, summary of the results: water absorption values and reduction of the effectiveness of the water repellents
