# MEDIEVAL YEGHEGIS, ARMENIA

# VII. THE “OLD CHURCH”

## An Archaeological Stratigraphic Analysis

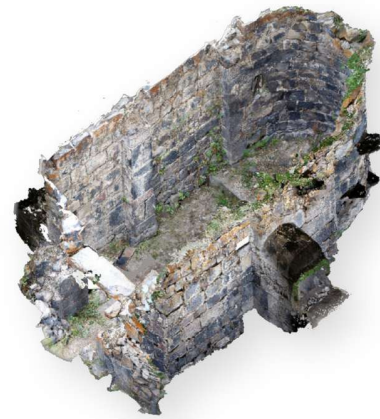
[fig. 1] On the left, the localization of the Old Church in the village Yeghegis; on the right, an overall view of the complex (photo by 3D modelling, 2019)

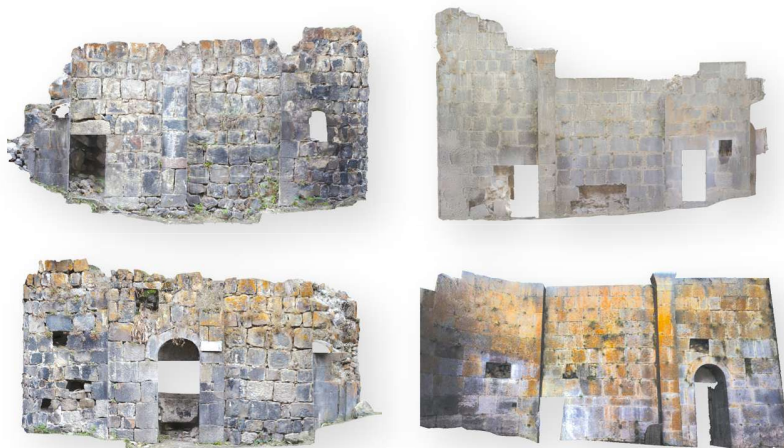
[fig. 2] A comparison between the Old Church in Yeghegis (left side) and St Sion Church of Arates (right side): above - the northern side; below - the southern side of the two churches

On the south-western edge of Yeghegis in Vayots' Dzor, there is a small church building mostly unknown from historical sources. Located today in a private garden, the church is presently in a ruined condition – the maximum height of the internal walls is about 3.80 meters – and the external walls are almost completely underground. However, it is possible to understand its architectural structure [fig. 1]. It is a single-nave church with an apsed hall, with a w-e orientation. The inner space (6.40 × 3.40 meters) is divided into two bays that end with an elongated semi-circular apse on a *bema* with one step. The bays are separated by semi-pillars that must have supported the arches of the roof (maybe a barrel vault), now completely lost. According to the architectural structure, it seems to be very similar to the St Sion Church, about eight kilometers north-east, in the Arates monastic complex, even if the dimensions and the manufacturing of stones are different [fig. 2].<sup>1</sup>

The plan and the inner spatial partition seem to be comparable, albeit smaller in size and manufacturing of stones, to that of the church of St Sion in Arates, about eight kilometers to the north-east, dated to the ninth or tenth centuries.<sup>16</sup> These elements of parallelism and the dating provided by the inscription allow us to hypothesize the foundation of the church in the ninth century, when the Syuni princely family’s senior branch made Yeghegis in Vayots’ Dzor its central residence.<sup>17</sup>

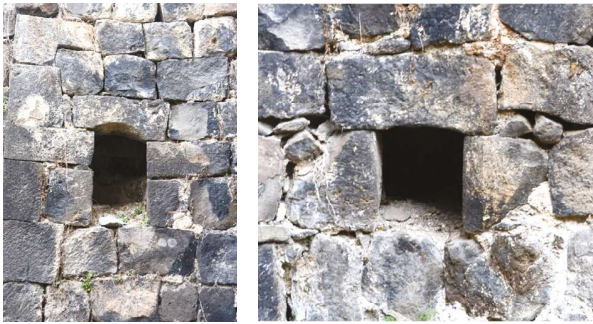
[fig. 4] On the left side, the single-light window on the northern side of the apse; on the right side, the small niche on the southern side of the apse

In the second “horizontal band,” near the corner, they built a single-light window (MSUs 19 and 20) [fig. 4], on the northern side of the apse, and a small niche with a lintel on the southern side (MSU 23) [fig. 4].<sup>6</sup>

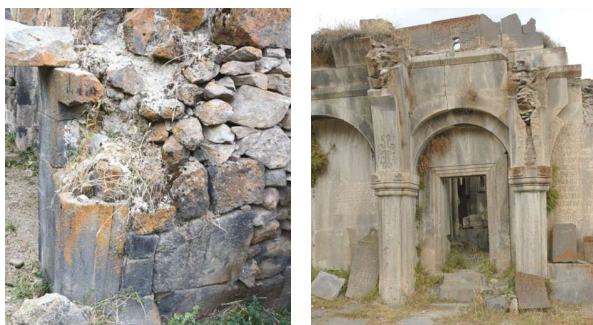
[fig. 6] On the left side a detail of the external profile of the western entrance; on the right side a detail of the main entrance to the church of St Astuatsatsin (church of the Mother of God) in Arates

The second construction phase involved mainly the creation of a new doorway on the western side (cuts MSUs 49 and 50 and door MSUs 45–47). The entrance is made of perfectly squared and smoothed basalt ash-lars.<sup>12</sup> According to the external profile of the jamb of the door, molded with an almost “torus” shape, it could be comparable with the decorations of the church of St Astuatsatsin (church of the Mother of God) in Arates, dated to the eleventh century, even if in the Old Church it is not so emphasized [fig. 6].<sup>13</sup> At our current state of knowledge, lacking other elements or historical documents, it is possible to affirm that the reconstruction of the access door could be attributed to the eleventh century, when Vayots’ Dzor was annexed to the Bagratid domains.

the church. Without any historical documents and considering that the door is almost in ruins, one may speculate only about its remaining decorations. Indeed, one of the jambs is molded with an almost “torus” shape, which seems to be similar to the decorations of the church of St Astuatsatsin (church of the Mother of God) in Arates, dated to the eleventh century, even if in the Old Church it is not so emphasized. At our current state of knowledge, it is possible to assess that the reconstruction of the façade of the Old Church in Yeghegis could be dated to the eleventh century. At the beginning of that century, Vayots’ Dzor was annexed to the Bagratid domains, and it is possible that under their rule, the construction of new religious buildings and the restoration of existing ones began, incorporating artistic decorations and design elements characteristic of the architectural school of Ani.<sup>18</sup>

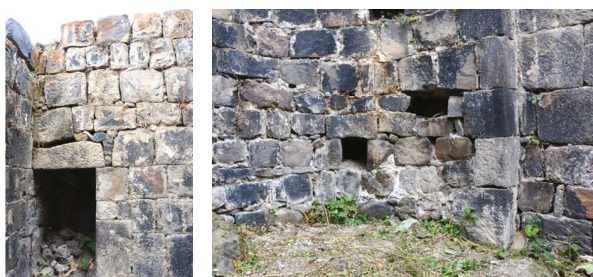
[fig. 7] On the left side, the new lintel replaced in the phase 2; on the right side, the small squared cut on the southern side

Even if there are no specific elements, lacking other data, we can include in this phase also other small restorations or such activities as the replacement of the lintel of the left chapel door (MSUs 4, 6, and 7) and a small squared cut on the southern side of the apse (MSU 31), maybe for the purpose of opening another niche [fig. 7].
