Seismic Vulnerability Assessment of a Building Aggregate in the Historical Centre of Florence

Keywords: Aggregate Buildings, Masonry, Internal Court, Vulnerability Index Method, FEM Analysis

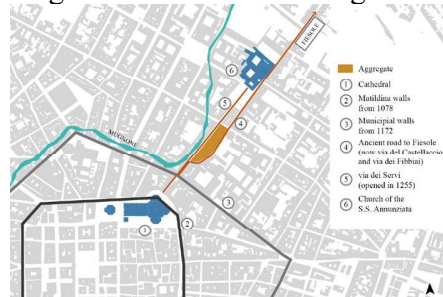
Figure 1. Urban plan with architectural emergencies and the identification of the aggregate.

The aggregate object of the study is located near the Cathedral of Florence (Fig. 1) and is constituted of 14 buildings, two palaces occupy the head positions and 12 *serial intercluded buildings* are placed in between. The buildings were 13 in origin before a merge intervention of two adjacent buildings was carried out.

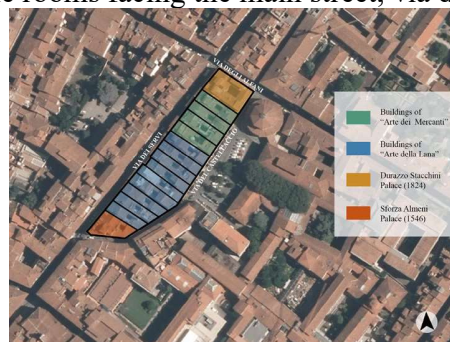
Figure 2. View of the roofs. Plan with the identification of different units: 9 belonging to *Arte della Lana* (blue) and 4 belonging to *Arte dei Mercanti* (green).

The parcelling is not uniform: excluding the corner palaces, the first 4 buildings, from the left of Figure 2, show a width of 10 m, the 7 further houses show a width of 8,70 m, and the last two southmost parcels show a width of 9,57 m since they show a shorter depth compared to other buildings [15].

Following the economic crisis that affected the textile industry, because of the deviation of the *Mugnone* river, the two *Arti* started a conversion of the area from production purposes to private housing, erecting 13 houses, 9 owned by the *Arte della Lana* and 4 owned of *Arte dei Mercanti* [16] (Fig. 2).
