Mechanisms of Block Instability at the Toe of a Slowly Deforming Rock Slope

Tommaso Carlà¹ · Giovanni Gigli¹ · Luca Lombardi¹ · Massimiliano Nocentini² · Teresa Gracchi¹ · Guglielmo Rossi² · Carlo Tacconi Stefanelli¹ · Federico Raspini¹ · Giandomenico Fubelli³ · Nicola Casagli¹

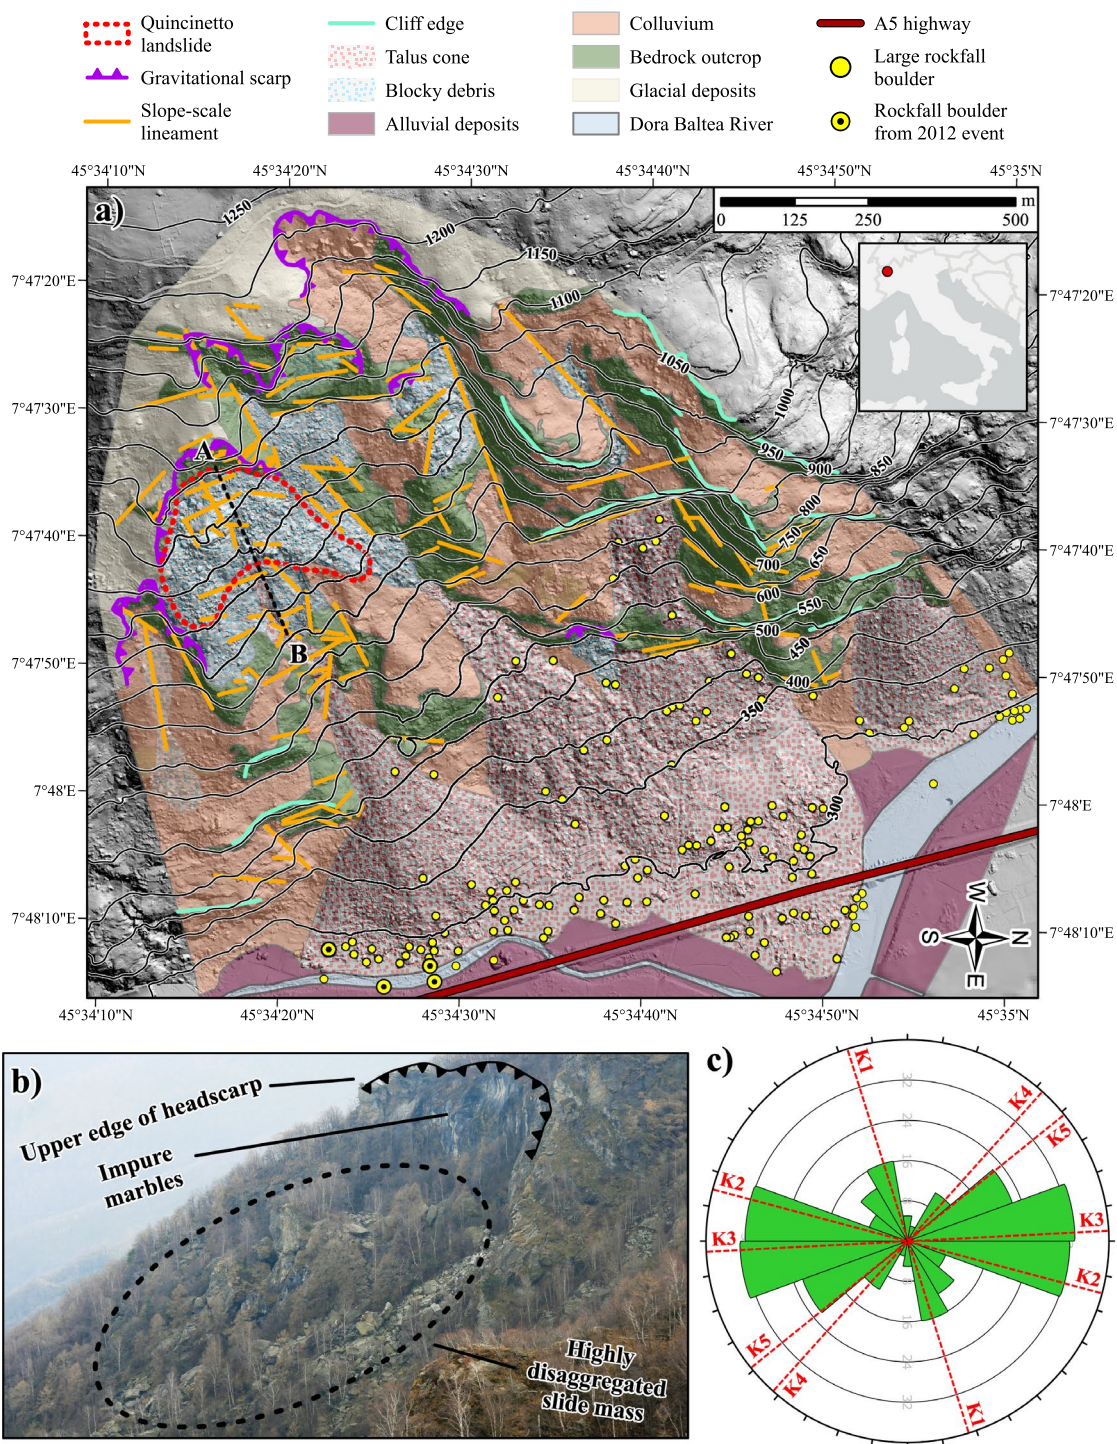
Fig. 1 **a** Geomorphological features on the E-facing flank of the lower Aosta Valley near the town of Quincinetto, showing the location of the A5 highway route and of the slide source area investigated in the present work (as delimited on the basis of satellite interferometric measurements, see Fig. 2). The background shaded relief derives from a 0.5 m aerial LiDAR survey performed in 2012 (courtesy of SAV). Line AB marks the topographic cross section extracted for finite-element modelling (see Fig. 6a). **b** Oblique photograph

of the Quincinetto landslide (taken from a panoramic viewpoint at ~1050 m of elevation further to the north, looking south), outlining the ~50 m high sub-vertical headscarp and the highly disaggregated slide mass below. **c** Rosette diagram of slope-scale lineaments. The red dashed lines denote the mean striking direction of the five main discontinuity sets (K1–K5) affecting the Eclogitic Micaschists Complex (see Fig. 3)

by additional rockfalls and reworked by the erosive action of the Dora Baltea River (Fig. 1a).

At present, angular blocks up to thousands of cubic meters in volume are chaotically distributed throughout the source area of the Quincinetto landslide (Fig. 1b), with block size having no recognizable spatial pattern. Much of the material is tightly interlocked and visibly detached from the bedrock (Fig. 2b); on the other hand, it is more challenging to evaluate the mechanical interaction with the bedrock of the larger blocks, since these are often encircled by finer debris. Periodic GNSS surveying of 5 rock-bolted threaded steel mounts (ARPA Piemonte, personal communication, April 2022) and satellite interferometric (SqueeSAR) measurements from the Cosmo-SkyMed constellation (TRE ALTAMIRA, personal communication, May 2022) show that the ground surface within the slide boundaries is moving at constant velocities of a few centimeters per year (Fig. 2a). However, information cannot be retrieved from the toe of the slide, where the May 2012 rockfall originated. This sector is delimited at the

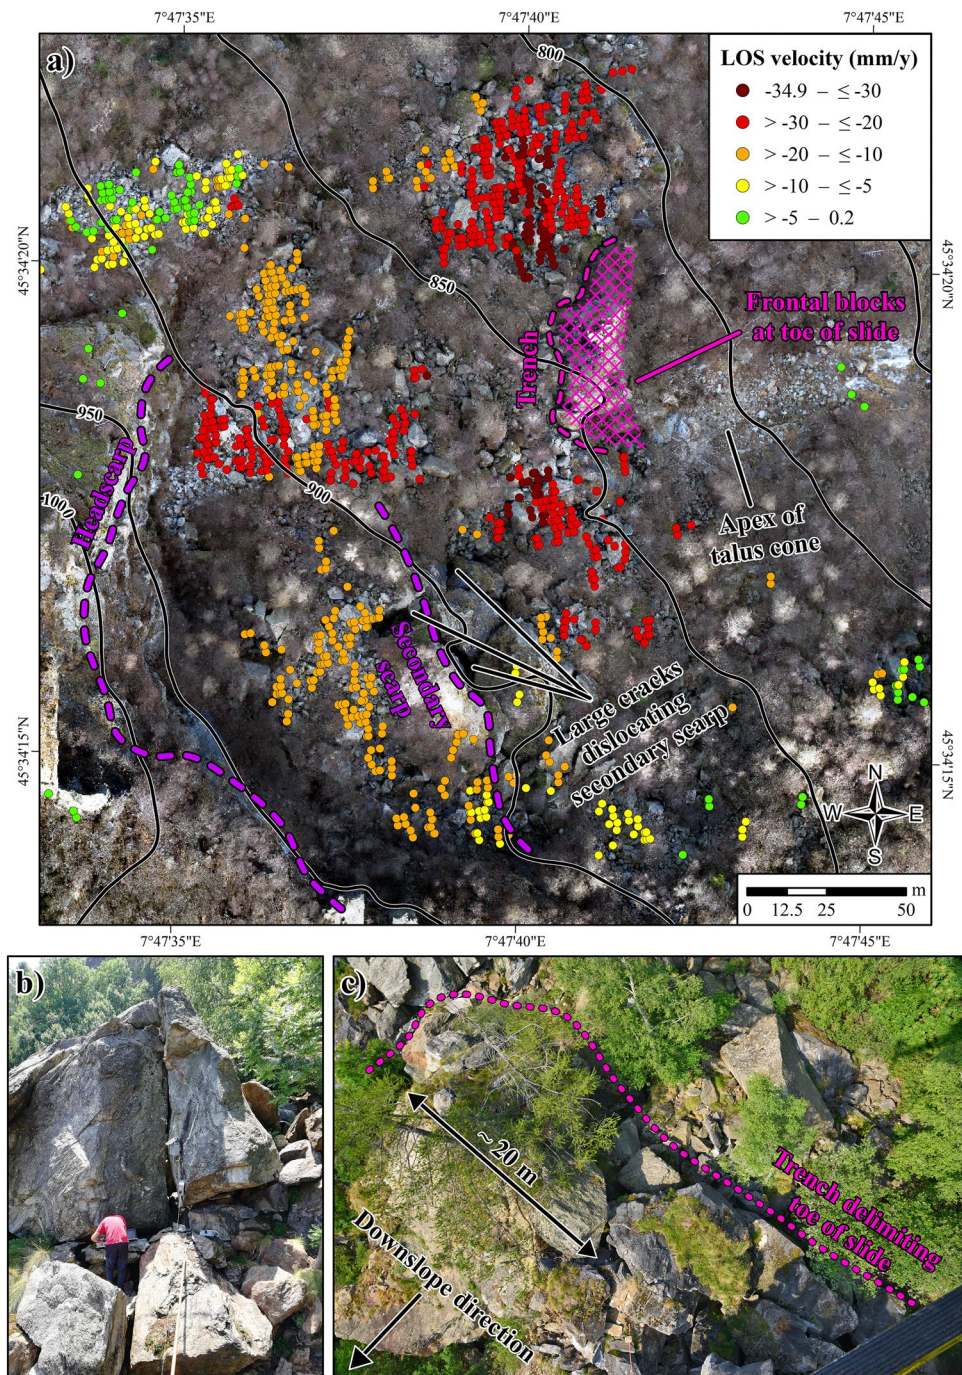
Fig. 2 **a** Aerial view of the slide source area. The background orthophoto is the product of a drone-based photogrammetric survey performed in March 2022 concurrently with the DLS survey described in the present work. Satellite interferometric (SqueeSAR) measurements acquired in ascending orbit by the Cosmo-SkyMed constellation (azimuth and incidence angle of satellite look direction: 79.75° and 30.01°) are courtesy of TRE ALTAMIRA. Negative values denote movement away from the satellite. **b** Typical blocky debris within the slide source area. **c** Vertical photograph (taken from helicopter) of the toe of the slide, outlining the trench behind the group of blocks with higher displacement activity

rear by an arcuate trench-like feature ~ 5 m deep and wide (Fig. 2a, c), which separates morphologically the group of blocks in closest proximity to the apex of the talus cone—the ones with the greatest potential of attaining kinematic release and travelling downslope far enough to reach the highway. The lack of interferometric measurements may be a consequence of too high ground surface velocities for the sensitivity of the technique (Wasowski and Bovenga 2014), while steel mounts for periodic GNSS surveying have not been installed locally for safety concerns.

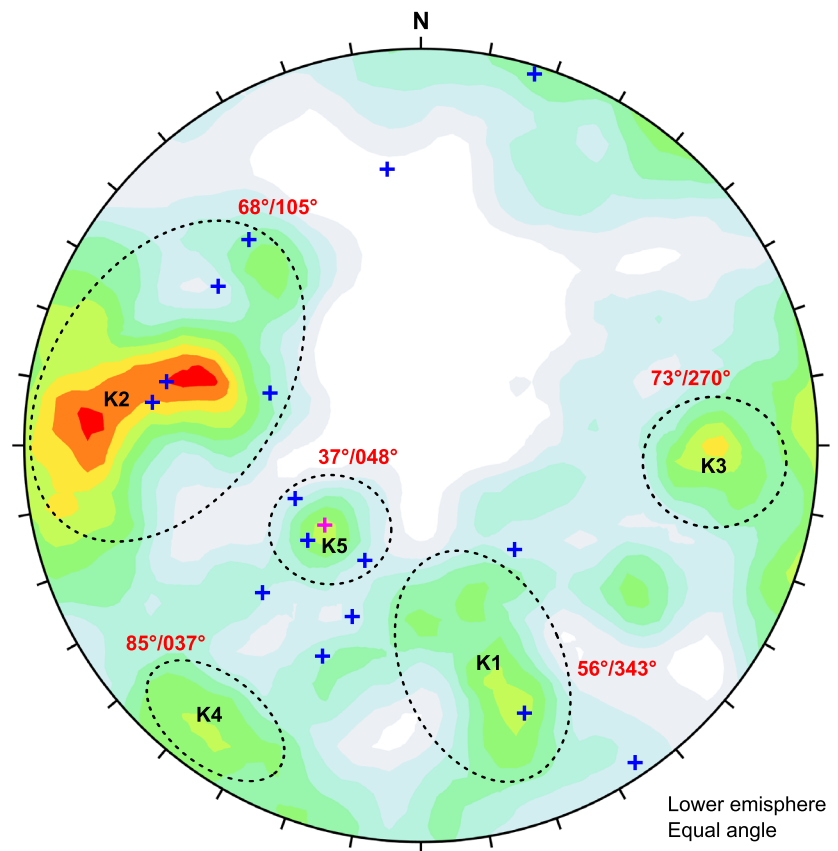
Fig. 3 Contour plot of poles to discontinuities from five scanline surveys at the toe of the slope. Red labels identify the average dip/dip direction of the resulting discontinuity sets. Blue crosses identify the orientation of discontinuities measured on block B2 by a geological compass or on point cloud data—some are rough estimates because of hazardous ground and poor point cloud density. The pink cross identifies the orientation of a remarkable sub-planar structure outcropping at the apex of the talus cone (colour figure online)

when (or after) the slope initially collapsed, notwithstanding the momentum gained under a condition of complete kinematic release. This is arguably improbable to have occurred owing to their dimensions and arrangement. A mechanical interaction with the bedrock can also be inferred by the stereographic projection in Fig. 3, where

blue crosses represent the orientation of 15 highly persistent discontinuities measured—sometimes roughly—on block B2 by a geological compass or on point cloud data (described later in this chapter). Most measurements can be associated with the more frequent sub-vertical set K2 and the schistosity-related set K5.

Justification for scenario 1 comes from a remarkably sub-planar structure dipping at $\sim 35^\circ$ (dip direction $\sim 50^\circ$, see pink cross in Fig. 3) on the very apex of the talus cone, ~ 25 m to the southeast of block B2 (Fig. 5a). Visual inspection, performed by use of rock climbing equipment, did not reveal obvious heterogeneities in weathering or roughness along the surface, suggesting that this was not involved as basal release of the recent May 2012 rockfall—as trees were damaged by the event only on lower slopes, the source block must in any case have been located somewhere in the immediate vicinity. Scenario 1, therefore, reproduces the existence of such a structure at the base of blocks B1/B2; scenario 2 models the opposite condition, namely, that B1/B2 are actually spurs of bedrock that remained in place after collapse of the slope; and scenario 3 considers deformation to be mechanically controlled by randomly oriented brittle fracture damage, having the pre-existing rock mass structure (as determined by the discontinuity sets and possible basal surface) effectively been suppressed.

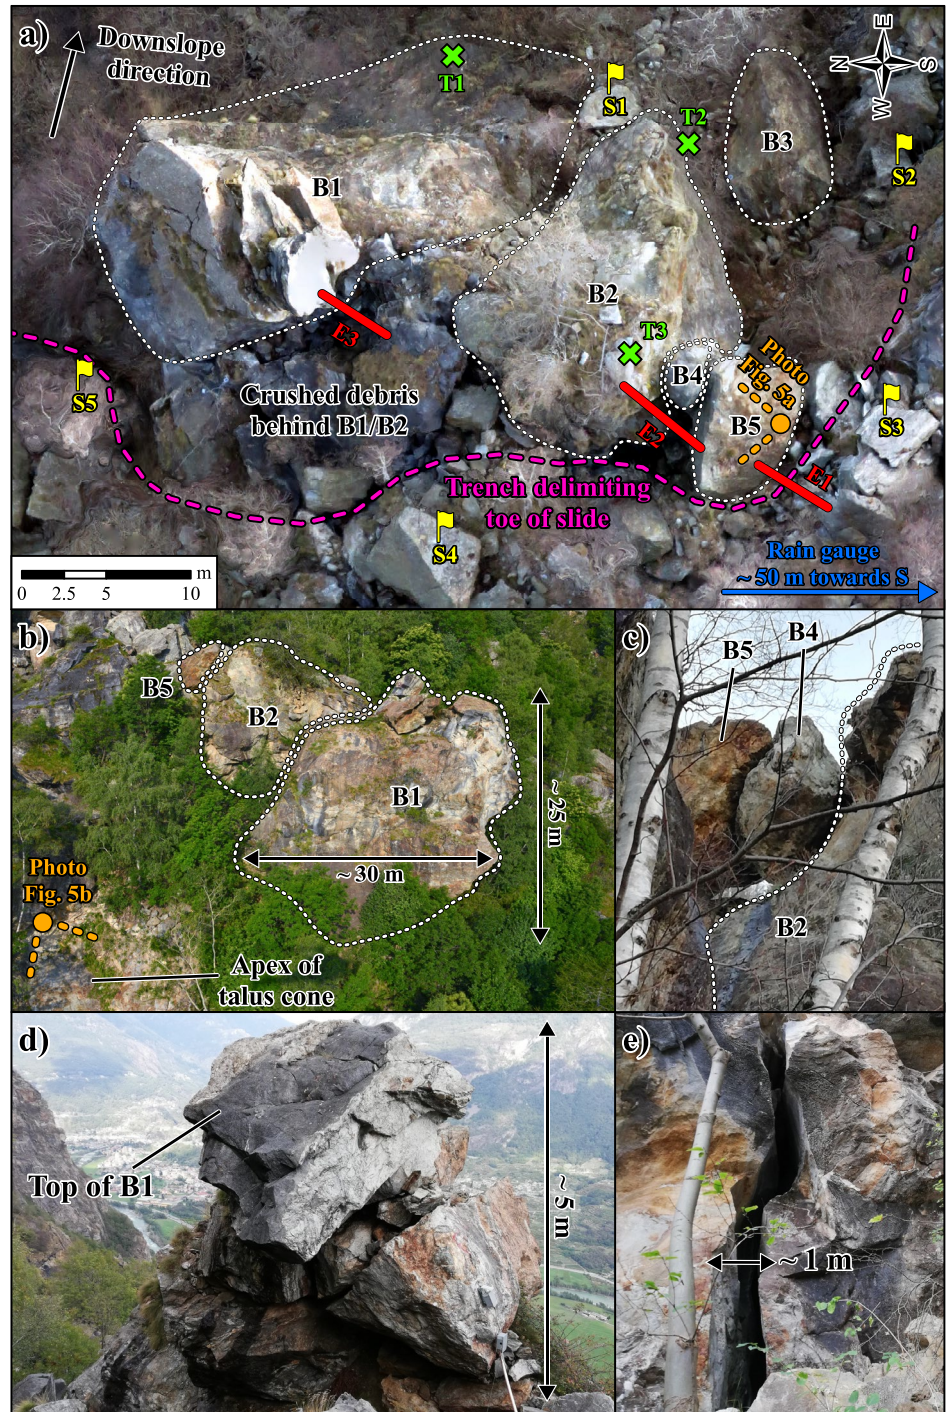
Fig. 4 **a** Detailed aerial view of the frontal rock blocks. Note that sub-verticality of some block faces (especially at B1) causes perspective distortion in the orthophoto. **b** Oblique photograph (taken from helicopter, looking upslope) of blocks B1, B2, and B5. **c** Close-up photograph (taken from S2, looking upslope) of blocks B4 and B5. **d** Rock mass disintegration at the top of B1. **e** Sub-vertical tensile fracture to the rear of block B1

Figure 4a–e provides photographic documentation of these frontal rock blocks (labelled B1–B5). Blocks B1 and B2 are the largest in the area, with approximate maximum length, width, and height of $20 \times 30 \times 25$ m and $20 \times 20 \times 22$ m, respectively (Fig. 4b). Their volume is estimated in the range $2\text{--}5 \times 10^3$ m³ based on laser scanner data (see ‘Methods of investigation’), depending on to what depth their base is projected. They lie, together with B3 (~ 300 to 400 m³), in the most advanced position behind the apex of the talus cone. B4 (~ 15 m³) and B5 (~ 200 m³) are in

contrast visibly detached from the bedrock: they lie across the trench that delimits the toe of the slide, with B5 leaning against B4 and B4 leaning against B2 (Fig. 4c). The bottom of the trench, as well as the ground between B1 and B2, is filled with variably sized blocky debris of unknown thickness.

Figure 4a identifies the location of the extensometers, tiltmeters, and rain gauge, all equipped with an automatic data logger to acquire measurements at a frequency of 20 min. The two ends of extensometer E1 were anchored on the S-facing lateral side of block B5 and the N-facing lateral side of another block on the opposite side of the trench. This choice was made based on the notion that the well-developed extent of the trench and the lack of coherent SqueeSAR targets at the toe of the slide (Fig. 2a) are indeed determined by ongoing accelerated movements with respect to the rest of the slide source area. Extensometer E2 connects the N-facing lateral side of B5 with the S-facing lateral side of B2 (Fig. 5c), whereas extensometer E3 connects the S-facing lateral side of B1 with one of the blocks in the accumulation of crushed debris at the bottom of the trench. Steep hazardous ground prevented us from connecting B1 or B2 to anchoring points outside the trench. As for the other instruments, tiltmeter T1 was installed at the base of the downhill-facing side of B1; tiltmeter T2 at the base of the downhill-facing side of B2; tiltmeter T3 at the top of the S-facing lateral side of B2, next to the anchoring point of E2; and the rain gauge on the top side of a flat block behind the trench.

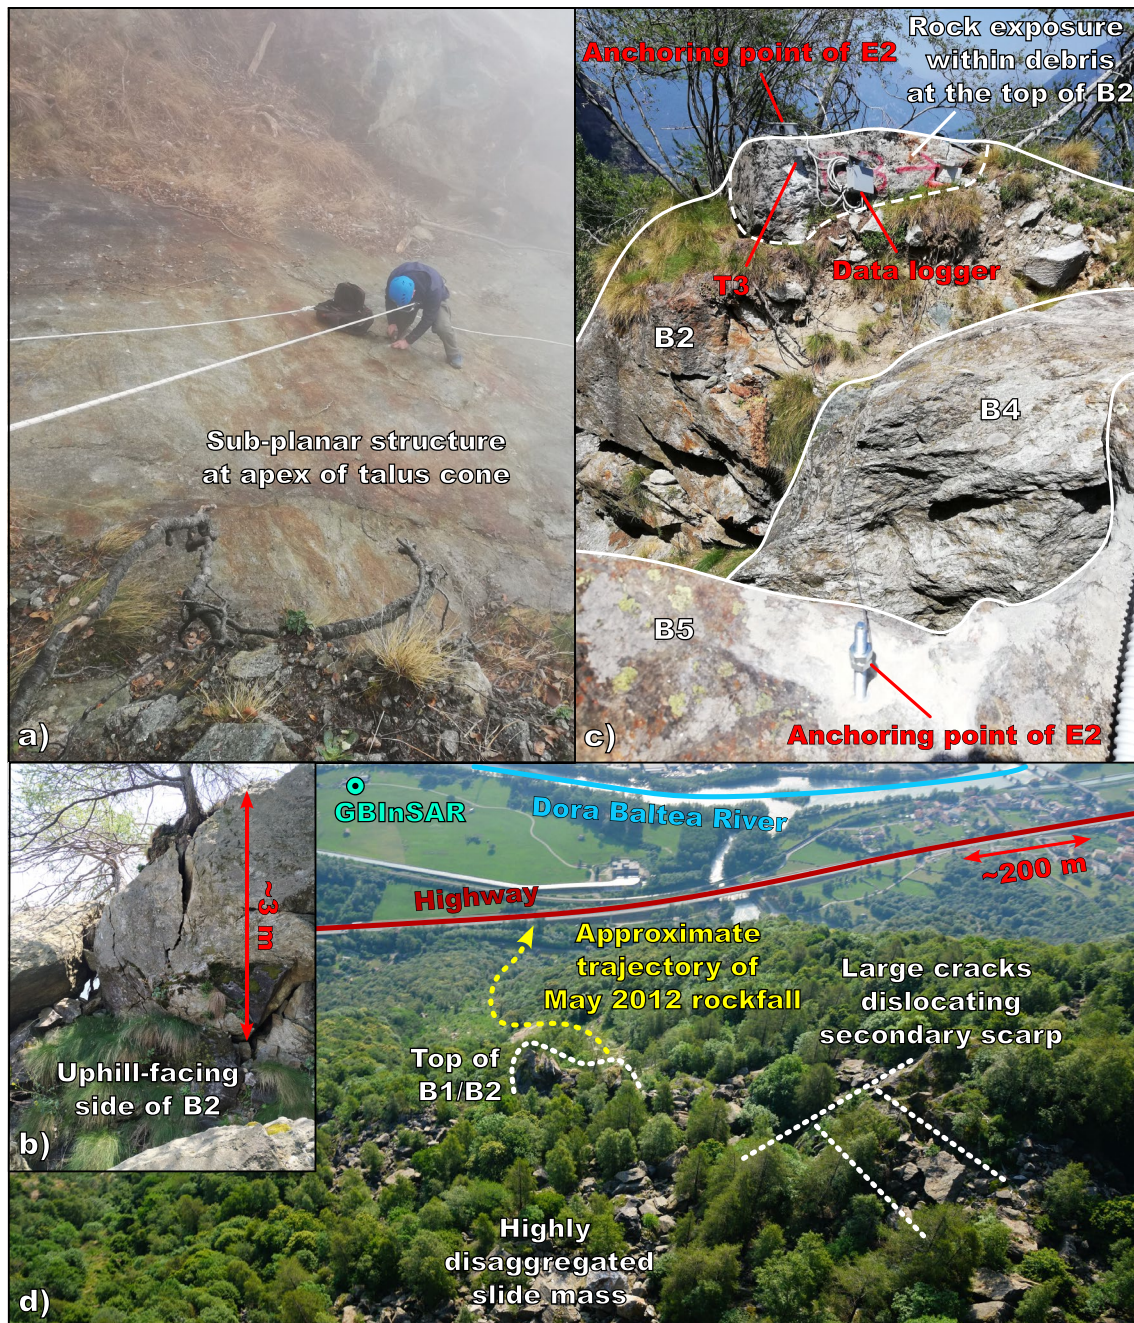
Fig. 5 **a** Sub-planar structure outcropping at the apex of the talus cone. **b** Evidences of brittle fracture damage on the uphill-facing side of block B2 **c** Close-up photograph of the upper S-facing lateral side of block B2 (taken from block B5, looking north), showing the anchoring points of tiltmeter T3 and extensometer E2 (downslope

direction is to the right of the photograph). **d** Oblique photograph (taken from helicopter, looking downslope) of the lower slide source area and talus cone, highlighting the relative location of the GBInSAR installation site and of the highway at risk for rockfalls

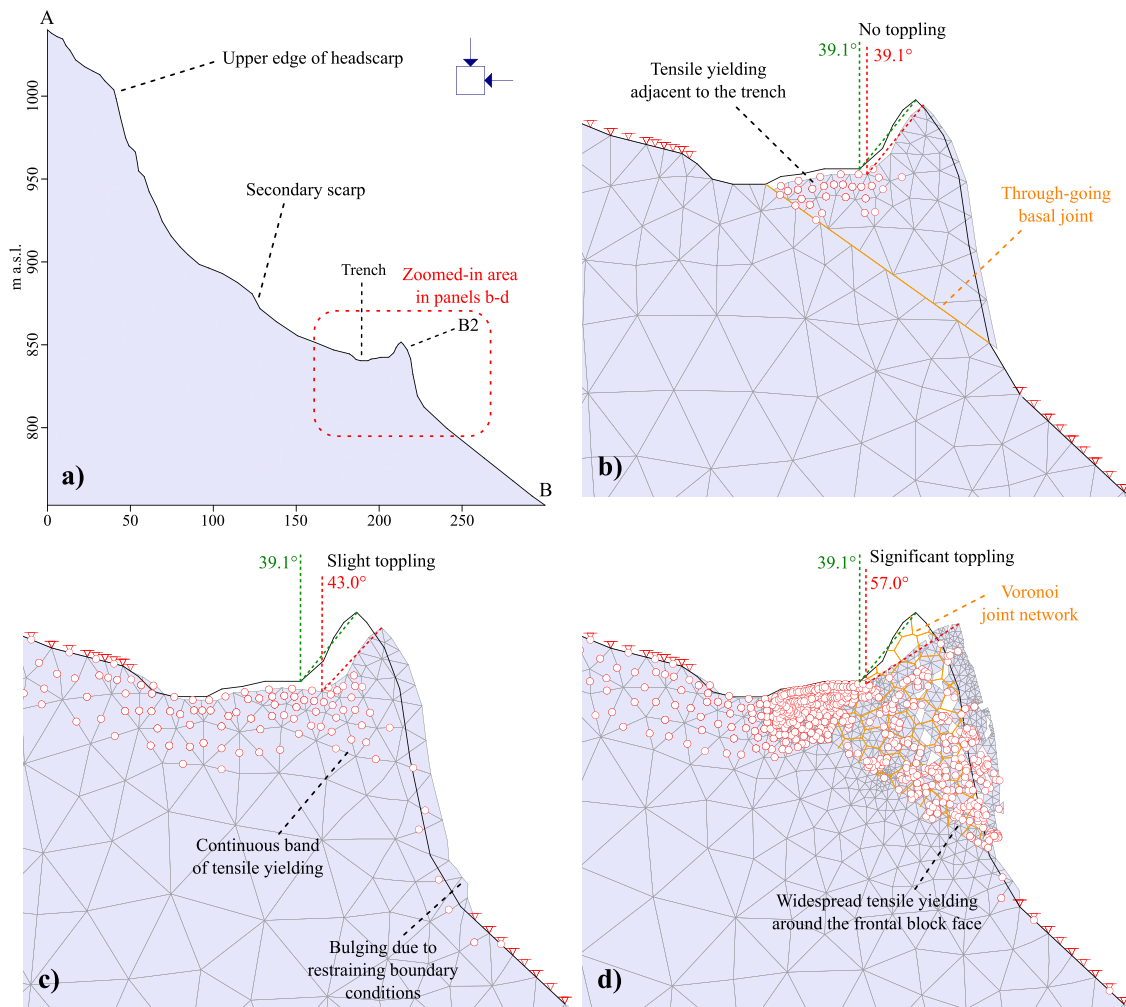
Fig. 6 Preliminary finite-element analysis of potential modes of failure of the frontal rock blocks: **a** selected topographic cross section passing through B2 (see line AB in Fig. 1a). **b, d** Outcomes of modelling scenarios 1 (through-going basal joint), 2 (spur of bedrock), and

3 (pervasive damage within the block), respectively. Triangular “pin” symbols indicate restrained boundary nodes in the x - y directions; note that these continue further to the left and right of the zoomed-in view, including the lateral and basal boundaries of the model

Examining the model simulations, scenario 1 shows the expected outcome (Fig. 6b). Slip is initiated along the through-going basal joint (drawn with an inclination of 35° by analogy with the dip of the sub-planar structure at the apex of the talus cone) when its shear strength is sufficiently reduced, and B2 is consequently displaced without rotation or internal deformation. Yielding in tension is observed near the back of the block at shallow depth, and especially concentrates in mesh elements adjacent to the area of the trench.

In scenario 2, no explicit joint elements are built into the model domain and B2 is regarded as an outcropping spur of undisturbed bedrock. Mesh deformation points to a slight forward rotation (toppling) of the rock spur leading to its failure (Fig. 6c). Mesh elements yielded in tension are more numerous than in scenario 1, forming an almost continuous zone that stretches from the rear to the frontal face of the rock spur. Bulging at the toe is interpreted as an artefact of the restraining boundary conditions imposed downslope.

To simulate the pervasive internal damage of block B2 in scenario 3, that is to reproduce a condition, wherein randomly oriented brittle rock fracture (Figs. 4d, 5b) has mechanically suppressed any strength anisotropy related to the pre-existing rock mass structure, a joint network composed of a medium-regular Voronoi tessellation (maximum joint length 1.5 m) was incorporated into the model. This tessellation scheme randomly subdivides the domain area of interest into non-overlapping convex polygons, whose bounding segments are regarded as joints. When the model is brought to failure, the block structure collapses by showing more pronounced forward rotation than in scenario 2

(Fig. 6d). Yielding in tension is widespread, as the main rock volume breaks into smaller pieces that are progressively released from the frontal block face.

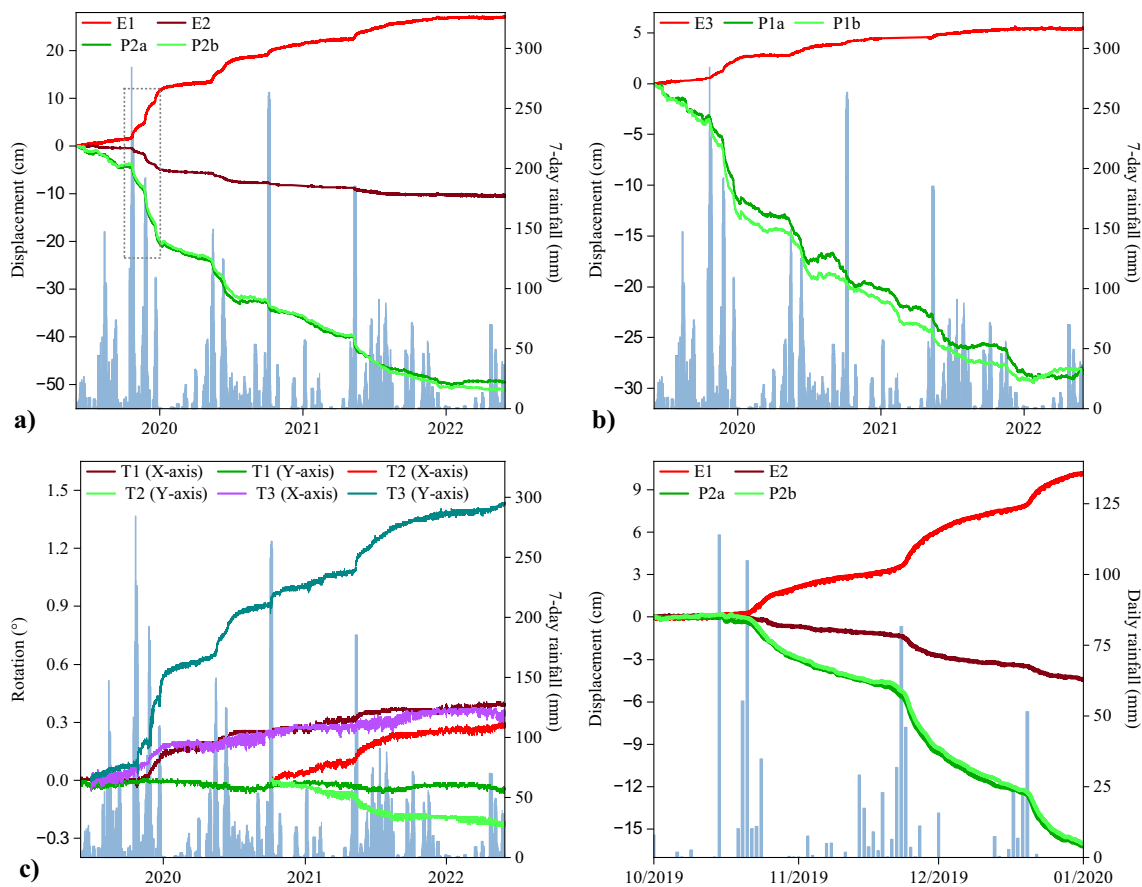
Fig. 7 **a, b** Cumulative time series measurements acquired by the extensometers and GBInSAR. The dashed black rectangle in (a) delimits the period detailed in (d). **c** Cumulative time series measurements acquired by the tiltmeters. **d** Displacements measured by

extensometers E1–E2 and radar pixels P2a–P2b between October–December 2019. In (a–c), rainfall measurements are cumulated on a weekly basis for better visualization

Figure 7a–d details the cumulative time series measurements acquired by the instrumentation network. The displacement curves of the extensometers all show a distinct sequence of acceleration and deceleration phases. The largest cumulative displacement in absolute value (~ 30 cm) is as expected recorded by E1, this being the only extensometer that could be installed across the full width of the trench. E3 records approximately one fifth of the displacements of E1, but this could partly be ascribed to the anchoring block at the bottom of the trench being to some extent destabilized by movement

of B1. E2 records negative displacements (i.e., shortening of the cable), implying either release of block B4 from an interlocked position between blocks B2 and B5, relative rotation of block B2 and/or block B5 around the vertical (yaw) axis, or a combination thereof. The trend of measurements from E1 also agrees closely with that of radar pixels P2a–P2b. This substantiates field observations that blocks B4/B5 are detached from the bedrock and lean against block B2, which, therefore, directly controls their stability. Extensometer measurements at E1 can in this sense be considered as a proxy for the displacements of B2. Repeated agreement between extensometer and radar measurements occurs at B1, where pixels P1a–P1b have the same displacement trend as E3—and again report comparatively larger cumulative values, although these are confirmed to be lower than at B2 (see cumulative displacement map in Fig. 8). Tiltmeter

measurements at T1 and T2, installed at the base of B1 and B2, do not show a sequence of acceleration and deceleration phases, such as the extensometers and radar points, or a definite rotation around one of the axes (measurements at T2 started in October 2020 due to technical malfunctions). The opposite is observed at T3, installed near the top of B2, where alternating accelerations and decelerations are detected around the Y-axis (cumulative value 1.5°), with positive values denoting rotation towards the south.

Extensometer and GBInSAR measurements show higher activity at block B2 (Fig. 7a), with acceleration phases being triggered by rainfall and influenced by background velocity

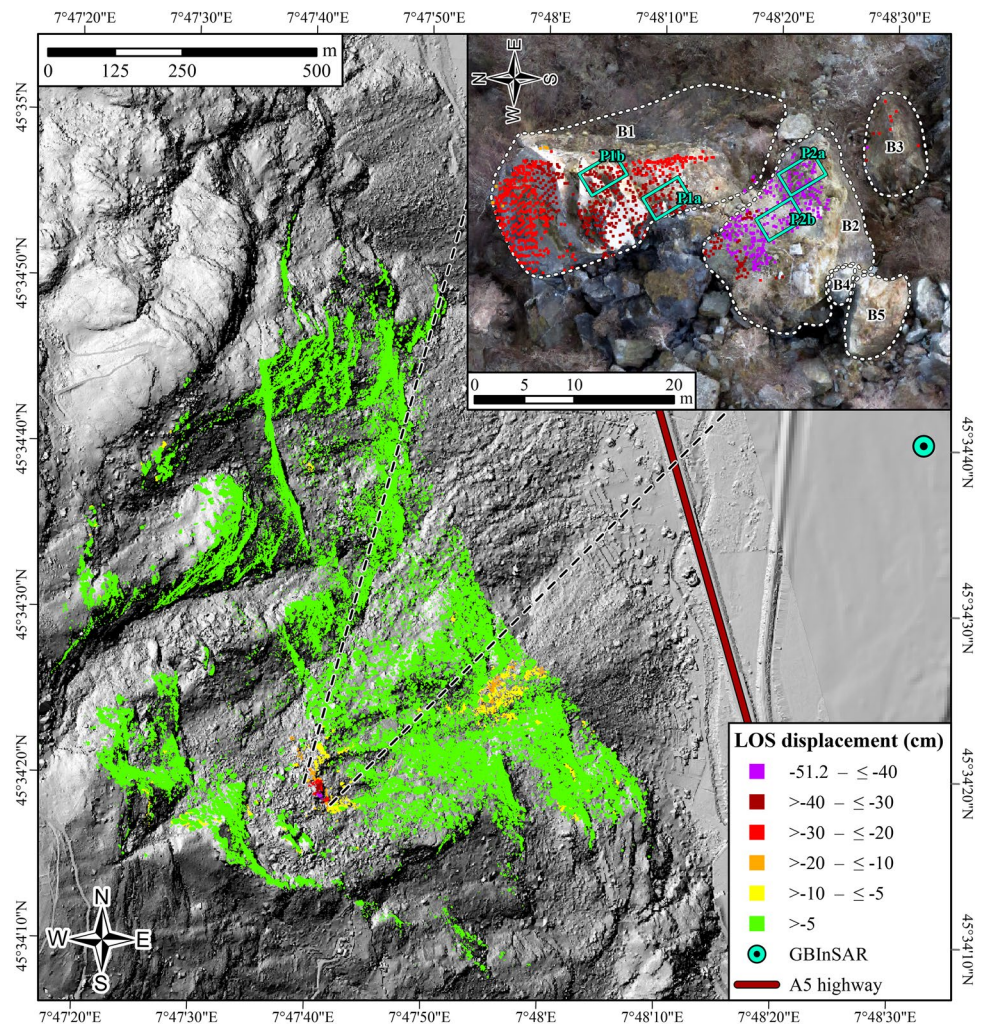
Fig. 8 Cumulative displacement map acquired by the GBInSAR between June 2019 and May 2022. Negative values denote movement towards the radar. In the inset, note that the amount of displayed measuring points is greater than the actual amount of radar pixels identified over blocks B1 and B2 (the light-colored rectangles illustrate the approximate coverage of the four radar pixels selected for analysis). This mismatch derives from resampling and projection of data on the TLS-based point cloud acquired from the installation site

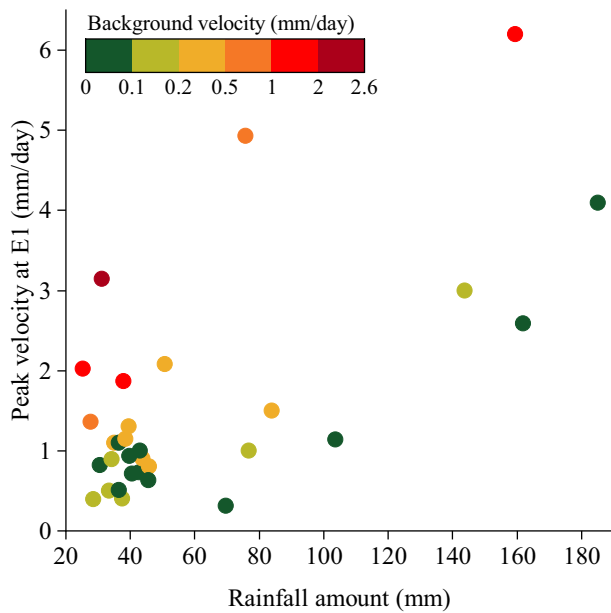
Fig. 9 Plot of total rainfall amount in a “rainfall event” versus the ensuing peak of velocity recorded at E1. Values of instantaneous velocity are calculated through differentiation of the cumulative displacement measurements in Fig. 7a on a 24-h basis (i.e., by subtracting each cumulative displacement measurement from the measurement acquired 24 h prior)

data point was left out of the regression, since it visibly deviates from the dominant trend, as discussed later). Equivalent results are obtained from extensometer E3 (Fig. 10b), although the plot is populated by fewer data points due to the lack of a measurable response of block B1 to rainfall events of lower magnitude.

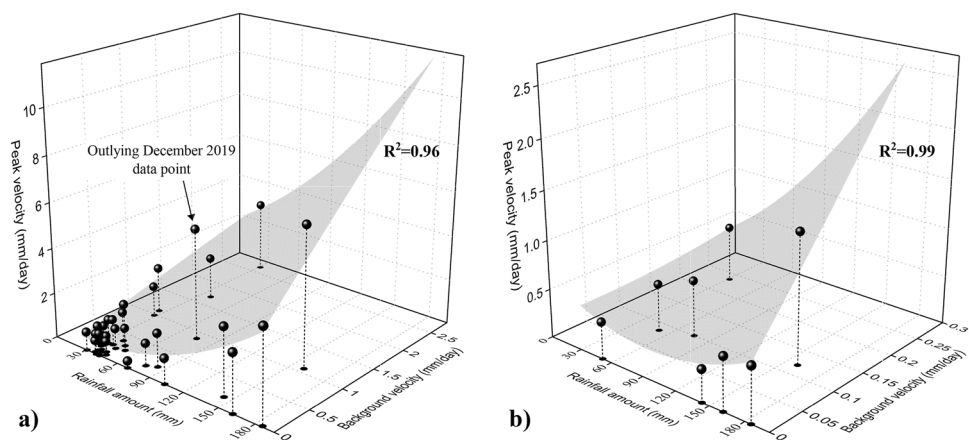
Fig. 10 3D scatter plot of rainfall amount, background velocity, and peak velocity characterizing rainfall events in the data set: **a** data from E1 (block B2); **b** data from E3 (block B1)

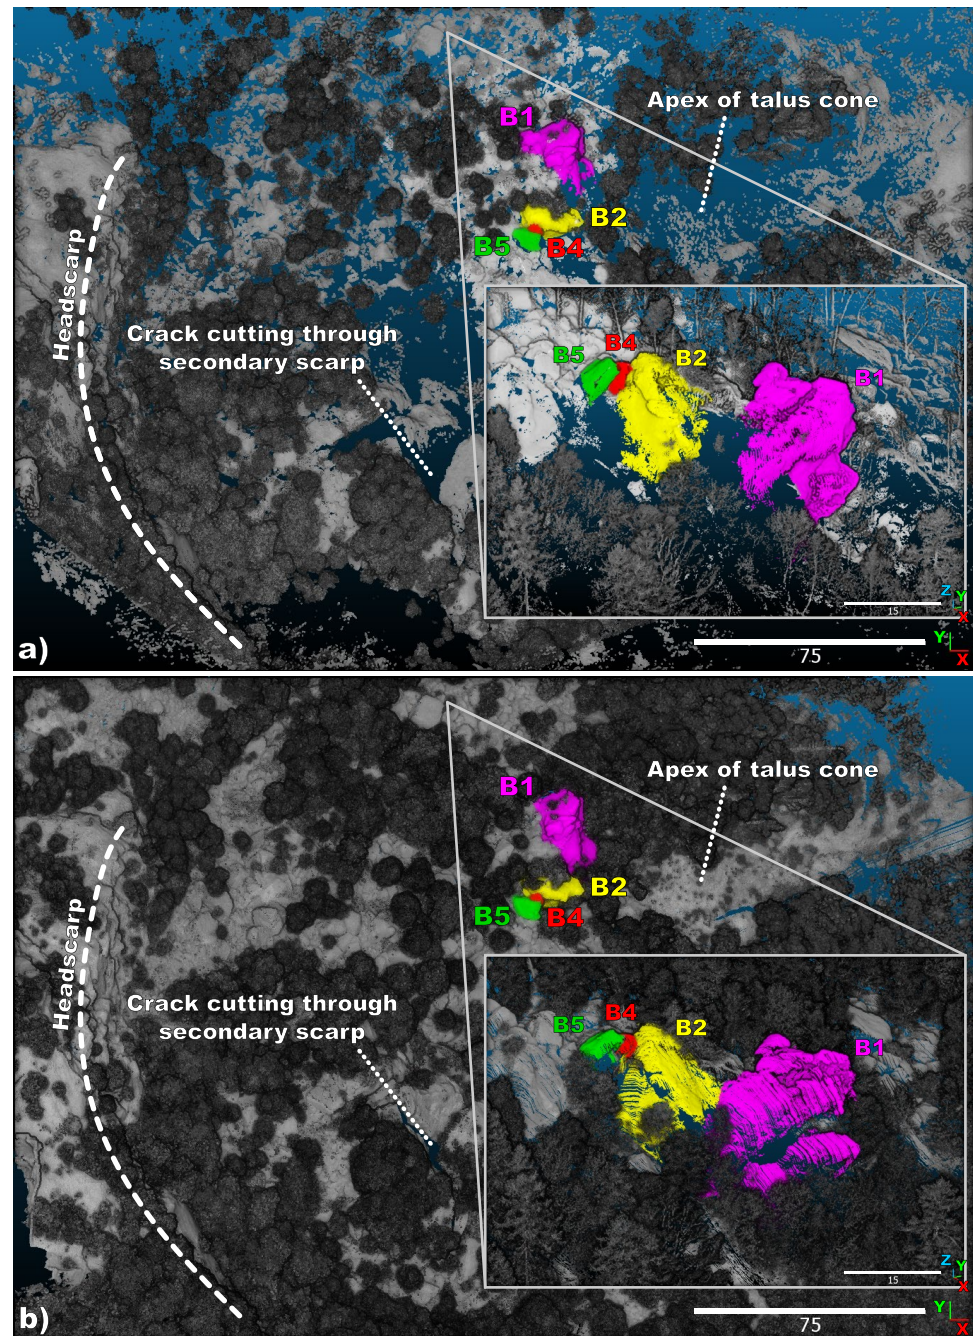
Fig. 11 Overview of the **a** merged TLS-based point cloud and **b** DLS-based point cloud, prior to removal of vegetation and co-registration. In both panels, blocks B1, B2, B4, and B5 are depicted with distinct colors (B3 is hidden by vegetation at the base of B2), whereas gray tones in the rest of the point cloud depend on laser return intensity

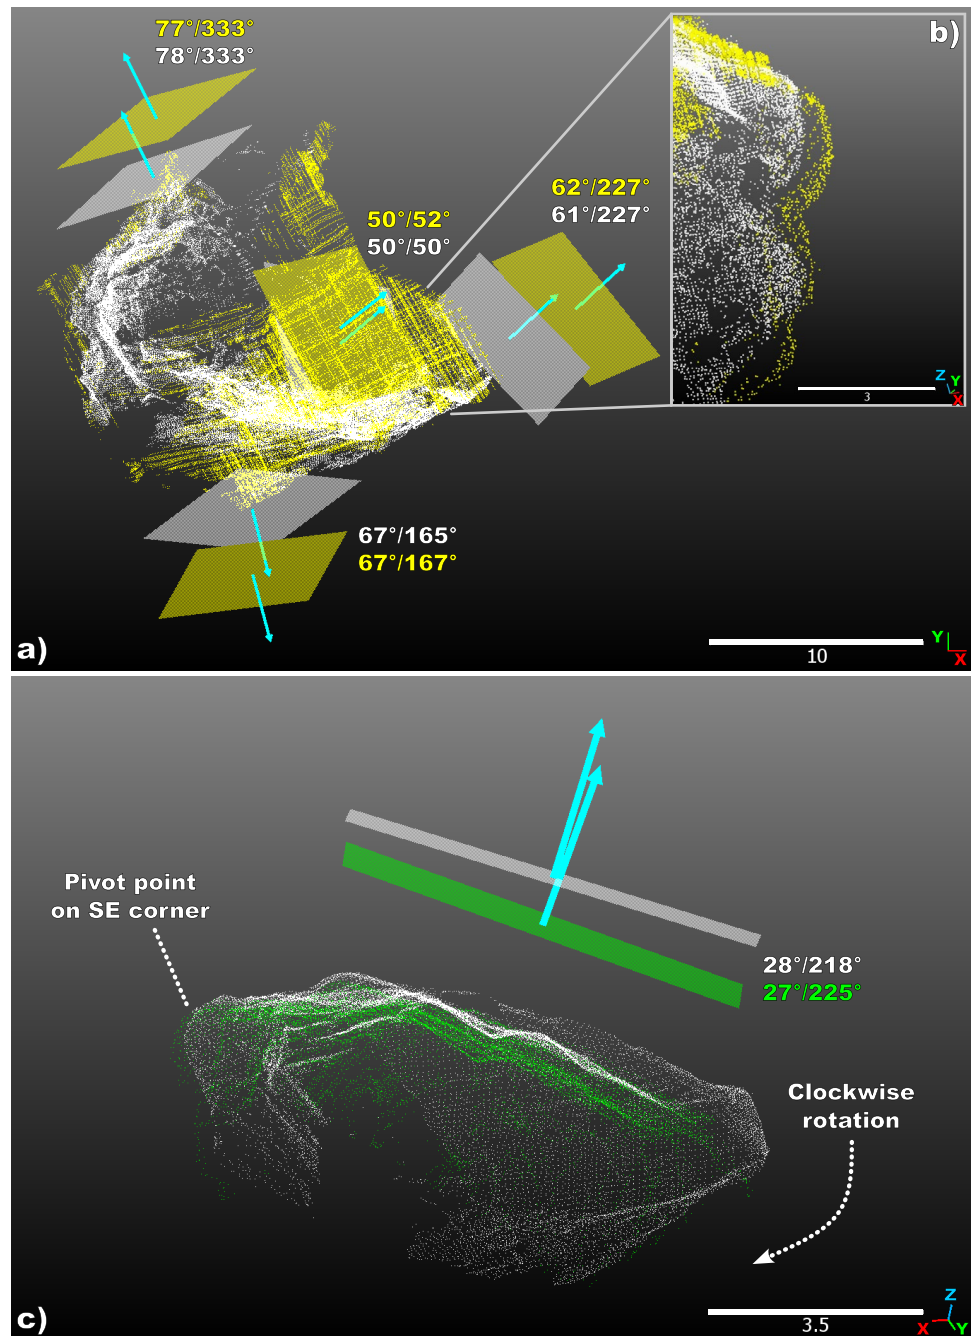
Fig. 12 **a** Pairs of best-fitting planes derived from homologous clusters of points on the lateral and top sides of block B2. White points/planes/labels refer to the TLS-based survey (September 2019), yellow ones to the DLS-based survey (March 2022). **b** Detail of the downhill-facing lateral side of block B2, highlighting a relative shift of ~ 60 cm between the two point clouds. **c** Pair of best-fitting planes derived from a homologous cluster of points on the top side of block B5. White points/planes/labels refer to the TLS-based survey (September 2019), green ones to the DLS-based survey (March 2022). In **(a)** and **(c)**, normal vectors to fitted planes have been flipped for better visualization in the case of overhanging rock surfaces (colour figure online)

Figure 12a summarizes the results of the analysis for block B2. Homologous pairs of best-fitting planes were derived from its uphill-, downhill-, S-facing lateral sides, and top side, with a relative shift between entities in the order of 60 cm (Fig. 12b). This value—an underestimation of the actual absolute displacement, since the point clouds were co-registered by assuming complete stability behind the trench—is consistent with GBInSAR measurements (Fig. 8), which are downscaled to the LOS. We find no evidence of toppling: the S-facing and top sides preserve their original dip; a calculated increase of 1° on the downhill- and uphill-facing sides may not be considered relevant either. In general, we noted that user selectivity in the manipulation

We rule out the presence of pervasive brittle fracture damage within B1 and B2 (scenario 3). Consistency in the dip of moving block faces (Fig. 12a, b), coupled with the abundance of rockfall boulders having volume in the order of 10^2 – 10^3 m³ at the distal edge of the talus cone (Fig. 1a), validate the visual perception that brittle rock fracture affects proportionally small parts of the rock volumes, with limited effect on failure kinematics and potential rockfall magnitude. Scenario 3 may nevertheless represent the last evolutionary step before rapid detachment and fall, as stresses within the blocks are amplified by continued sliding towards steeper slopes. Reconstructing the past evolutionary steps of the blocks, in terms of the complex sequence of gravitational and glacial processes that led to their emplacement at the toe of the slide, is beyond the scope of the present work.

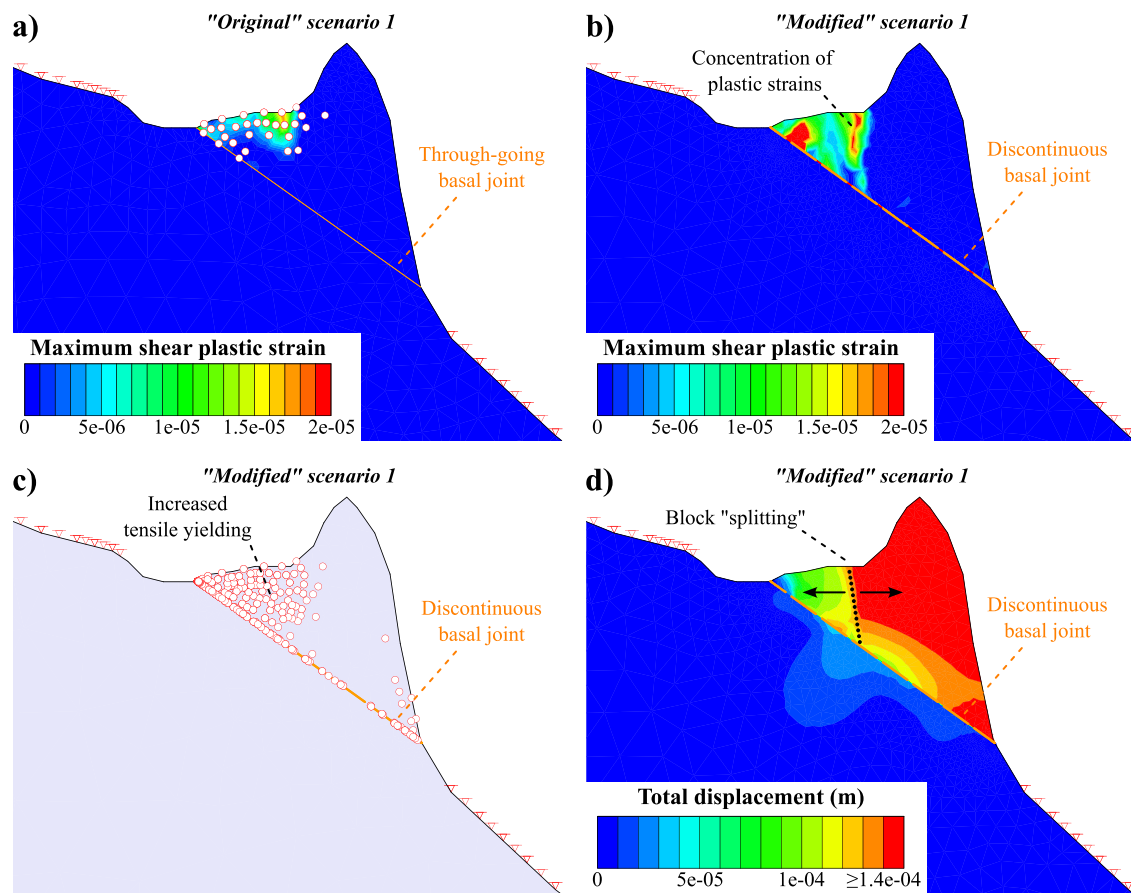
Fig. 13 Interpretation of the underlying internal structure of block B1. **a** Maximum shear plastic strains and tensile yielding induced by movement along a through-going basal joint (original scenario 1). **b**, **c** Respectively, concentration of maximum shear plastic strains and increased tensile yielding induced at the back of the block by movement along a slightly discontinuous basal joint (modified scenario

1) having the same in-plane trace of the through-going basal joint in (a). The two informative layers are reported in separate panels for better visualization. **d** Distribution of calculated total displacements. The black arrows are purely illustrative of the differential movement "splitting" the block; they are not scaled to movement direction or magnitude

factor of 0.8 and a unit length of sub-joints of 4 m. This leads to increased plastic strain and tensile yielding at the back of the block (see Fig. 13a for the “original” scenario 1 and Fig. 13b, c for the “modified” scenario 1), which is thus “split” in a sub-vertical manner by the induced differential movement. Two areas with distinct total displacements are in fact formed inside the block (Fig. 13d) consistently with the location of the aforementioned fracture intersecting B1, suggesting that its formation has been primarily conditioned by block kinematics. We observe that: (i) differential movement gradually reduces beginning from a tensile strength about three times higher (i.e., ~ 0.3 MPa) than what assumed here, which, however, may be less appropriate for the investigated rock mass; (ii) the spatial distribution of calculated strains and displacements is more significant than absolute values, as these are influenced by the convergence criteria of the shear strength reduction analysis, the model/mesh geometry, and the approximations to the connectivity of elements that must be satisfied in the solution procedure of the adopted code.
