Artefacts in contrast enhanced digital mammography: how can they affect diagnostic image quality and confuse clinical diagnosis?

Contrast-enhanced digital mammography (CEDM) is a diagnostic tool for breast cancer detection. Artefacts are observed in about 10% of CEDM examinations. Understanding CEDM artefacts is important to prevent diagnostic misinterpretation. In this article, we have described the artefacts that we have commonly encountered in clinical practice; we hope to ease the recognition and help troubleshoot solutions to prevent or minimise them.

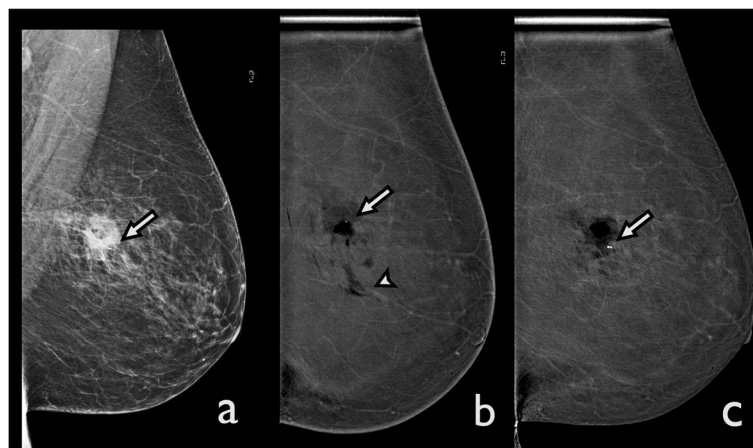
Fig. 1 Motion artefact. A ductal carcinoma in situ was diagnosed in the left breast after an ultrasound-guided core needle biopsy. CEDM was performed for preoperative staging. **a** The LE image shows a post-biopsy hematoma with a marker (arrow). **b** The recombined CEDM image demonstrates that the margins of the hematoma are blurred secondary to motion artefacts. Some black bands are visible (arrowhead), and the post-biopsy marker appears to be in a different position from the previous image (arrow). **c** A new recombined CEDM image was performed. Here, the motion artefacts are no longer visible, and the marker appears to be in the right position (arrow)

The current CEDM process, which involves a dual energy acquisition, was developed to overcome this limitation. It is characterised by two images acquired in rapid succession by applying X-rays of distinct energy, both after the administration of contrast media. Motion artefacts have been significantly minimised due to the brief interval of time between the two exposures. However, CEDM images are still more prone to motion artefacts compared to traditional mammography because dual-energy acquisition requires longer exposure and compression times. In the recombined images, motion artefacts appear as blurring of the margins of lesions (Fig. 1). Adequate compression can reduce motion artefacts both in FFDM and CEDM [8].

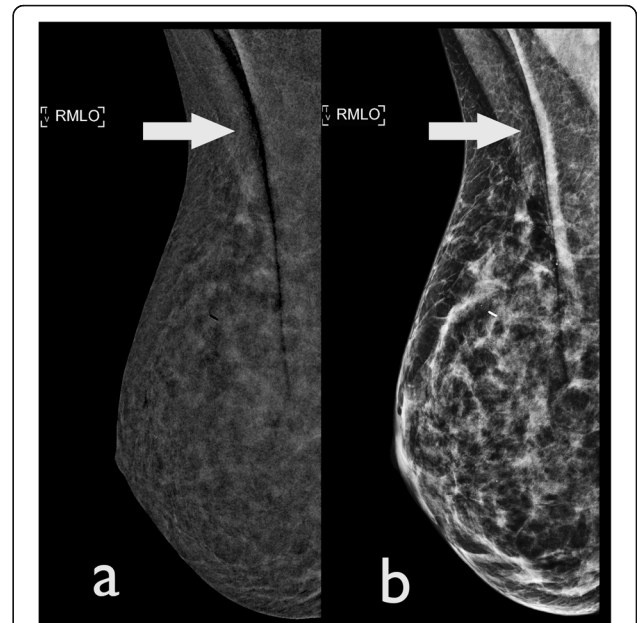
Fig. 4 Air trapping artefacts: A CEDM performed for problem solving in a 52-year-old woman, using a **(a)** CEDM-recombined image and **(b)** LE image. Both images demonstrate the presence of a vertical, black band (arrows) secondary to trapped air

Air trapping is a common artefact caused by partial contact between the skin and the detector or compression paddle [1]. This leads to the presence of air, which creates a dark artefact in the configuration of the area of incomplete contact, possibly hiding underlying abnormalities (Fig. 4).

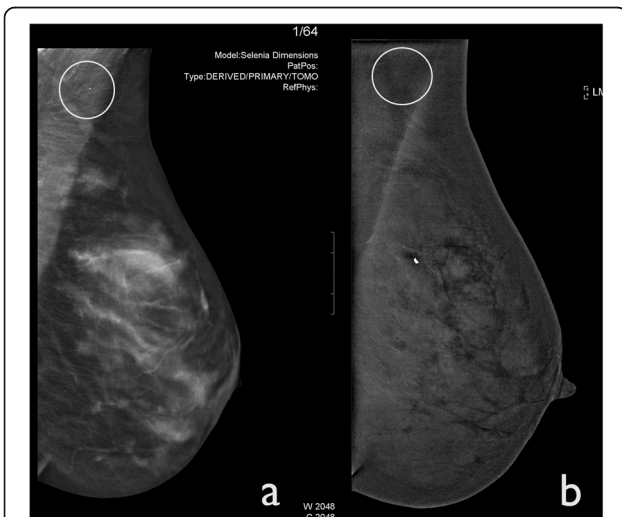
Fig. 3 Antiperspirant artefact. CEDM was performed for staging an IDC in the right breast of a 59-year-old woman. **a** Left MLO tomosynthesis shows a little white spot in the axillary region caused by the presence of the antiperspirant substance (circle). **b** The CEDM-recombined image demonstrates that antiperspirant is barely perceptible as a small, black dot (circle)

The active ingredients of antiperspirants are complex-aluminium-based; these substances produce radiopaque particles that can mimic microcalcifications in LE images. Usually, antiperspirant particles appear black on

CEDM recombined images (Fig. 3). It is important for technologists to recognise this artefact and to ask the patient to clean the axilla or skin folds before the subsequent image acquisition is performed.

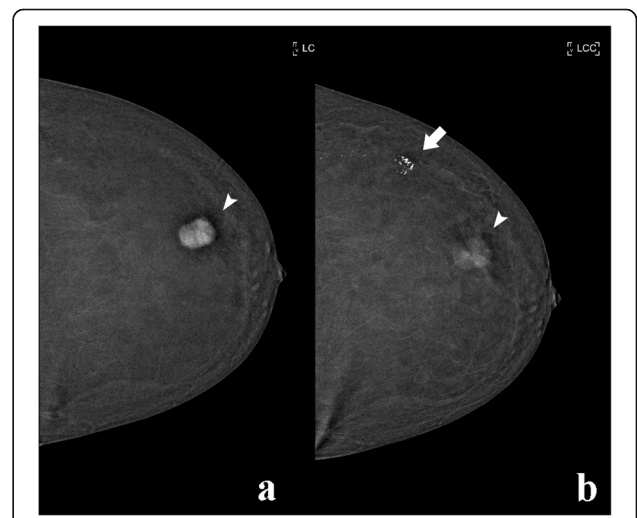
Fig. 5 Contrast splatter. CEDM was performed in a 55-year-old woman for preoperative staging. **a** The recombined image shows an avidly enhancing lesion in the outer quadrant (arrowhead). **b** A delayed acquisition was performed where contrast contamination of the skin is visible (arrow). Contrast washout is also demonstrated within the lesion (arrowhead)

It is critical to pay close attention to the technique during contrast administration to prevent contrast contamination. When detaching the tubing from the power injector, the contrast media may accidentally splatter onto the adjacent equipment or skin, resulting in the appearance of small white dots on recombined images, which may be confused with microcalcifications (Fig. 5).

administers the contrast media should not assist in patient positioning [10]. Carefully cleaning the region to be examined and the detector of the mammography unit prior to subsequent acquisitions can resolve this artefact.

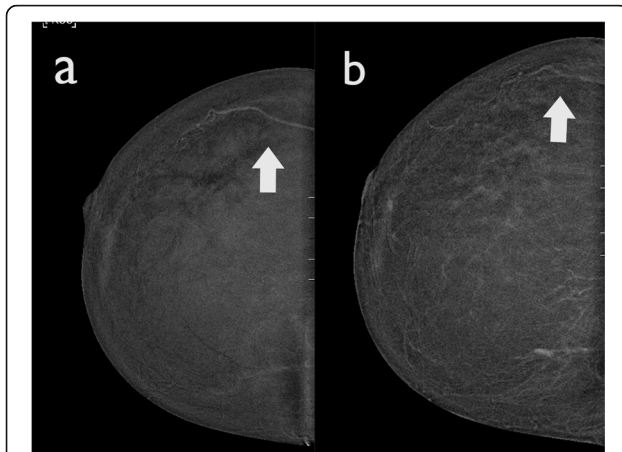
Fig. 6 Transient retention of contrast in blood vessels: a CEDM was performed in a 66-year-old woman to evaluate a suspicious finding in the left breast on mammography. **a** The right, recombined image shows a bolus of contrast within a blood vessel (arrows); **b** this artefact disappeared is less promiscuous in the following CEDM acquisition (arrow)

The retention of contrast media in the blood vessels is frequent. However, it does not compromise image quality (Fig. 6). This phenomenon is typically due to premature breast compression and it is not visualised in the subsequent image acquisition of the same breast.

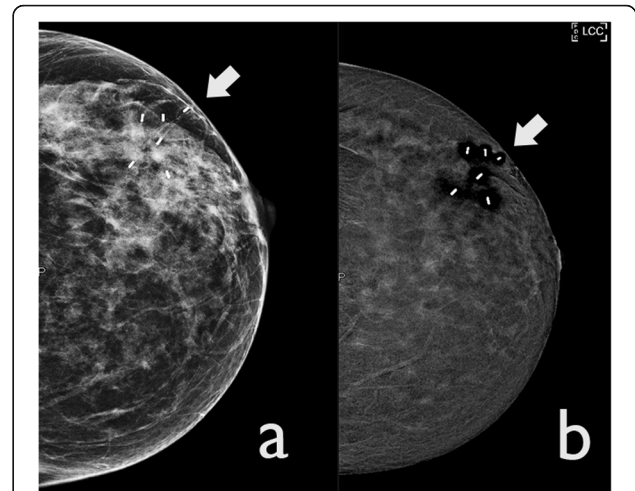
Fig. 7 Artefact due to the presence of post ultrasound guided biopsy markers: **a** LE CEDM image. There are some markers seen at the outer quadrant of the left breast (arrow); **b** in the recombined image, the markers are seen as high attenuation structures and they demonstrate a surrounding dark halo

Placing markers after breast biopsy is very common. Markers of different composition and materials can demonstrate a variable appearance. In our centre, titanium markers are inserted in case of vacuum assisted biopsy while zirconium-oxide markers are inserted during ultrasound-guided biopsy procedures. On the recombined CEDM images, all markers appear as high attenuation structures; however, a surrounding dark halo is occasionally seen with the zirconium oxide markers (Fig. 7).

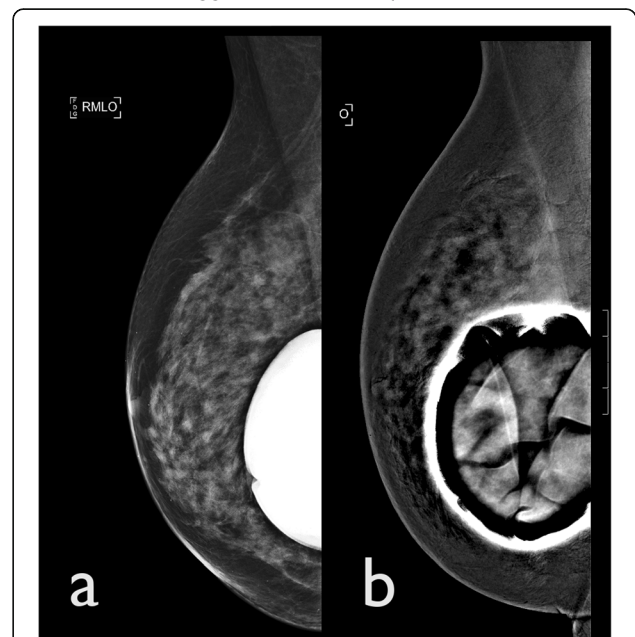
Fig. 8 Breast implant artefact. A CEDM was performed for suspected microcalcifications in a 55-year-old woman with a right breast implant. **a** LE CEDM image shows a breast implant in situ. **b** CEDM recombined image presents a significant post-processing artefacts secondary to the presence of the implants

Breast implant rupture can lead to either intracapsular or extracapsular involvement, which requires them to be removed and replaced. The sensitivity of MRI in assessing the integrity of breast implants is about 90% [11]. Breast implants tend to produce significant artefacts on CEDM recombined images, which may obscure an underlying pathology (Fig. 8). Therefore, MRI continues to be the imaging modality of choice in women with breast implants.

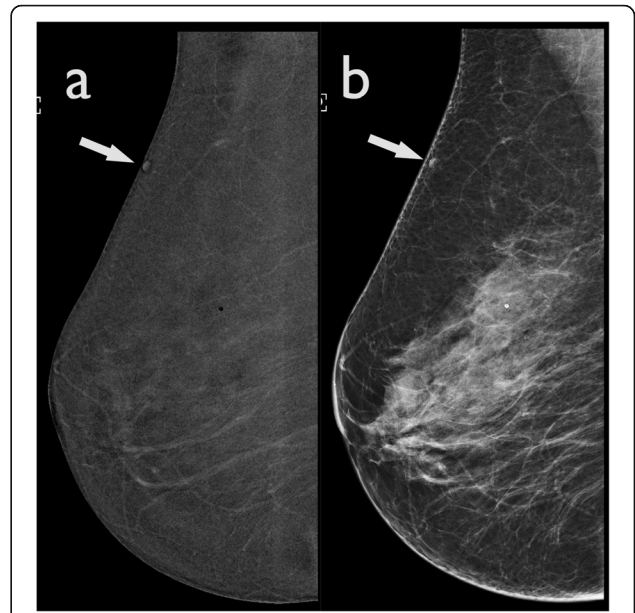
Fig. 14 Enhancement of skin lesions. **a** The recombined image demonstrates a small oval enhancing lesion in the upper quadrant of the right breast, which could mimic a small enhancing mass (arrow). **b** The LE CEDM image shows an oval hyperdensity formation in the upper quadrant. Evaluation of the patient's skin in this region confirmed the presence of a small skin angioma

Moreover, some vascular skin formations, such as skin angiomas, may show contrast enhancement, mimicking the presence of suspicious lesions (Fig. 14). A careful clinical examination of the patient’s skin may be necessary.

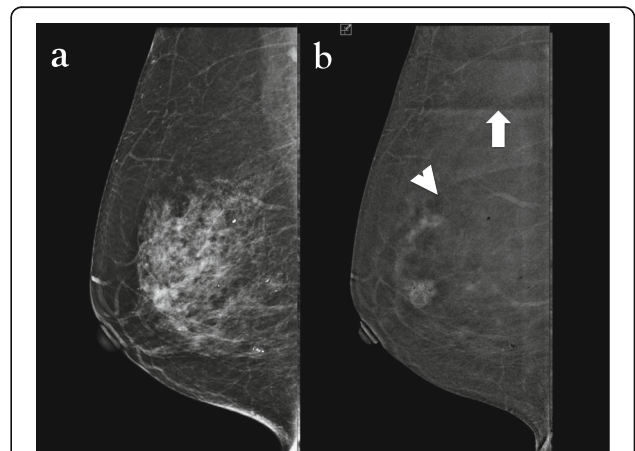
Fig. 15 Ghosting artefact: a 50-year-old woman presented with a right breast lump. **a** The LE CEDM image shows no obvious artefacts, and **(b)** ghosting of the latent CC view (arrowhead) of the previously imaged breast is projected within the MLO image and an axillary line artefact (arrow) is also evident in this image

This artefact occurs when a previous image acquisition remains latent and overlaps with the subsequent image. In CEDM, rapid transitions between acquisitions can be the cause of a persistent latent signal that overlaps the new acquisition (Fig. 15). This artefact is not commonly seen and recalibrating the machine to remove the memory of the previous image can rectify this complication.
