A Multidisciplinary Approach to the Evaluation of Air Quality and Thermo-Hygrometric Conditions for the Conservation of Heritage Manuscripts and Printed Materials in Historic Buildings: A Case Study of the Sala del Dottorato of the University of Perugia as a Model for Heritage Preservation and Occupants' Comfort

Abstract: The Sala del Dottorato (Hall of Graduates) is a magnificent library in the University of Perugia which plays the double role of providing optimal conservation of valuable books and manuscripts while also hosting important events. This double role is closely connected to contrasting indoor microclimatic conditions. This paper presents the results of a multidisciplinary study, begun in 2019, which investigates optimal conditions for the conservation of volumes by monitoring thermo-hygrometric and air quality parameters. The study describes the current conditions of the Hall (in terms of air temperature, relative humidity and concentration of CO₂), highlighting critical aspects, defining strategies for their mitigation and control, and outlining future developments. Improvement measures relate to the installation of a permanent monitoring system with alarm settings

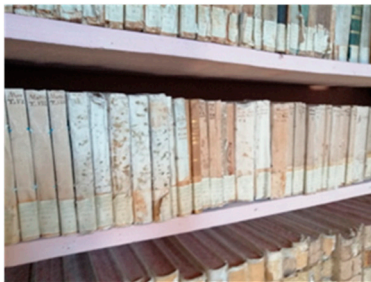
<p>Darkening and discoloration of the ribs of many volumes located on the opposite side of the windows on the mezzanine level.</p>

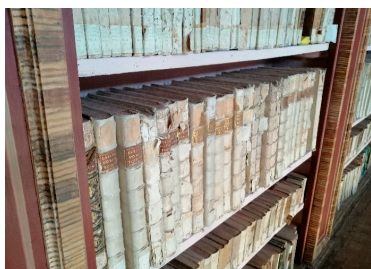
<p>Paper dissolution, with many book bindings completely uncovered; material dissolution is also responsible for the accumulation of dust on paper.</p>

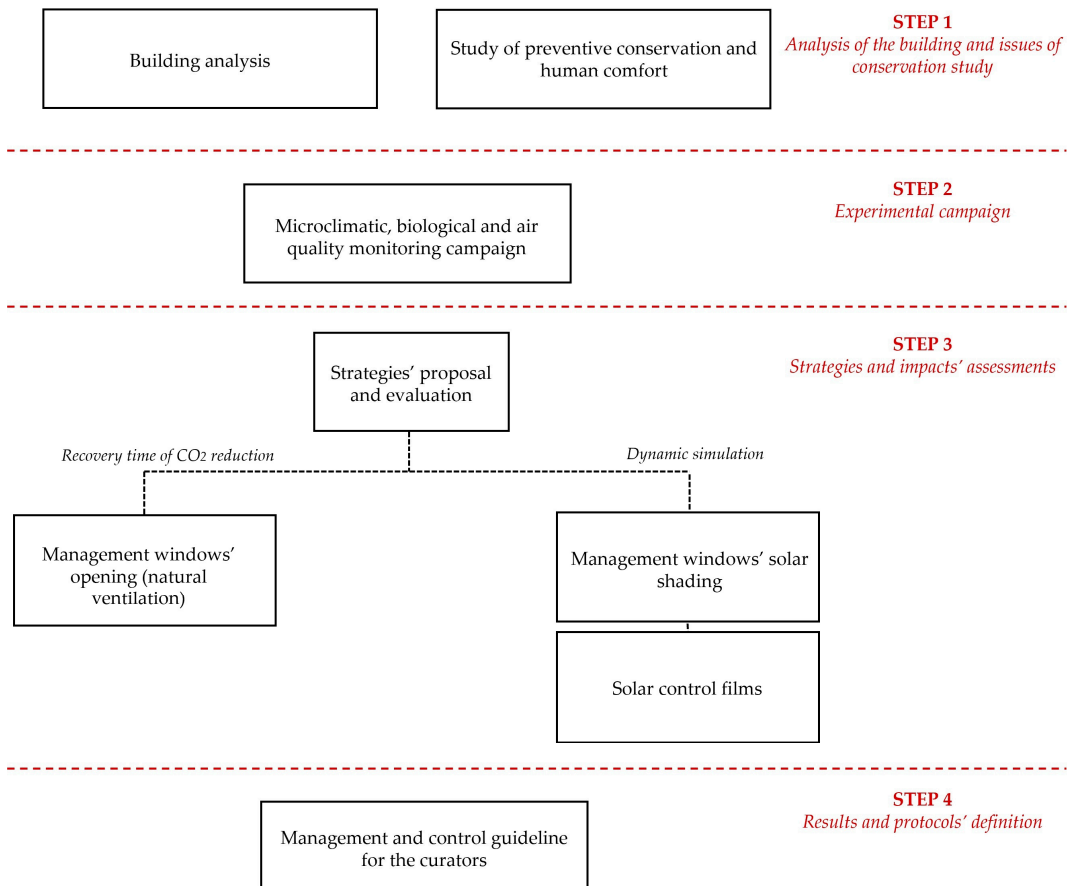
Figure 2. Flow chart of the research methodology.

- *Analysis of the building envelope and HVAC system*, in order to understand the relationship between the variation of indoor and outdoor microclimate conditions; this concerns the study of the thermal performance of the materials composing the building envelope and the characteristics of the HVAC system;

- *Study of issues concerning preventive conservation and human comfort*. This concerns the study of the principal standards and guidelines set out to determine acceptable ranges of parameters used for the purpose of conservation and recommended values for human comfort;

- *Microclimatic, indoor air quality, and biological monitoring*; these activities seem disjointed but integrate each other. The thermo-hygrometric parameters and indoor air quality monitoring are needed to establish indoor environmental conditions. The biological monitoring is necessary to reduce or eliminate the risk of biological attack by fungi, bacteria, mould or other parasites that may lurk in the wooden bookshelves. This type of monitoring is linked to microclimatic monitoring because the association of dampness with mild-to-moderate temperatures and dust deposits creates a favourable habitat on all materials;

- *Strategies assessments and dynamic simulation*, to improve conservation conditions and human comfort in the hall. Additionally, thanks to virtual calibrated modelling of the building, strategies regarding the envelope, the HVAC or the lighting systems are simulated in order to evaluate their impact and help library staff make decisions.

The activities, based on the literature addressing the issue of microclimate risk, can be summarized in the following flow chart (Figure 2).

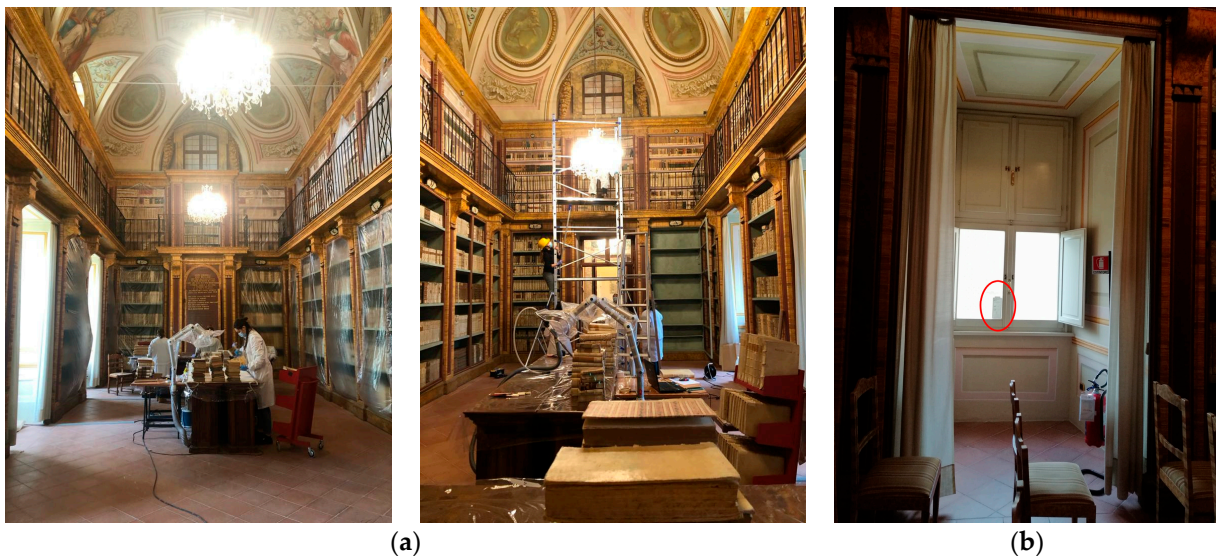
Figure 4. Volume dusting (a) and setting of insect traps on the windows (b).

For this reason, in February 2021, a group of restorers was involved in the project with the task of dusting the volumes preserved in the Sala del Dottorato and reporting a list of restoration priorities for each one, linked to the presence of traces of medium/serious entomological or microbiological attacks. An annual entomological monitoring was therefore set up (from May 2021 to May 2022), placing insect traps on the windows and in other places in the hall [33,34]. The aim of this type of action was to verify, on a monthly basis, the presence or absence of woodworms or other types of insect pests, since traces of them had been discovered in some bookcases of the Hall and in rooms adjacent to the floor. Due to the presence of the traps on the windows, the shutters and curtains were kept open for the entire period of monitoring (Figure 4).

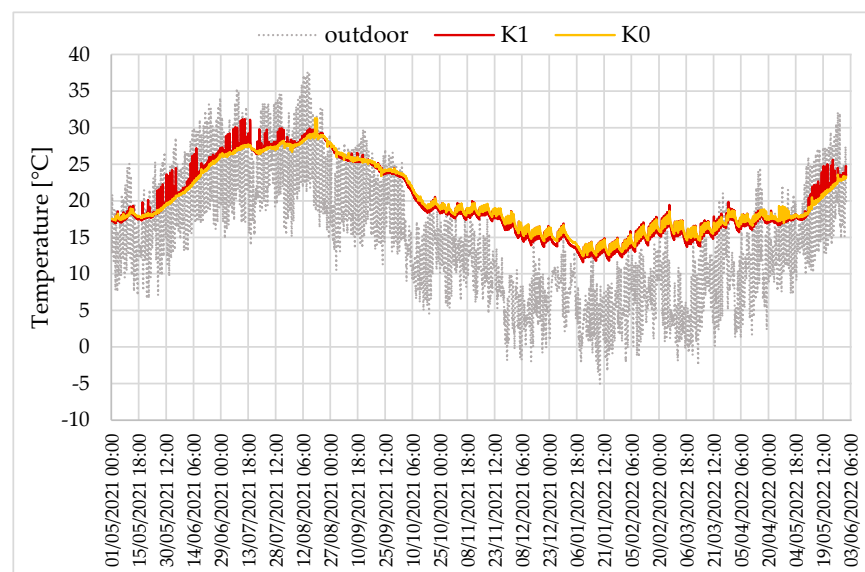
Figure 5. Indoor and outdoor temperature, annual trend (hourly averaged data).

As regards indoor air temperature, Figure 5 shows an annual trend: from May the temperature increases and in the warm seasons the mezzanine's values are higher than the floor-level ones, due to the direct solar radiation coming through the windows, while in the cold seasons conditions are the opposite because of the heating system.

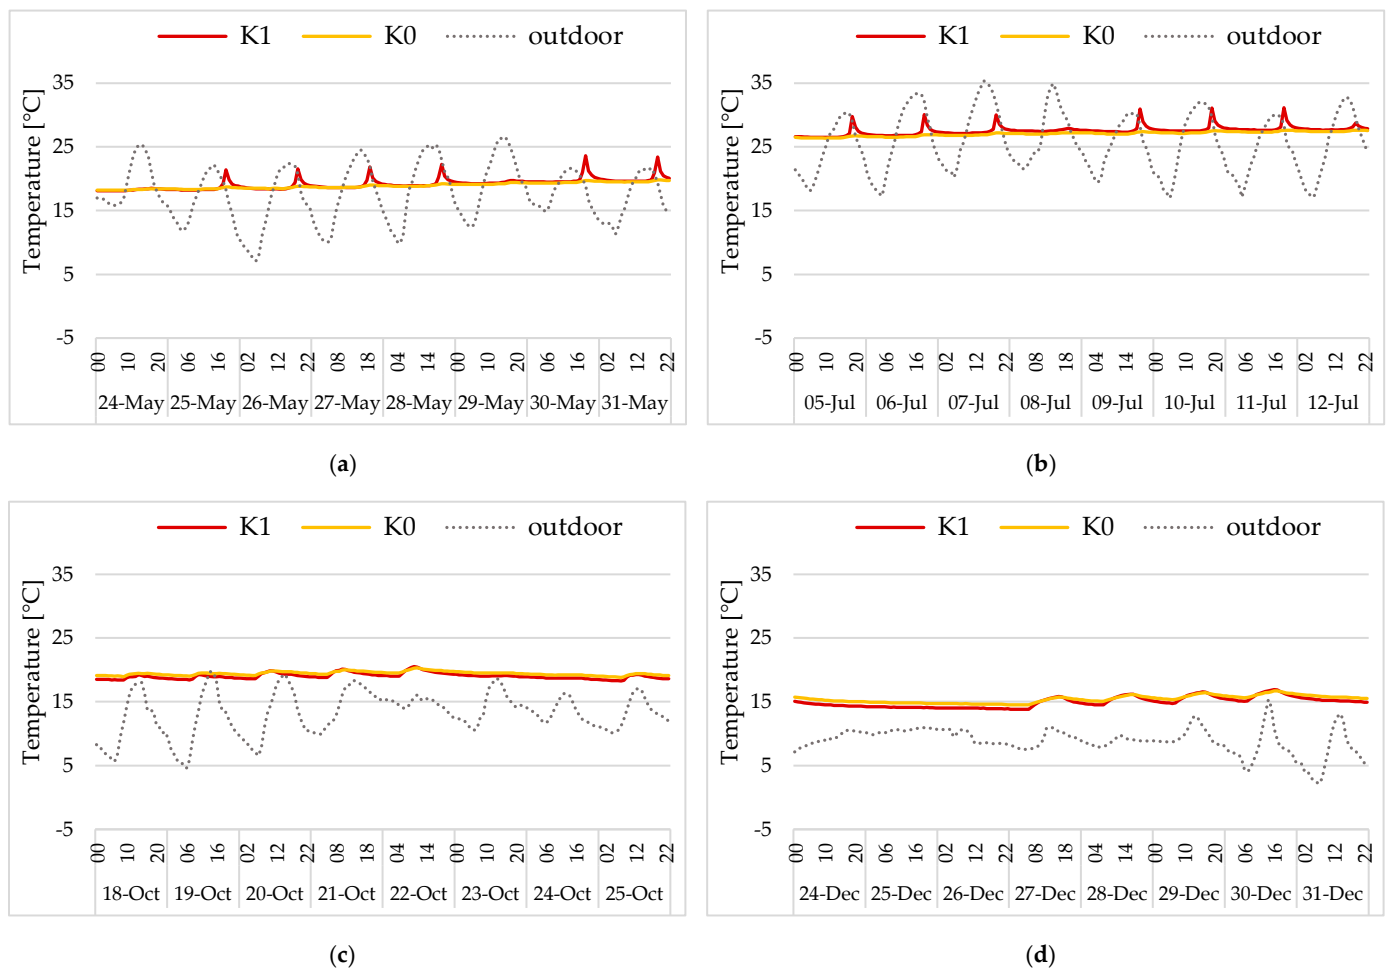
Figure 6. Weekly indoor and outdoor temperature trends during Spring (a), Summer (b), Autumn (c) and Winter (d).

Figure 6 shows the weekly trends of specific months, representative of the seasons: May, July, October and December.

In Spring (a), the thermal inertia of the thick walls keeps the indoor temperature lower than outside; the temperature values are similar at both levels, even if on the mezzanine the effect of solar radiation in the afternoon (from 18:30 to 19:00), with peaks of over 3 °C difference, is already evident.

In Summer (b), the effect of solar radiation is stronger and at this time, temperatures tend to be warmer, more than 25 °C, and thermal layering stratifies the air, also due to the effect of the solar gains from the upper windows. The increase on the mezzanine level has high peaks from 18:30 to 19:30.

In Autumn (c), the heat accumulated during the warm months makes the internal temperature higher than the average daily temperatures. In the selected week, on workdays the heating was already turned on, with evident differences from the weekend, when it was turned off. In this period, because of the effect of heating, the floor level was warmer than the mezzanine level (by about 1 °C).

In December (d), even when the heating system was on, the temperature did not reach 20 °C: this was a positive condition for the conservation of the volumes but not for people. Conditions worsened during the Christmas break when the heating system was off for several consecutive days and temperatures dropped as low as 14 °C.

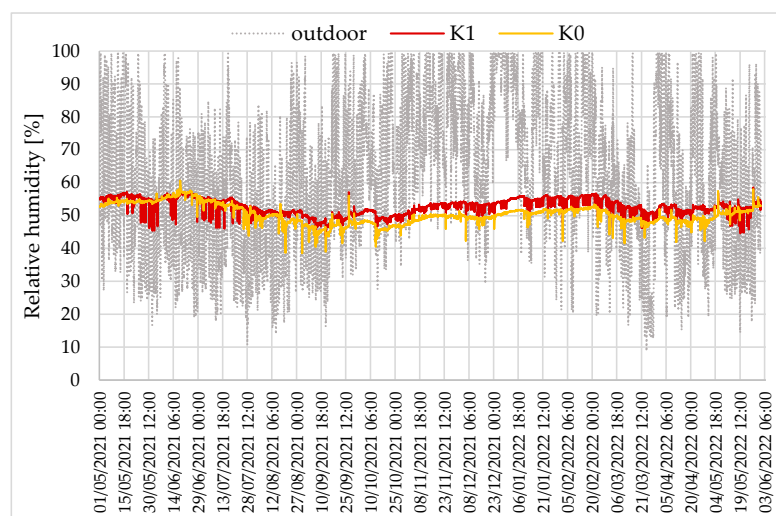
Figure 7. Indoor and outdoor relative humidity, annual trend (hourly averaged data).

The same type of analysis was carried out for relative humidity; this parameter also presents a historical yearly trend which is shown in Figure 7. During the cold season, the relative humidity values of the mezzanine level are higher than the lower level, in accordance with the temperature trend. However, the values of both levels are inside the recommended range for the entire annual period. A weekly analysis was carried out for the representative periods of the seasons.

In general terms, relative humidity values did not exceed the suggested maximum value (60%) and daily fluctuations were limited, as reported in Table 9. During summer, the trends on both levels were similar, while in winter the floor level presented lower values, owing to heating by the radiators.

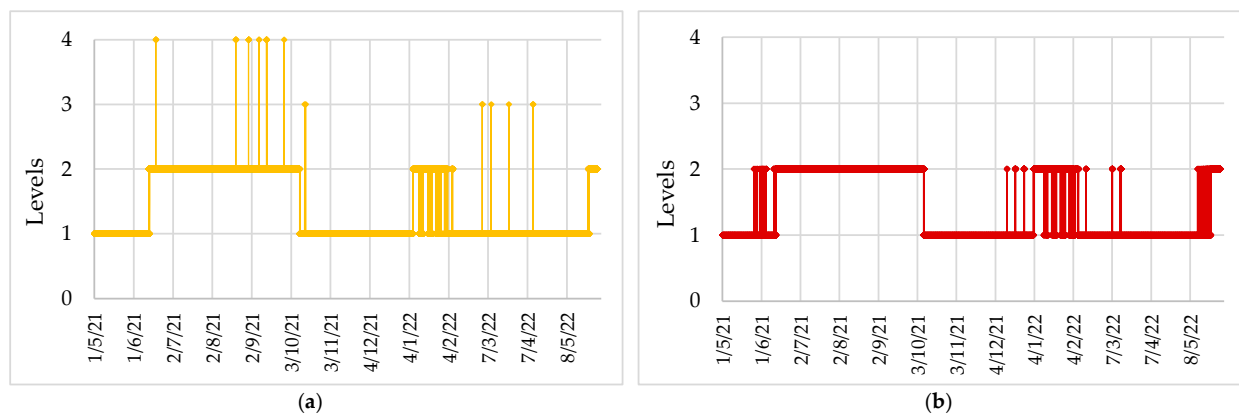
Figure 9. Comparative data analysis for indoor air temperature and relative humidity on the floor level (a) and the mezzanine (b).

Figure 9 shows, in graphic form, the results of this analysis: in the monitoring period (from May 2021 to May 2022), more than 50% of the measured data of both positions were within level one (the acceptable range for temperature and relative humidity), but a large

percentage of both positions, about 40%, registered temperatures outside the recommended range. This phenomenon occurred especially in Summer when indoor temperatures were too high, particularly on the side of the mezzanine level opposite the windows, which received direct solar radiation, increasing temperature. This consequently raised questions linked to the acceleration of the rate of degradation which can occur when high temperatures are maintained for a long period.

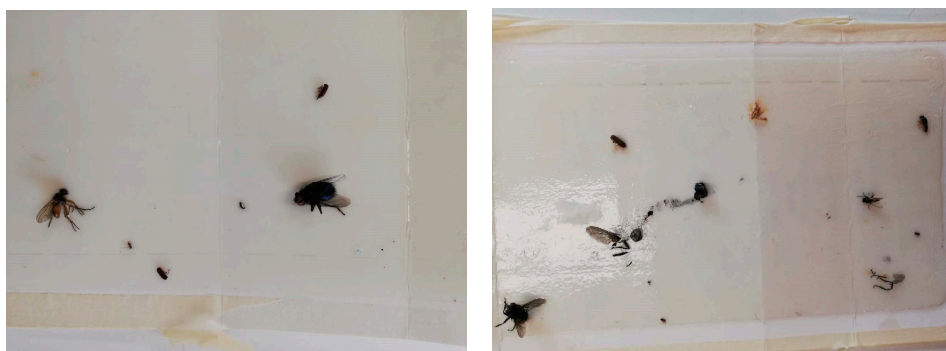
Entomological monitoring using insect traps detected several specimens that were identified by experts as originating from wooden furniture, also located outside the room and in the adjacent areas (Figure 11).

Figure 11. Insect specimens found in the traps. Dusting mitigated and, in some cases, also removed the causes of the proliferation of insects and fungal spores. However, considering that the furniture of the hall is wooden (and partially damaged), it cannot be excluded that under favourable conditions and without periodic disinfection, new insect outbreaks may occur (such as parasite eggs or larvae).
