Subsoil characterization and stability analysis for the Bourbon del Monte Palace in Piancastagnaio (Siena, Italy)

G. Ciardi, G. Bartoli & C. Madaia

Department of Civil and Environmental Engineering, University of Florence, Italy

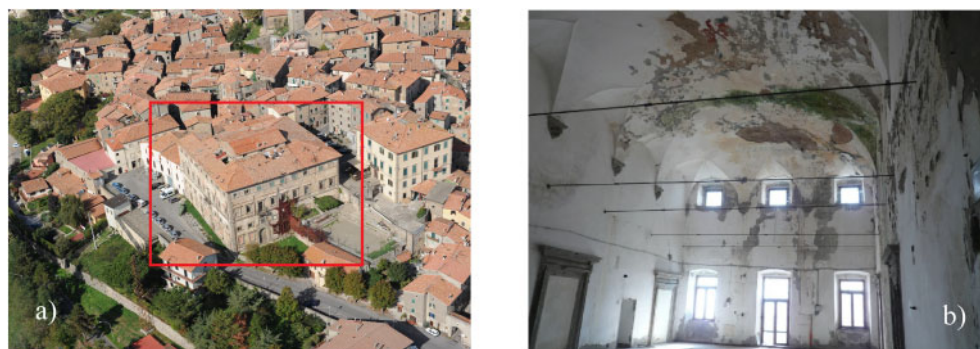
of the '80s of the last century when it was declared unfit for use by the Public Authorities. Such a drastic decision was motivated by the high degree of instability that characterizes the whole building and that started growing significantly from the '70-'80's. Figure 1a shows the outside of the Bourbon del Monte Palace with the South-East corner in the foreground. Figure 1b shows the extreme degradation in the biggest central room inside the building.

Figure 1. The Bourbon del Monte Palace in Piancastagnaio: (a) outside view; (b) inside view.

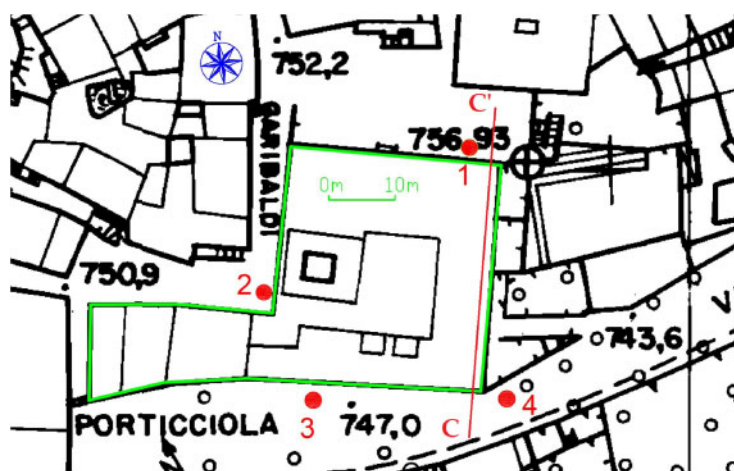
Seven different soil types can be distinguished from the 4 litho-stratigraphic borehole profiles (Baldi 2008): filling soil (R), loose brown sand (Sa), sand with trachyte small clusters (Sa+Tra), fractured trachyte (Tra), grey silty sand (Sl), grey-brown sandy silt (Ls), and silt (L). Figure 3 shows the location of the 4 boreholes described in Baldi (2008) and the cross Section CC' that was used for numerical analysis (see Section 3.2).

Figure 3. Survey Boreholes location (red dots) and Section CC'. The basement is located close to borehole n°4.

The subsoil morphology of the analyzed Section CC' was reconstructed based on the profiles obtained from boreholes n°1 and n°4 located close to the East wall (Figure 3), assuming each litho-stratigraphic profile as a boundary condition for lithotypes identification and location; an additional boundary condition was represented by the lithotype Tra, outcropping at the basement entrance (Figure 4a). The surficial morphology in correspondence of the Palace was easily obtained by architectural surveys and previous analysis (Bartoli & Betti 2012; Betti et al. 2010). The Section CC' layout is shown in Figure 5. As can be seen, the separation between lithotypes Ls and Tra

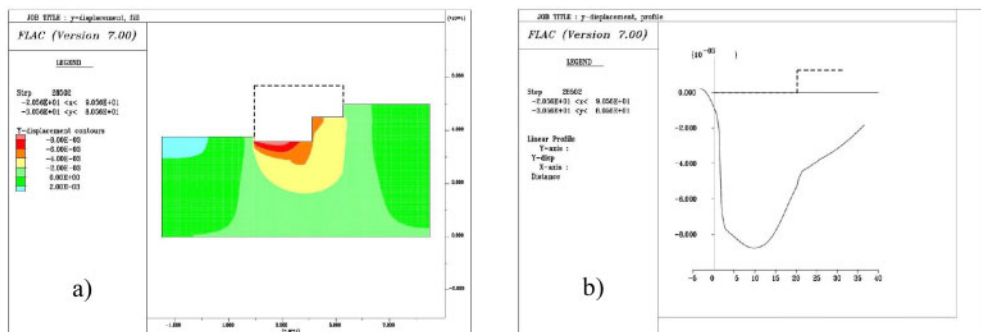
The results of numerical models are described in this section for all models. Figure 6a shows the vertical displacements obtained from model 1; the maximum vertical displacement was ≈ 8.8 mm, located under the South-East corner of the East wall. Figure 6b shows a detail of the settlement basin under the South-East corner; all results are reported in meters. When groundwater is considered (model 2), the shape and location of the settlements' basin did not essentially change; the maximum vertical displacement was ≈ 10 mm. It is worth observing that, despite the heavy simplifications of

Figure 6. Section CC'. Vertical displacement from model 1 (a); zoom at the South-East corner (b).

the proposed models, the location and shape of the settlements' basin is compatible with the crack systems along the building East wall (Figure 2a).

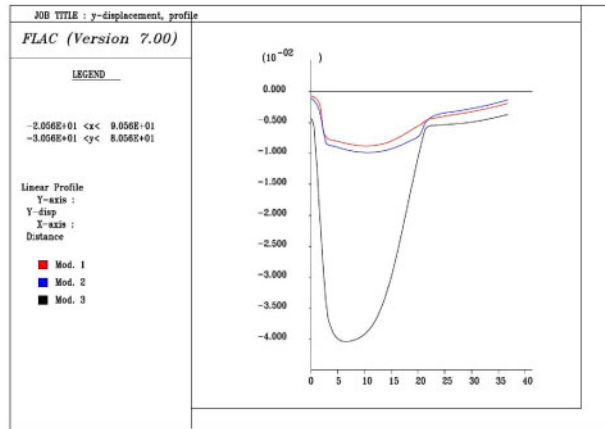
Model 3 introduces the decay of mechanical properties of Ls lithotype, related to water infiltration. Figure 7 shows a comparison among the settlements' basin obtained from models 1–3: as can be noted, the shape and location are essentially the same. Despite the numerical values obtained from model 3 (as stated in Section 3, the reduction of Ls mechanical characteristics is not test-based), this model confirms that the settlements' basin is strongly influenced by Ls characteristics, as it may be hypothesized considering that the upper side of the East wall is built on rock; thus, a decay of Ls mechanical properties would have essentially increased differential settlements without significantly changing the location of the settlements basin.

Figure 7. Vertical displacement comparison among Models 1–3.

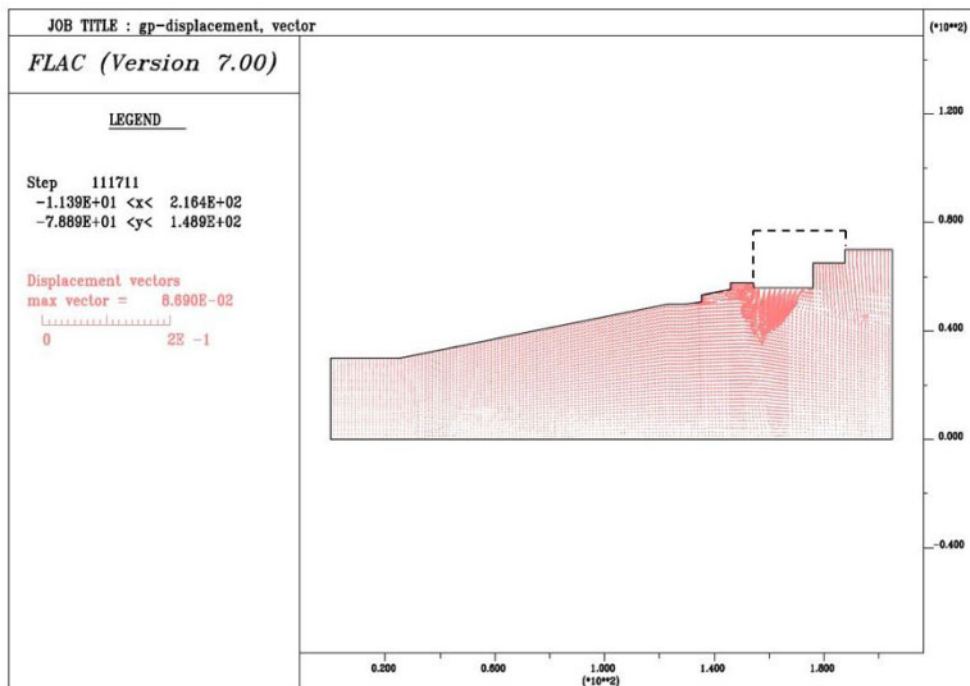
Figure 9. Section CC'. Displacement vectors from model 5.

shape of the settlements basin agrees with the actual crack systems on the East wall. As it was for model 4, the condition associated with maximum y_d was for $\alpha = 45^\circ$.
