### **Integrated survey techniques for the study and the restoration of the archeological heritage**

## INTEGRATED SURVEY TECHNIQUES FOR THE STUDY AND THE RESTORATION OF THE ARCHEOLOGICAL HERITAGE

## 2. A CASE STUDY: THE ROMAN THEATRE OF LIBARNA

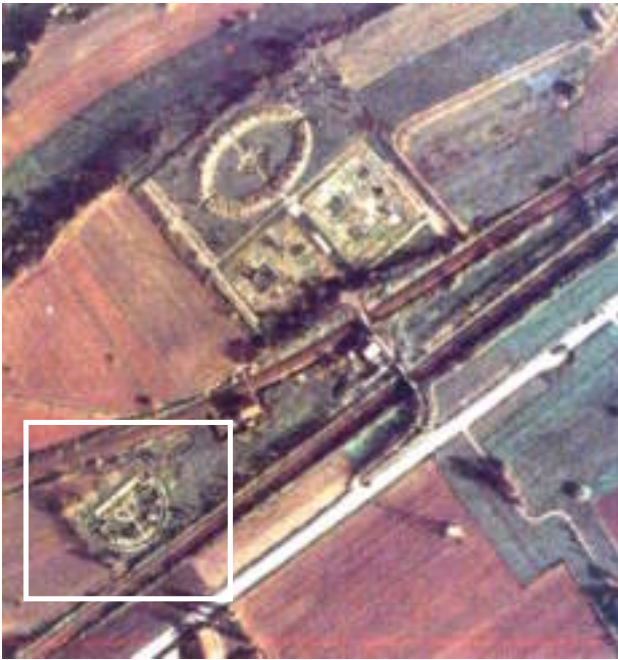
Figure 1. Libarna: aerial view of the whole archeological site
