Landslides (2013) 10:409–420
 DOI 10.1007/s10346-012-0329-5
 Received: 25 February 2011
 Accepted: 4 April 2012
 Published online: 22 May 2012
 © The Author(s) 2012. This article is
 published with open access at
 Springerlink.com

Riccardo Fanti · Giovanni Gigli · Luca Lombardi · Deodato Tapete · Paolo Canuti

Terrestrial laser scanning for rockfall stability analysis in the cultural heritage site of Pitigliano (Italy)

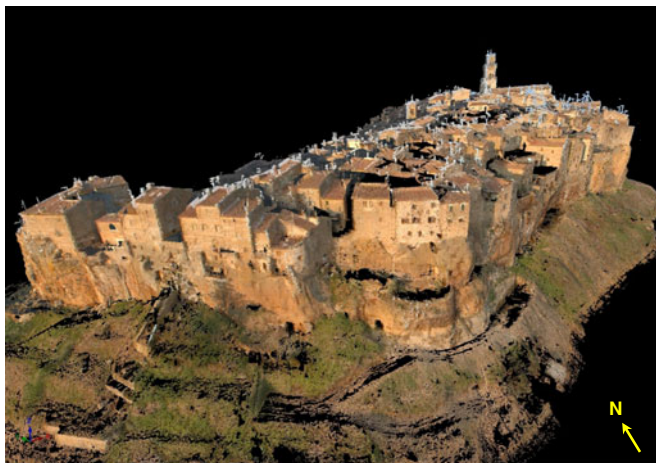
Fig. 4 Holistic true coloured point cloud of the Pitigliano cliff and the historic centre

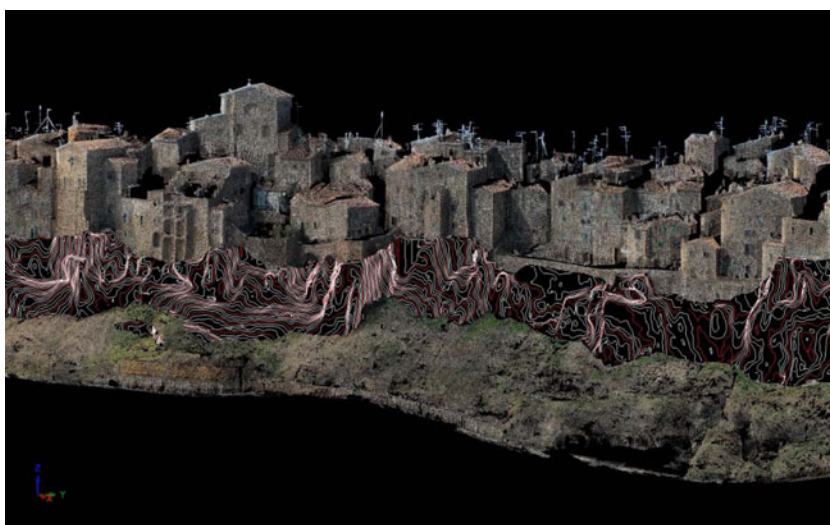
Fig. 8 True coloured point cloud of the southern side of the Pitigliano cliff; *contour line* representation highlights morphologic features of the outcropping rock mass

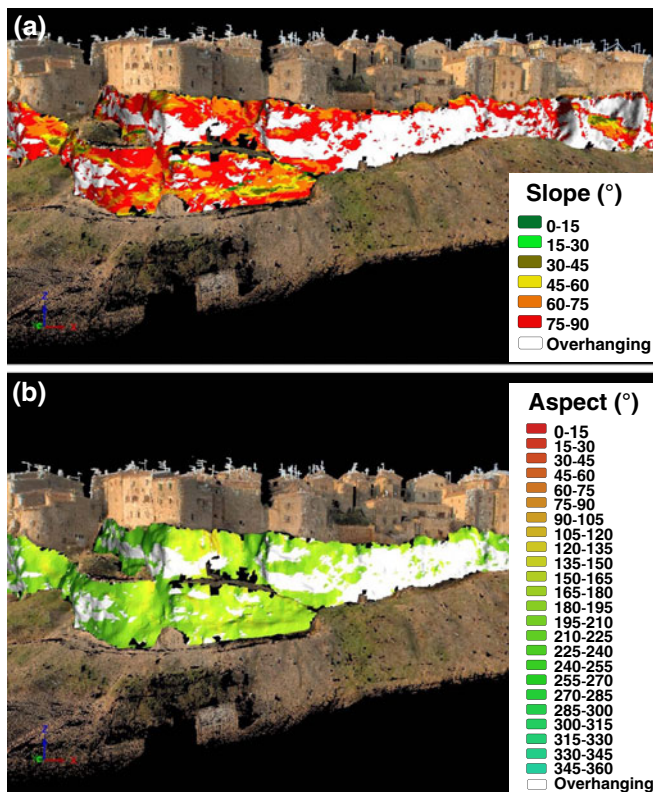
Fig. 9 Point cloud of the southern side of the Pitigliano cliff with the distribution of rock mass dip (a) and dip direction values (b) calculated and extracted by processing 3D laser scanning data

The analysis input parameters are the slope dip and dip direction (Fig. 9), the discontinuity surface orientations (obtained from the field survey and from laser scanning data analysis) and discontinuity friction angle (obtained from the geomechanical survey).

Looking at Fig. 9, we can observe that a considerable portion of the rock wall is overhanging. The analysis of the 3D mesh obtained from the laser scanning data shows that the area of the overhanging sectors is about 33 % of the total area of the rock outcrop.

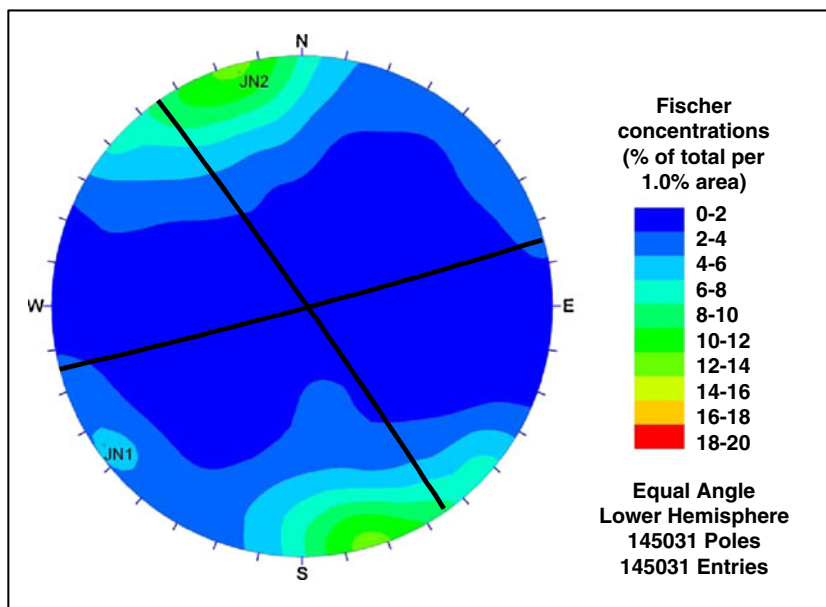
Fig. 10 Stereographic projection of the orientation of the *triangles* constituting the 3D mesh obtained from laser scanning data

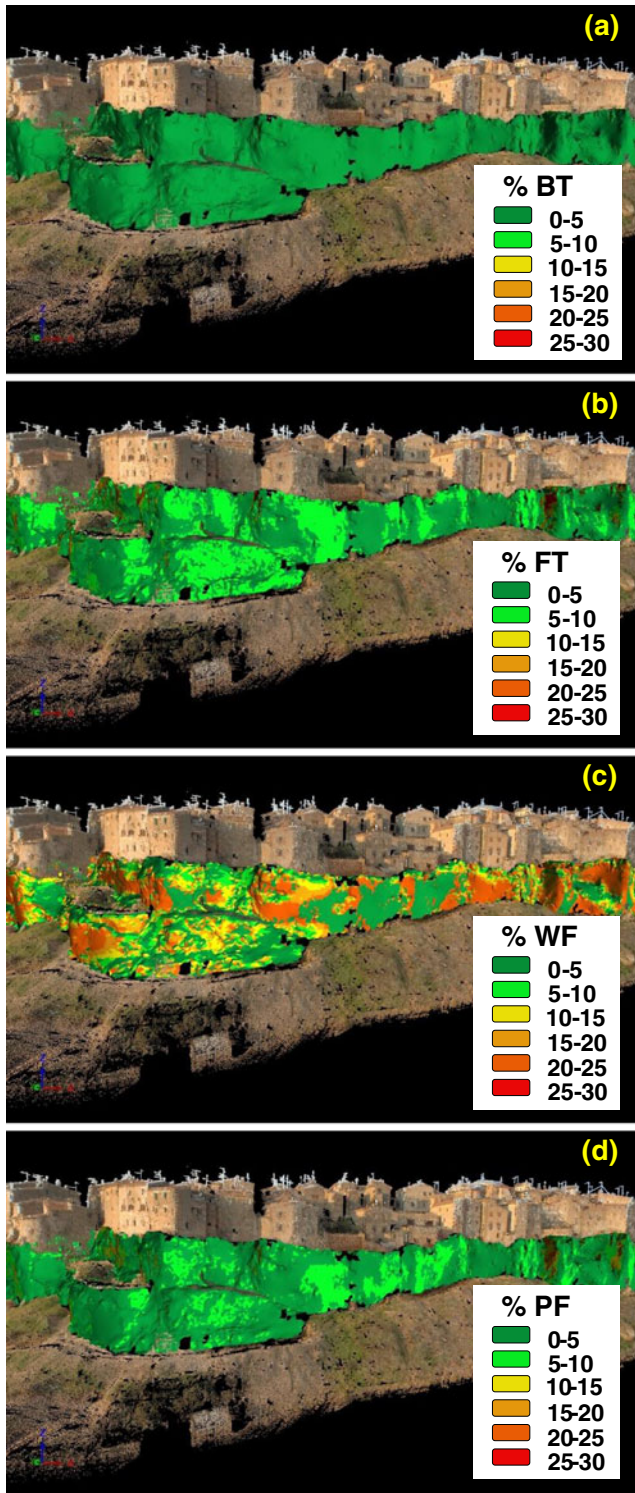
Fig. 12 Results obtained from the 3D kinematic analysis for the different analyzed instability mechanisms in correspondence of the southern side of the cliff: **a** block toppling, **b** flexural toppling, **c** wedge failure, and **d** plane failure. The probability of occurrence (hazard) is expressed following a common colour scale

The results from this analysis are summarized in Fig. 12, where the kinematic index of the triangles of the mesh is reported for each instability mechanism for a portion of the southern side of the cliff. The probability of occurrence for each mechanism is expressed by

means of a colour scale, varying from green to red as the hazard increases. It means that green areas correspond to sectors with very low, up to negligible, hazard with reference to the specific instability mechanism, while orange/red colours mark the sectors highly prone to instability. The maximum values of the kinematic indexes which were calculated range from 25 to 30 %.

In this regard, the highest kinematic index (28 %) is related to the wedge failure (WF; Fig. 12c), with a respective hazard which affects several sectors of the cliff surfaces. The spatial distribution of the WF index confirms that conservation criticalities can be raised both for the tuff blocks located immediately underneath the buildings located along the edge and the lower sectors of the exposed cliff. Consequently, a progressive undermining can destabilize huge portions of the cliff at different heights.

Comparing the spatial distribution of the kinematic indexes for the other instability mechanisms, it is quite evident that block toppling represents a negligible deterioration process (kinematic index up to 2 %; Fig. 12a) while flexural toppling (FT; Fig. 12b) and plane failure (PF; Fig. 12d) reach maximum values, respectively, of 22 and 20 %. In particular, hazard patterns of the FT and PF mechanisms show some similarities in their spatial distribution, with values of kinematic index averagely higher for the FT over the same sectors.

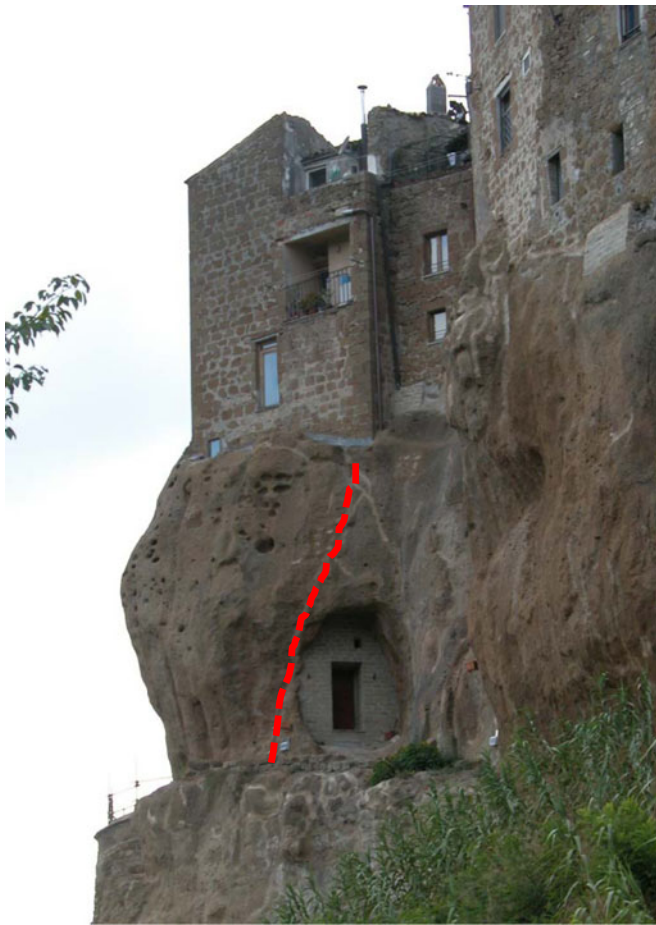
Fig. 14 Test area selected on the southern side of the Pitigliano cliff. Deformometers were installed to monitor the joint (*dashed line*) which controls the wedge geometry. Spatial relationship with the overlying building suggests probable direct impacts on the preservation of the built heritage

Figure 14 shows the test area where the buildings are built above a tuff block affected by a joint suggesting the presence of a probable plane of failure. Detachment of the block would compromise the stability of the overlying buildings, even causing structural collapses. A further element of instability is here constituted by the presence of the underground cave, whose excavation could have influenced the overall structural setting of the rock mass underneath the buildings. This case clarifies how a geomechanical analysis of instability mechanisms in built-up contexts requires a wider approach which would take into account all different geological and not-geological hazard factors.
