Analysis of building deformation in landslide area using multisensor PSInSAR™ technique

Andrea Ciampalini ^{*}, Federica Bardi, Silvia Bianchini, William Frodella,
Chiara Del Ventisette, Sandro Moretti, Nicola Casagli

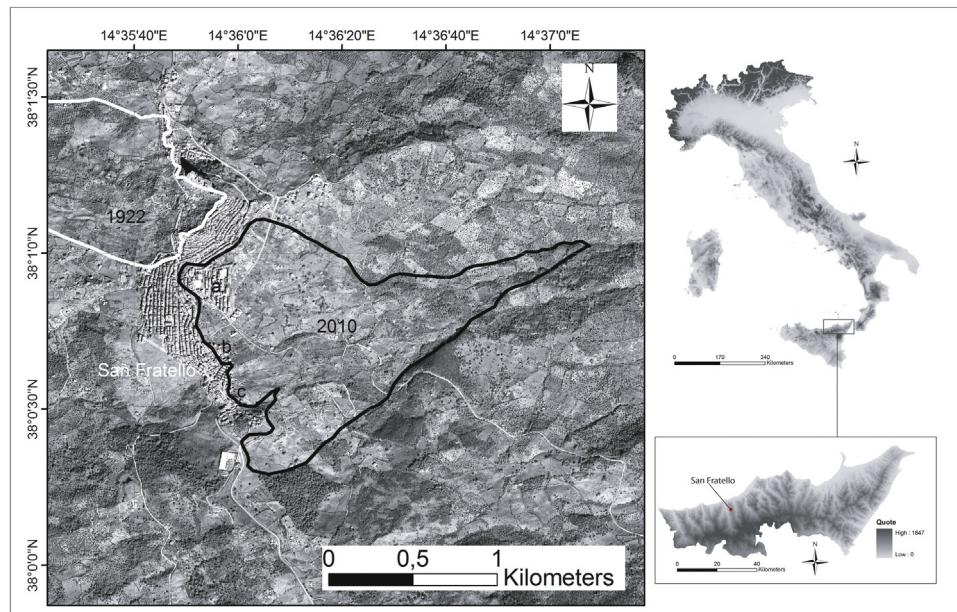
Fig. 1. Location of the study area and 1922 and 2010 landslides boundaries. (a) Stazzone quarter; (b) Riana quarter; (c) San Benedetto quarter.

The town of San Fratello is located in the northeastern sector of Sicily (Italy), along the Tyrrhenian coastline (Fig. 1), close to the boundary between the Nebrodi and Peloritani mountain chains. The study area was historically affected by landslides (Goswami et al., 2011; Mondini et al., 2011; Del Ventisette et al., 2012;

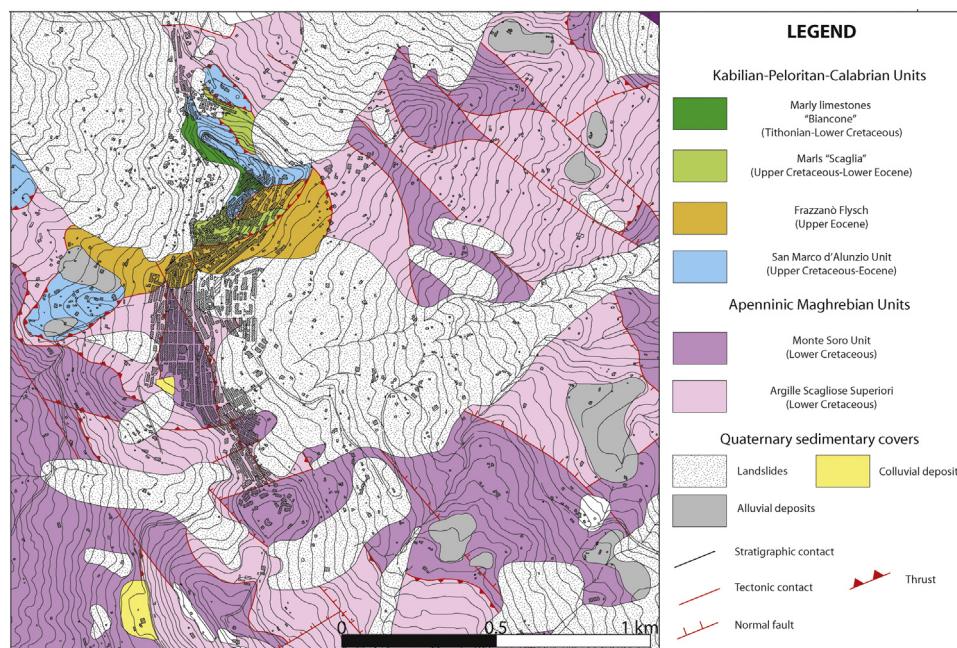
Fig. 2. Schematic geological map of the town of San Fratello (courtesy of DRPC).

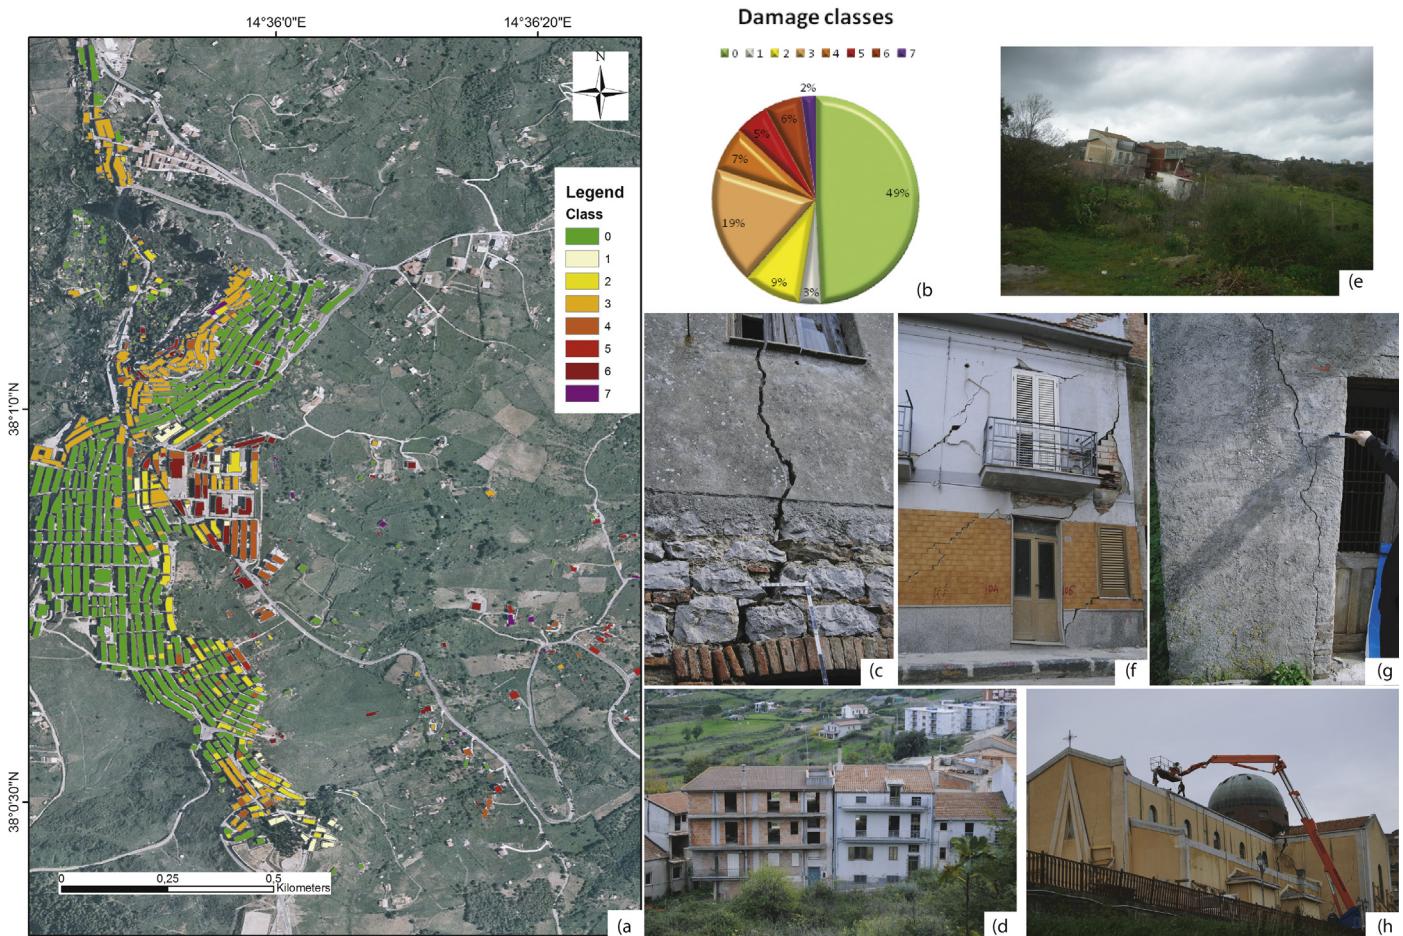
Fig. 3. Damage assessment map of San Fratello according to the degree of damages of Table 1 (a); and the related frequency of buildings considering the degree of damages (b). Some examples of the damages of San Fratello (c) class 3; (d) class 6; (e) class 7; (f) class 5; (g) class 2; (h) class 5.

The damage assessment map (Fig. 3) reports the degree of damages of a total of 738 buildings classified following the scheme reported in Table 1. The map shows that more than half of San Fratello buildings are affected by damages caused by slope instability; amongst them 20% of buildings are strongly damaged (more than class 4). The most affected areas are located on the town eastern slope, within the Stazzone quarter and East of the city center (Fig. 3a). In these areas, also some of the most recent buildings collapsed or were damaged to the point that they required to be

demolished. Intense damages can be observed also in the Riana and San Benedetto quarters along the 2010 landslide crown (Fig. 3e). The field surveys revealed also the presence of several damaged buildings located in the northwestern part of town, corresponding to the 1922 landslide crown area.

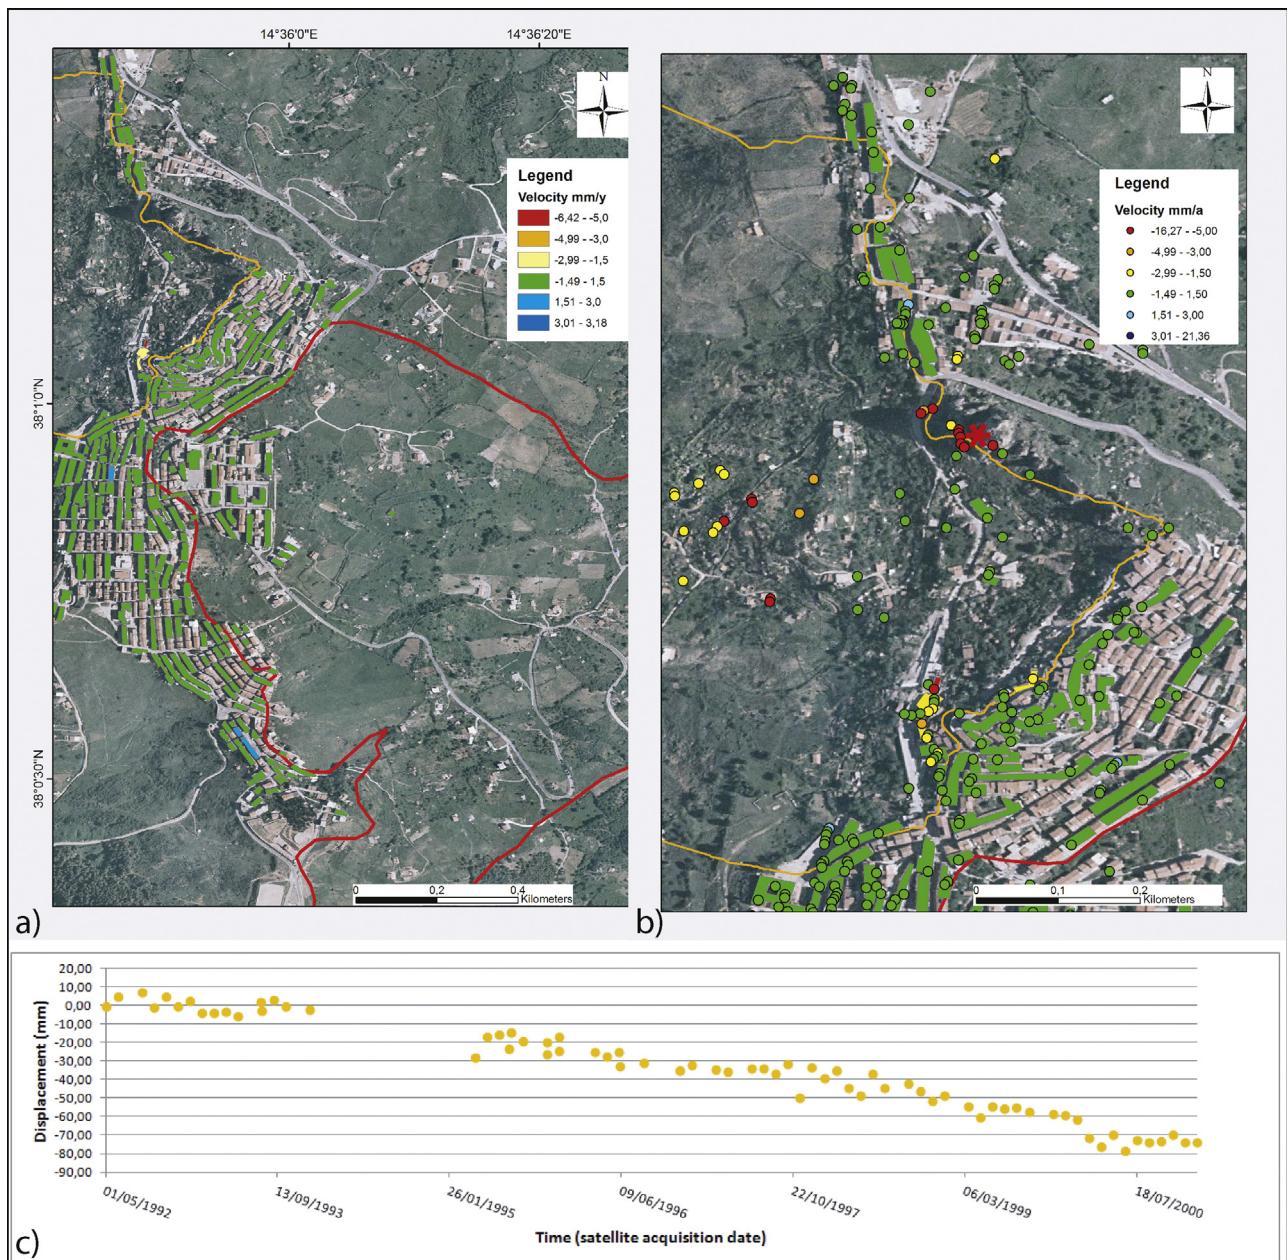
Fig. 4. (a) Buildings deformation velocity map obtained using ERS 1/2 descending data. (b) Details of the 1922 landslide with the PS dataset. The red asterisk stands for the PS time series of (c). The red line corresponds to the 2010 landslide boundary; the orange line corresponds to the 1922 landslide boundary.

landslide are affected by deformation, however a maximum of 178 (24.12%) buildings were mapped using the descending dataset (Fig. 4a). Along the 1922 landslide crown, some buildings show a deformation velocity, which is consistent with the damages observed on their walls and facades. In this case, the extent of the area affected by deformation is underestimated. A better result can be obtained by the observation of the whole PS dataset (Fig. 4b). PS targets clearly show the presence of at least two other areas characterized by ground deformation, one located along the 1922 landslide crown (Fig. 4a), where the mean deformation velocity is up to -9 mm/y (Fig. 4b and c), and another one within the landslide body (Fig. 4b).

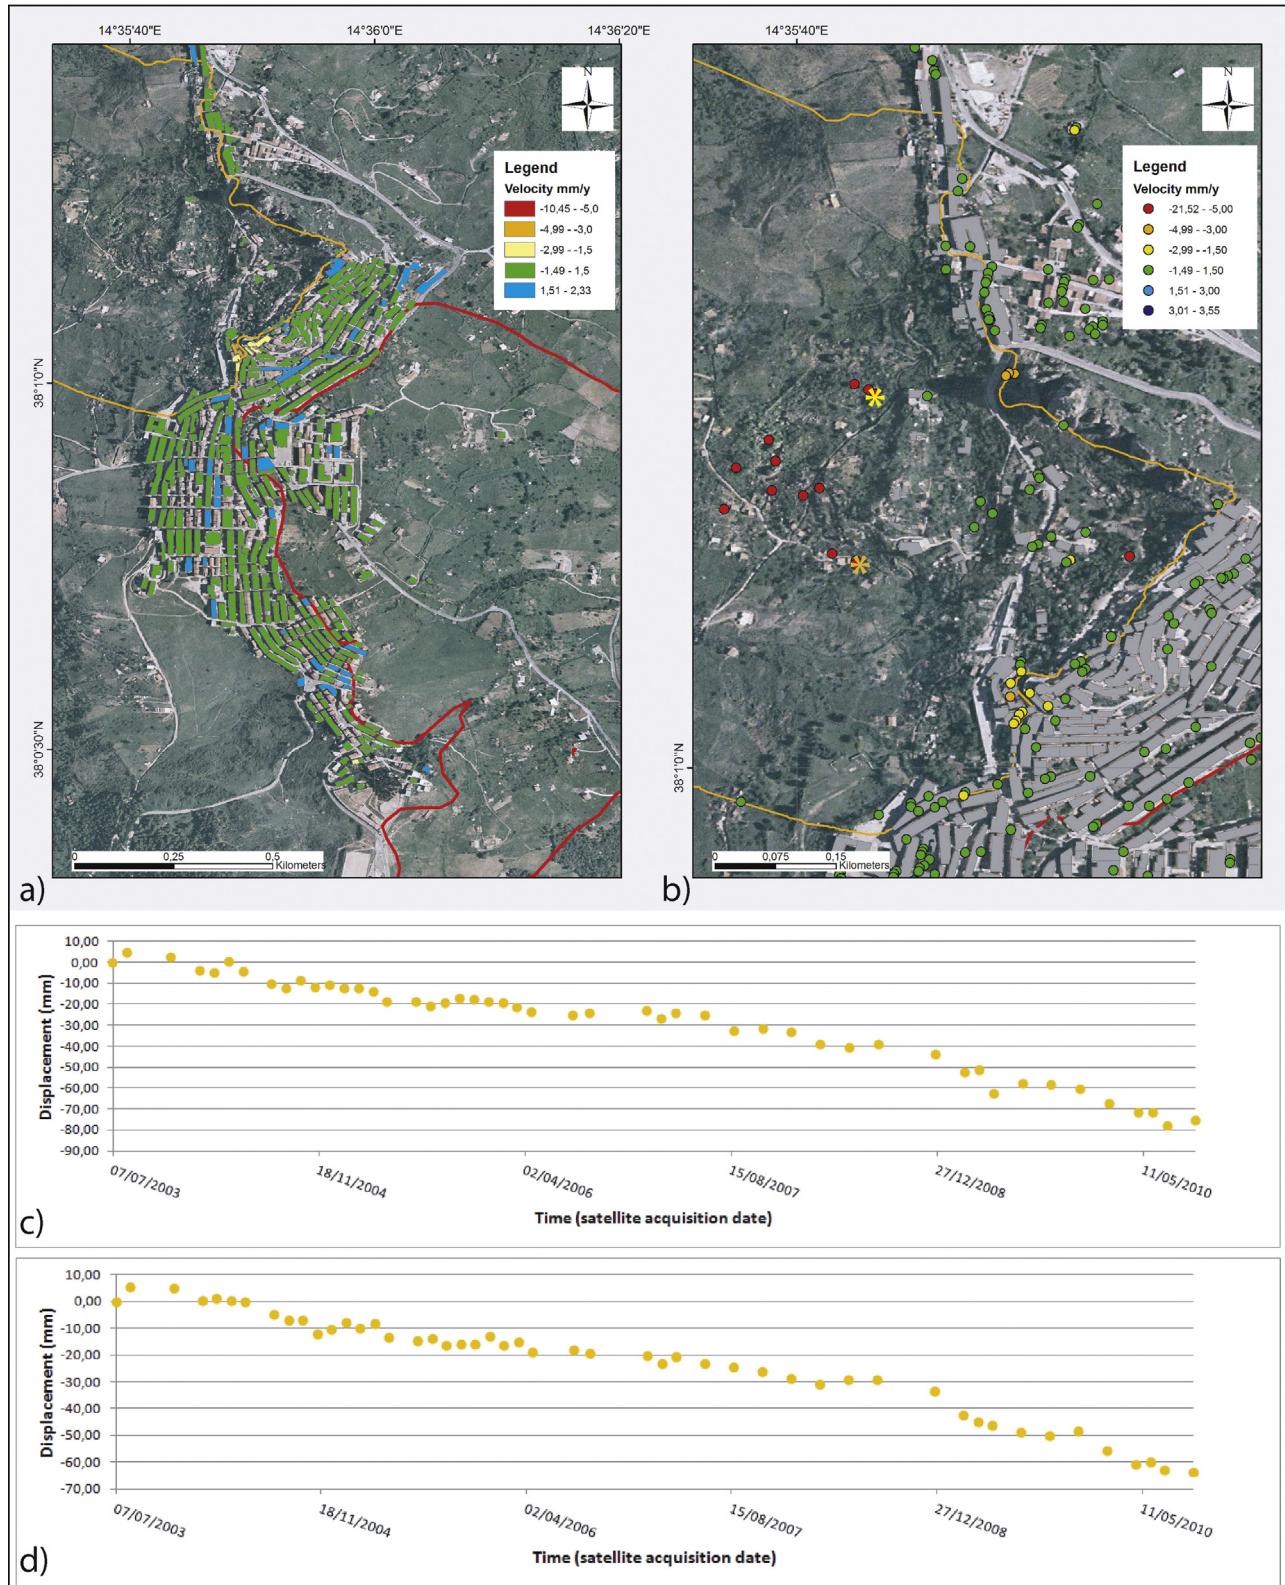
Fig. 5. (a) Building deformation velocity map using both ascending and descending ENVISAT datasets. (b) ENVISAT PS dataset related to the 1922 landslide with two selected time series (c and d). (c) Corresponds to the yellow asterisk; (d) corresponds to the orange asterisk.

The use of the ENVISAT datasets allowed the mapping of up to 279 (37.80%) of the town buildings. The related building deformation velocity map (Fig. 5a) is very similar to those obtained with ERS 1/2 datasets. Results highlight a substantial stability of the town. A very small amount of buildings is characterized by deformation velocities outside the stability range. Along the eastern slope, only one edifice shows an average velocity of -10 mm/y. On the western slope, along the 1922 landslide crown, the buildings affected by deformation are almost the same of those highlighted by the map obtained with ERS 1/2. The use of ENVISAT sensor increased the number of monitored buildings; however, these PS data were still not suitable to detect possible ground displacements to be considered as landslide precursors. Also in this case using the whole PS datasets it was possible to retrieve more information about slope instability (Fig. 5b). Along the western town sector the area affected by ground deformation could be better recognized using PS which highlighted the presence of a wide area affected by deformation, located along in the eastern sector of the 1922 landslide (Fig. 5b). The most interesting information obtained using the ENVISAT data concerns the ground deformation of the eastern slope (Fig. 6a). Here two areas, showing clusters of PS characterized by high ground deformation velocities, can be recognized. Even though both these areas are located inside the 2010 landslide body, including a very low number of buildings, the number of PS is sufficient to highlight ground deformation. The comparison between the PS and the damage assessment map shows a good agreement between the distribution of the PS having the highest velocities and the most damaged buildings by the 2010 landslide (Fig. 6b).

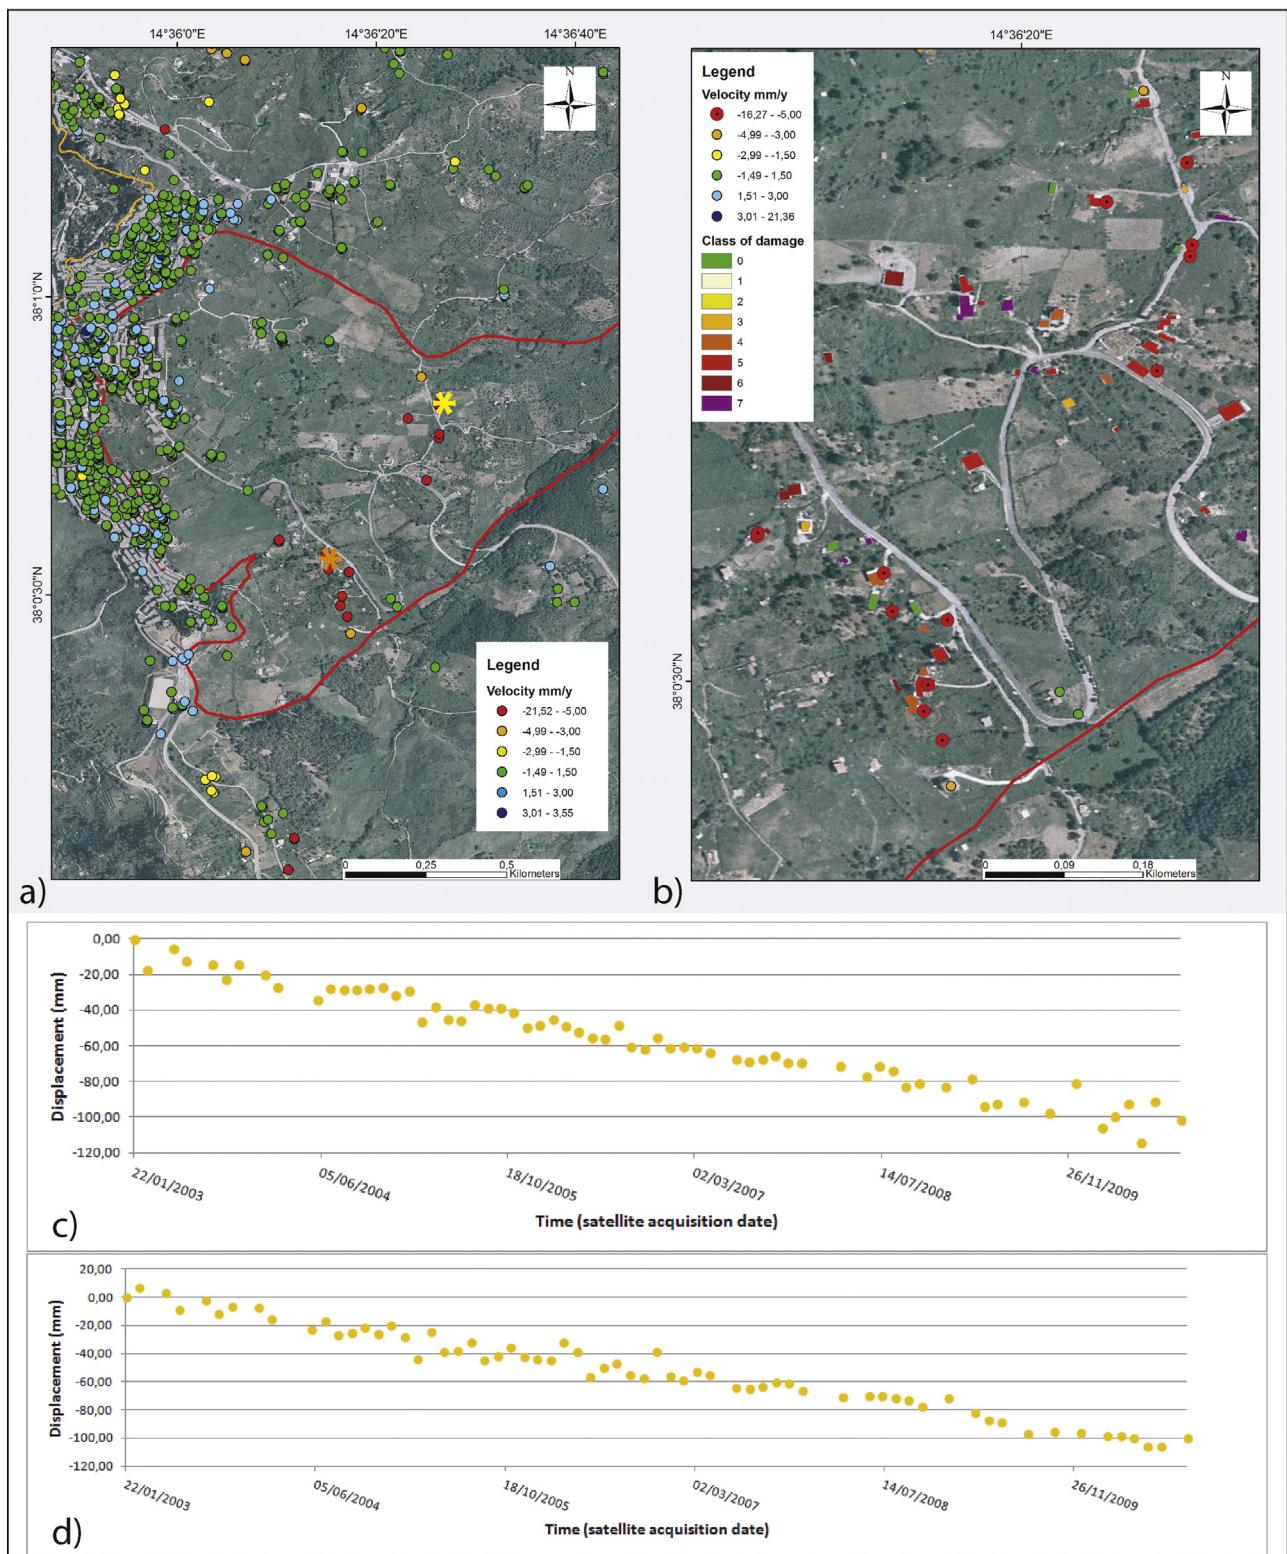
Fig. 6. (a) ENVISAT ascending PS dataset; (b) comparison between the ground deformation velocity map and the damage assessment map; (c) time series correspondent to the yellow asterisk; (d) time series correspondent to the orange asterisk.

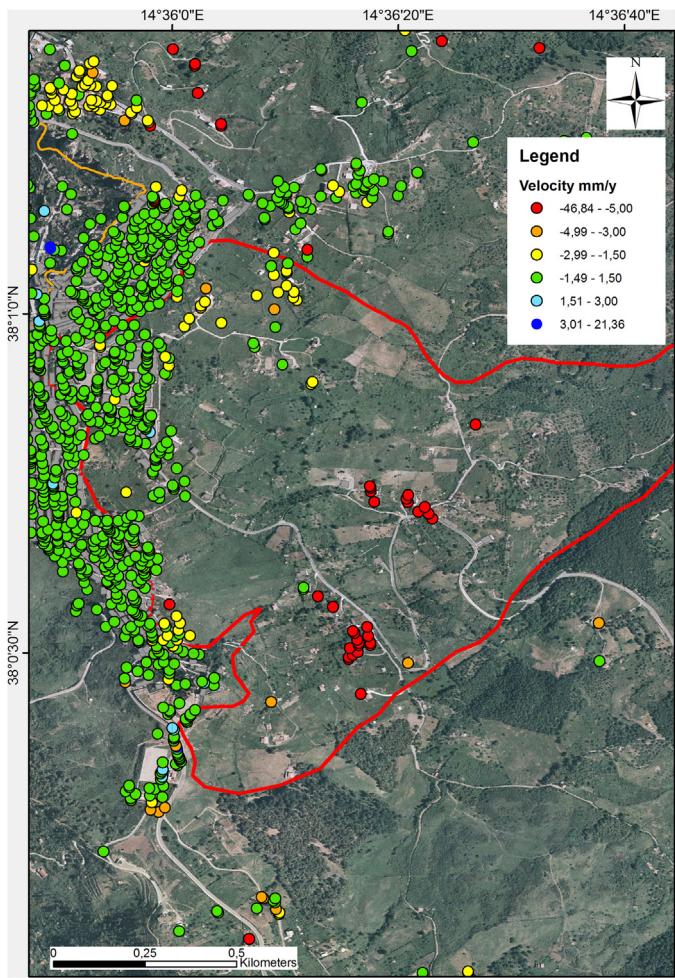
Fig. 7. Building deformation velocity map using both ascending and descending RADARSAT-1 datasets.

RADARSAT-1 data can be used to confirm the results obtained by ENVISAT data due to the partial overlapping of their temporal coverage. The main advantage of the use of RADARSAT-1 is represented by the higher density of PS that allows mapping the deformation velocity of almost the half (48.37%) of the monitored buildings. Results clearly highlight three areas where buildings are affected by deformation (Fig. 7). The first area is located within the eastern slope, confirming the results of ENVISAT data. In addition, the deformation of the edifices located along the 1922 landslide crown is confirmed. The third area corresponds to the San Benedetto quarter, where four buildings show velocities slightly higher than the stability range. Considering the whole PS RADARSAT-1 ascending dataset (Fig. 8a), the area affected by ground deformation located within the eastern slope is clearly recognizable. Also, in this case, the agreement between the ground deformation velocities and the damage assessment map is good (Fig. 8b), confirming the usefulness of the C-band sensors relatively to this area, where the buildings affected by severe damages are surrounded by PS showing the highest velocities. Also along the western slope, RADARSAT-1 confirms the results obtained by ENVISAT highlighting the presence of ground deformation within the body and along the 1922 landslide crown.

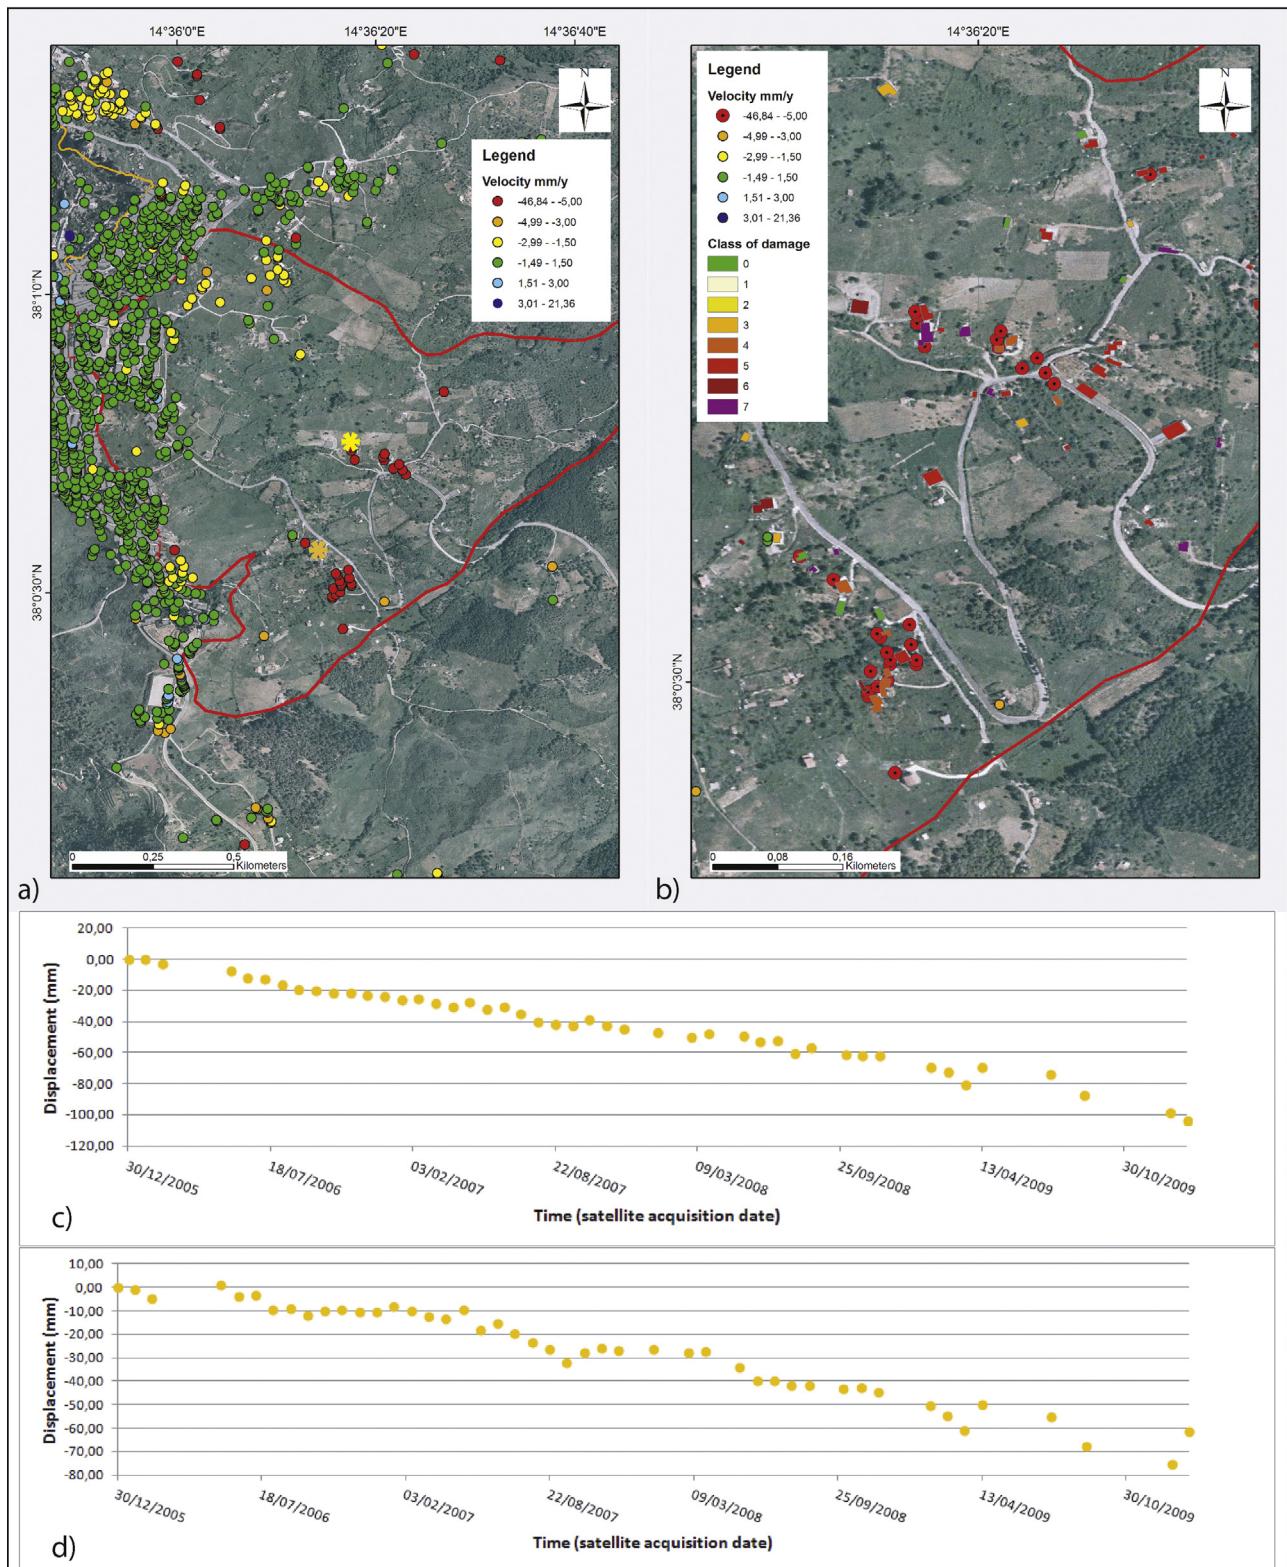
Fig. 8. (a) RADARSAT-1 ascending PS dataset; (b) comparison between the ground deformation velocity map and the damage assessment map; (c) time series correspondent to the yellow asterisk; (d) time series correspondent to the orange asterisk.

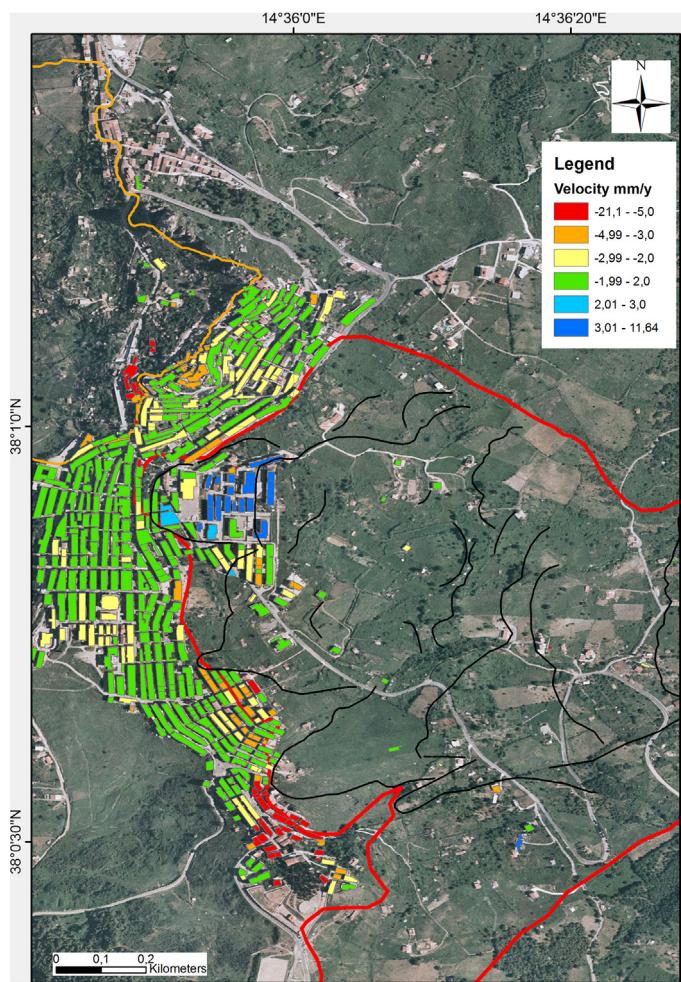
Fig. 9. Building deformation velocity map using both ascending and descending COSMO-SkyMed datasets. The black lines correspond to the secondary scarps developed during the 2010 landslide.

CSK images were acquired after the 2010 landslide, thus they can be useful to evaluate possible post-event ground deformation phenomena. The available data were acquired only in descending orbit, making them suitable especially to study the deformation of the western slope. Anyway, the high density of the PS allowed to retrieve also interesting information about the eastern slope deformation. The stability range for CSK data was increased to ± 2 mm/y because of the higher average standard deviation of PS velocity, if compared to those of the C-band data. The increase of the standard deviation is related to the short acquisition period (only one year) and to the location of San Fratello, which turns out to be far from the reference point and at the boundary of the used SAR images. In this case, the building deformation velocity map permits to recognize three different areas (Fig. 9), along the 2010 landslide crown, where several buildings are affected by a considerable deformation. These areas correspond, from north to south, to the Stazzone, Riana and San Benedetto quarters, which were intensely damaged during the event. The difference in colors between the Stazzone and San Benedetto quarters, that represent different displacement direction, is related to the different position of the areas within the 2010 landslide. Buildings that are moving toward the satellite characterize Stazzone quarter, whereas in San Benedetto the edifices are moving away with respect to the sensor. The first ones are located inside the landslide body, whereas the second ones are placed along the landslide crown.

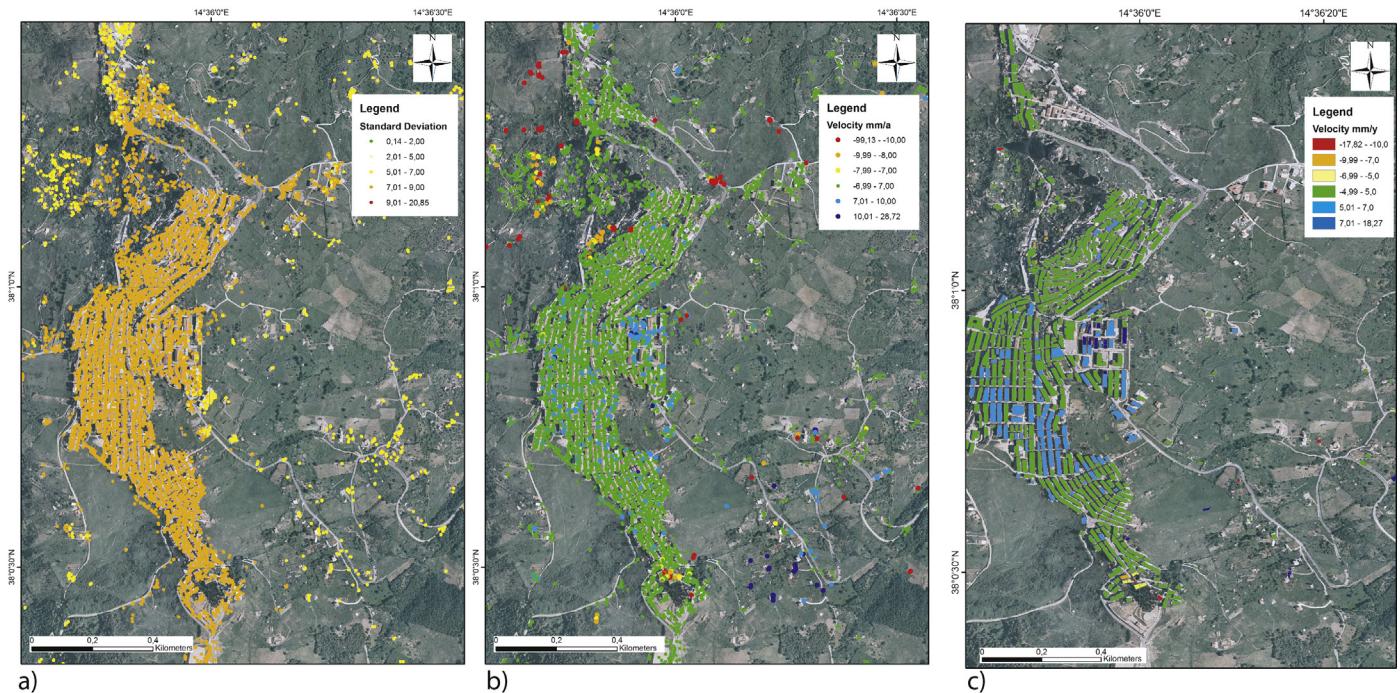
Fig. 10. Standard deviation (a), ground deformation velocity map with $\pm 7 \text{ mm/y}$ stability range (b) and building deformation velocity map with $\pm 5 \text{ mm/y}$ stability range (c) using the descending TerraSAR-X dataset.

The available TSX data were acquired between October 2011 and December 2012. Part of the acquisition period is overlapped with that of the CSK data. This dataset is affected by a very high standard deviation, especially in correspondence of San Fratello town area, where the average standard deviation is 7.6 (Fig. 10a and b). These high values depend on several factors (e.g. the choice of the reference point, the short acquisition period, the topographic factor and the position of the area, located close to the boundary of the SAR images). For these reasons, TSX data could not be used to calculate the building deformation velocities. However, some consideration about the ground deformation can be made considering as not moving the areas resulting stable from CSK. A differential analysis can be useful to highlight areas affected by ground deformation. In this case, the applied stability threshold was selected between $\pm 7 \text{ mm/y}$, considering the standard deviation. Results suggest that almost three areas of the town are affected by ground deformation:

the northern one is located along the crown of the 1922 landslide, the second one is represented by part of the Stazzone quarter and the southern one corresponds to the San Benedetto quarter (Fig. 10c). Ground displacements highlighted by TSX confirm the results obtained using CSK but, considering the standard deviation, the evaluation of the ground deformation velocities can be made only with the last one.

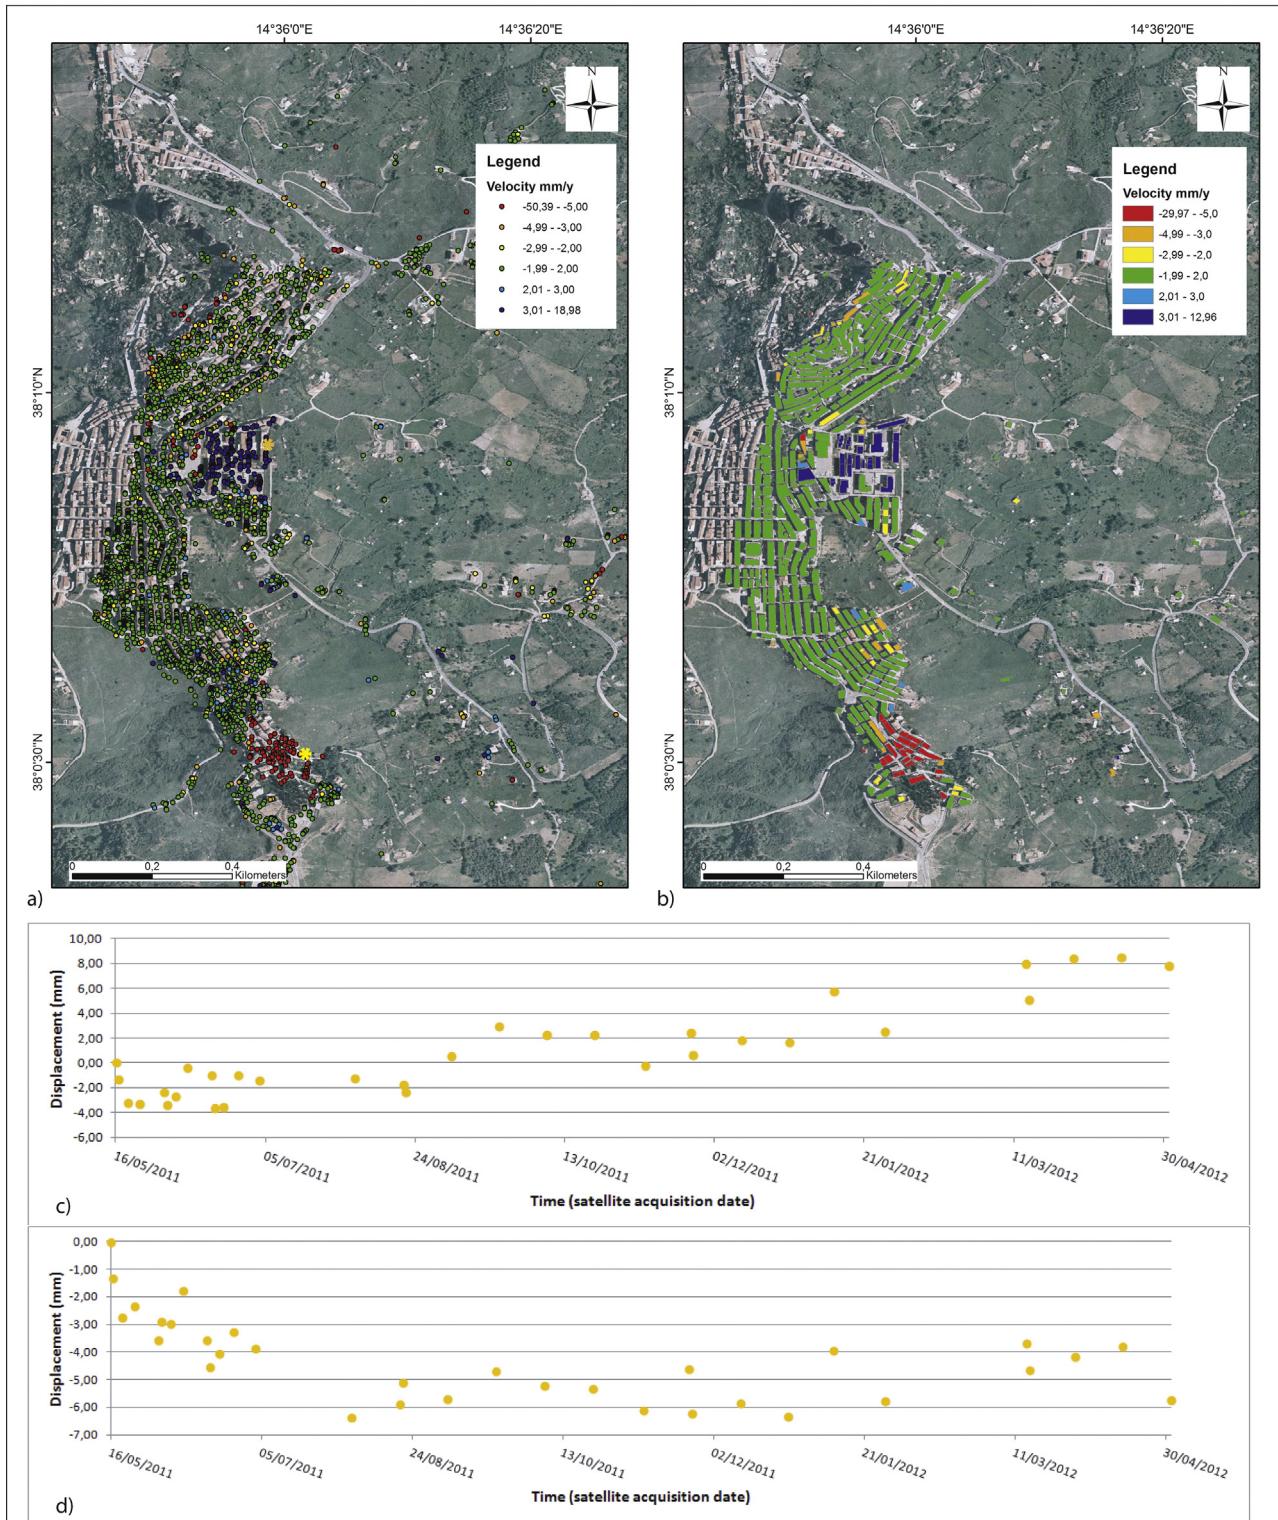
Fig. 11. (a) CSK ground deformation velocity map; (b) building deformation velocity map obtained by using CSK data; (c) time series correspondent to the orange asterisk and (d) time series correspondent to the yellow asterisk.

Considering the interesting results highlighted by X-band sensors, the TSX and CSK datasets were reprocessed, choosing a different reference point, in order to minimize the standard deviations. The new reference points were located inside San Fratello, in correspondence of buildings considered stable. This procedure allowed a more accurate measurement of building deformations velocities. During the reprocessing of the CSK data, several PS, located in the western part of the town were lost, but the building deformation velocity map clearly shows that Stazzone and San Benedetto quarters are affected by important deformations (Fig. 11). In addition the reprocessed TSX data (Fig. 12) confirmed that these two areas are subjected to ground deformations, especially San Benedetto where the extent, the geometry of the deformations and the average velocities are comparable to the CSK data. TSX data can be useful also to observe the deformations located along the western slope, where several buildings show high velocities.

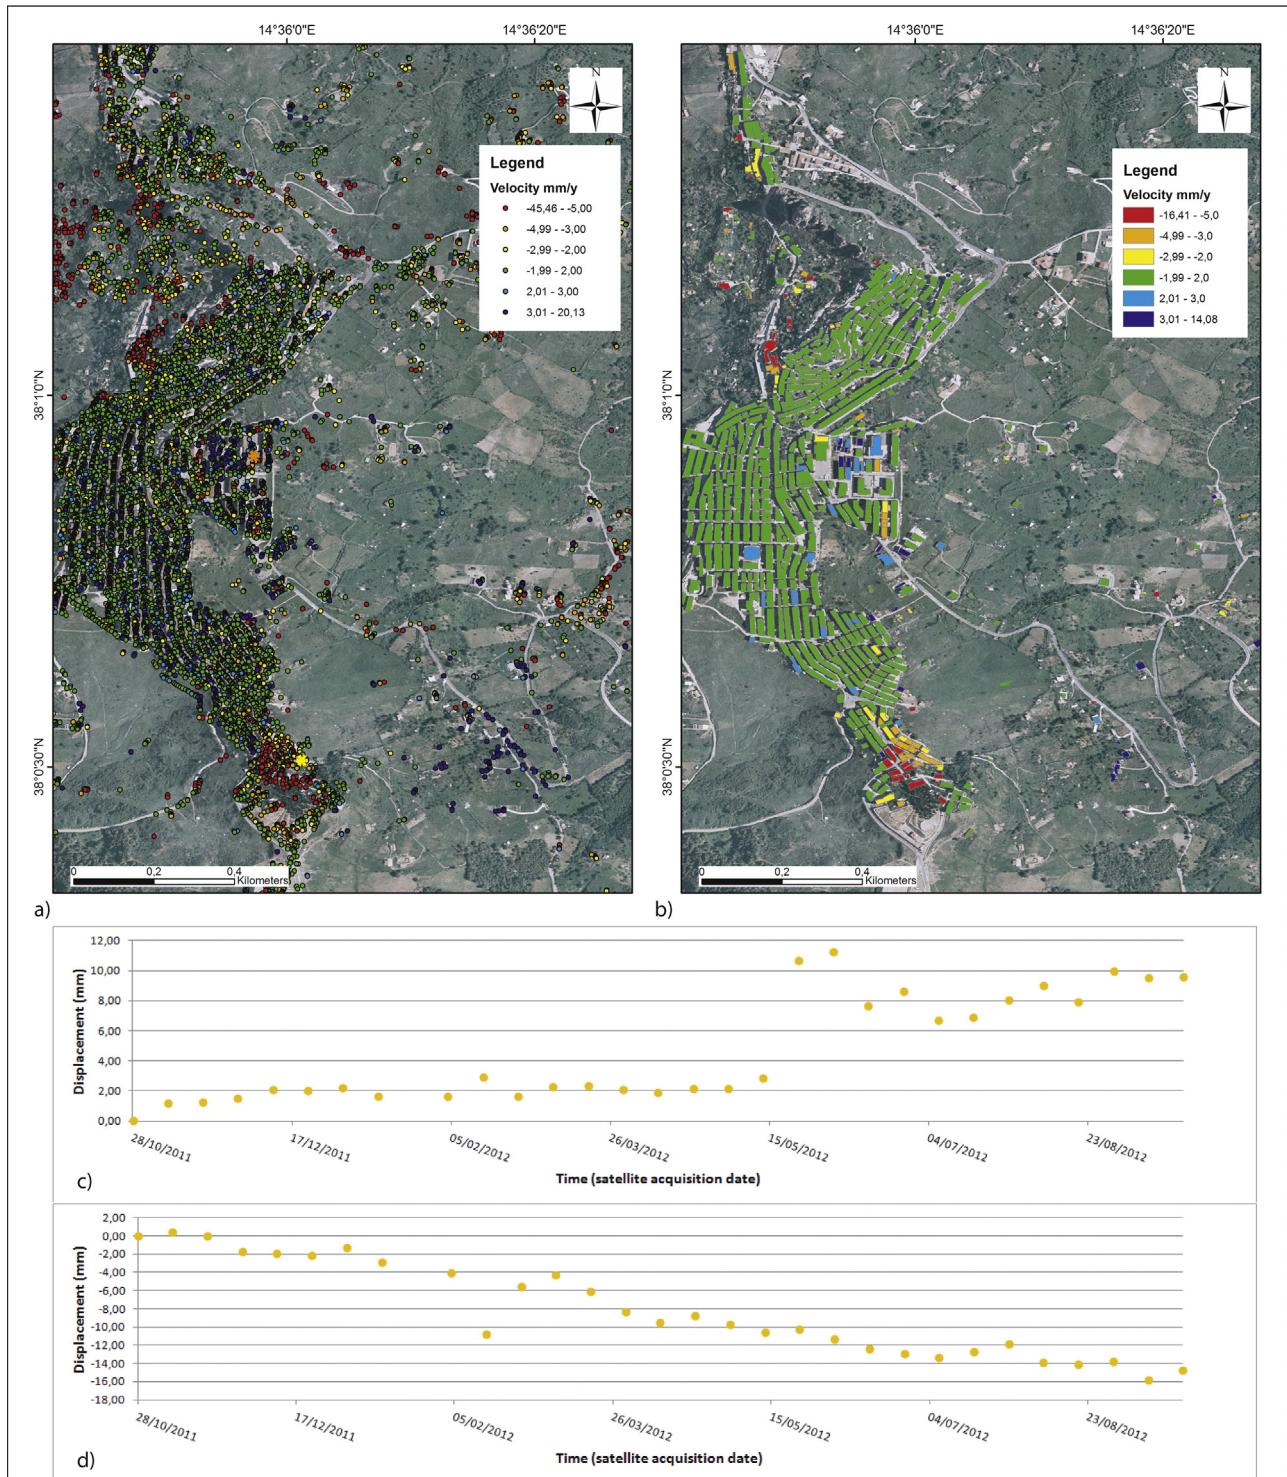
Fig. 12. (a) TSX ground deformation velocity map; (b) building deformation velocity map obtained by using TSX data; (c) time series correspondent to the orange asterisk and (d) time series correspondent to the yellow asterisk.

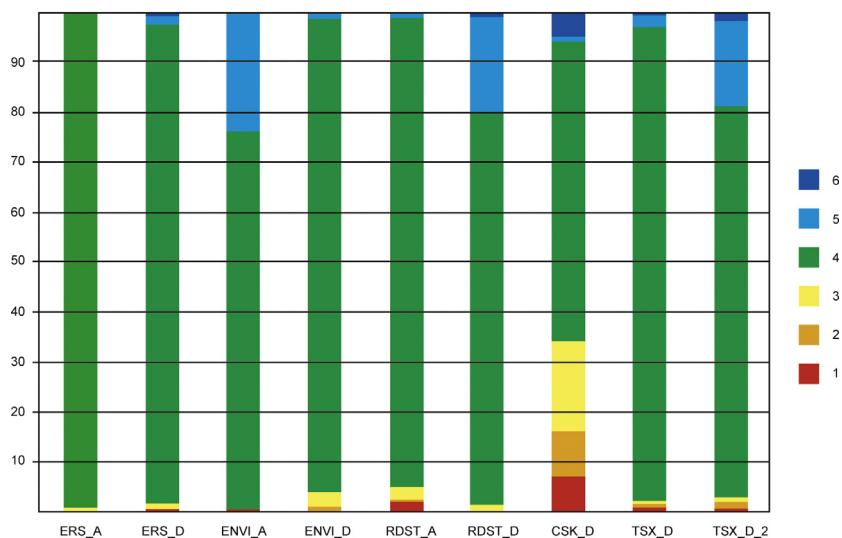
Fig. 13. Percentages of buildings monitored with the available sensors considering the used velocity (in mm/y) classification described in the previous paragraphs. For C-band sensors: class 1: <−5; class 2: −4.99 to −3.00; class 3: −2.99 to −1.5; class 4: −1.49 to 1.5; class 5: 1.51–3.00; class 6: >3. For CSK: class 1: <−5; class 2: −4.99 to −3.00; class 3: −2.99 to −2.0; class 4: −1.99 to 2.0; class 5: 2.01–3.00; class 6: >3. For TSX.D: class 1: <−10; class 2: −9.99 to −8.00; class 3: −7.99 to −7.0; class 4: −6.99 to 7.0; class 5: 7.01–9.00; class 6: >9; for TSX.D_2: class 1: <−10; class 2: −9.99 to −7.00; class 3: −6.99 to −5.0; class 4: −4.99–5.0; class 5: 5.01–7.00; class 6: >7.

indicate a substantial stability of the town (Fig. 13). In particular, up to the 96% of the monitored buildings with ERS 1/2 are characterized by velocities included within the stability range. Despite of the low number of monitored edifices, the ground deformation velocity maps for the eastern slope also confirm these results: no significant deformations were observed. The number of buildings affected by higher deformation velocities increases considering ENVISAT and RADARSAT-1. This increase can be related to the higher PS density. The ground deformation velocity maps obtained using ENVISAT and RADARSAT-1 suggest that the area corresponding to the 2010 landslide body was affected by ground deformation. Thanks to the higher PS density of RADARSAT-1, the instability can be also appreciated in the related building deformation velocity map. The number of buildings affected by deformation increases sensibly considering the X-band sensors, especially with regards to CSK, which highlights that only 60% of the monitored buildings are
