The Church of Meryem Ana in Göreme, Cappadocia

Correct documentation for a meaningful heritage at risk

Maria ANDALORO¹ | Tatiana PIGNATALE² | Giorgio VERDIANI²

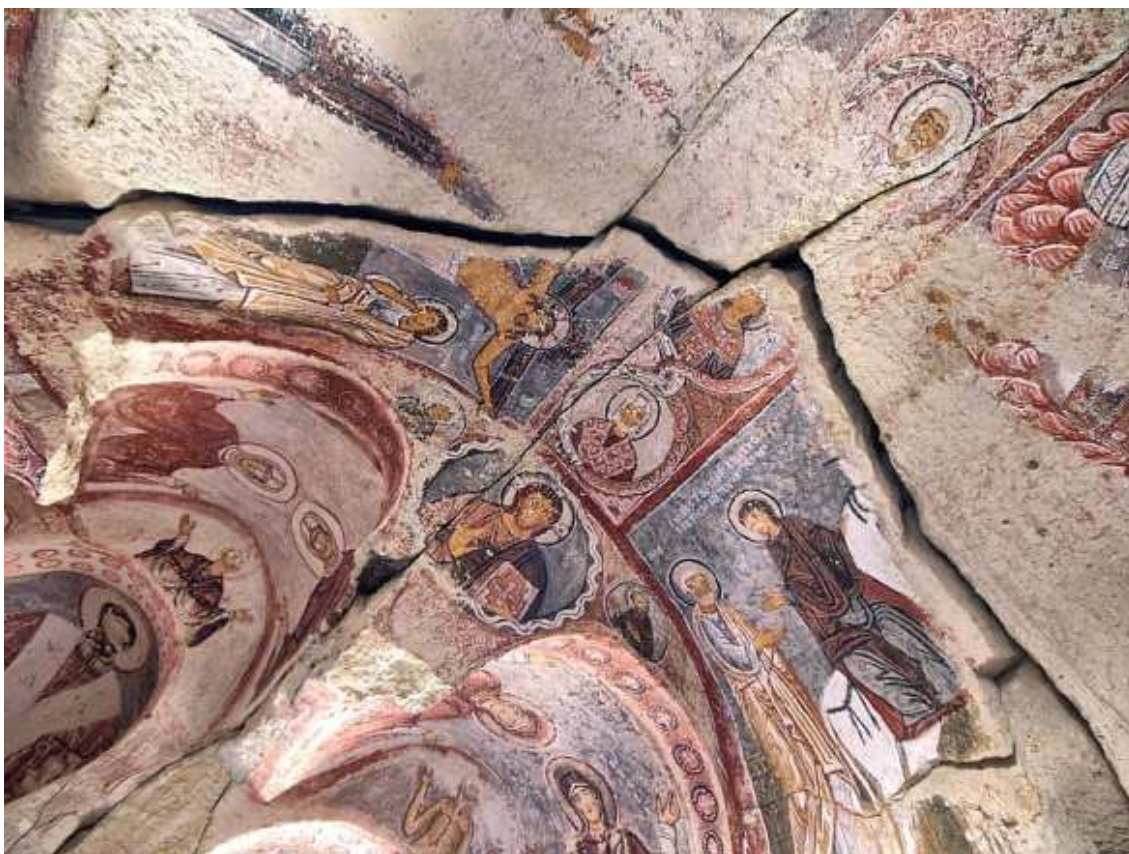
Fig. 2 – The great crack passing all over the vaults

The Meryemana church, commonly defined as Göreme 33, is carved, together with a small monastic complex, in an emerging peak overlooking the valley of Kiliçlar – the Turkish name means the “valley of the swords”- from a 25 meters of high over the area where the valley becomes narrow. Here the fertile area rich of cultivations leaves the space to hard stones and high natural walls, where a feeble river has sculpted this valley. The path to reach the church is not easy, the only available passage crosses some rupestrian rooms with ruined fronts, where the visitor sometimes has to pass crawling on his knees because of the small size of the openings, and then reaches the plan space containing the entrance of the Church. Commonly the passage is not open to the public; a small gate closes one of the narrow openings leaving no possibility to continue the visit. The rooms giving the access to the church were separated by numerous rooms connected one another, and there are still the remains of a millstone door. Arrived at the entrance it is possible to notice that it is characterized by the typical horseshoe arch, which was once enriched with wall paintings. The paints are mainly dedicated to the narration of the life of St. Mary and all the biblical events connected to her figure. The architectural typology of the church is different from the other monuments of the area for the presence of a transverse nave blanket of two barrel vaults of different sizes, without support in between. The sequence of spaces shows clearly the complex development of the church across time, with some quite aggressive intervention, like the connection with the room of the tombs which has altered and destroyed a part of the original mural paints. The whole space is dimensioned in small proportions, but it has a very impressive effect on the visitor (fig. 1), the rich colours, the articulated shapes, the sequence of levels and a certain “sense of drama” capture the eyes and generate a strong sense of admiration. The bema is elevated on three steps, and it was originally separated through a carved iconostasis with six arches and five columns, but two columns get lost and so the large missing part creates an asymmetric perception of the church emphasizing the value of the remains. Besides this partially fallen and destroyed colonnade there are a cross-corridor and apses. Only two of the three original apses are preserved, the one on the South side is almost completely disappeared and a large opening toward the valley allows an impressive view toward the opposite peaks. Beneath the right part of the bema, there are other two main rooms excavated down the peak, they are structured one over the other, probably they were carved in different phases and were connected with wooden staircases which now is lost. For this reason the two lower rooms are accessible only “jumping” down, but they are not that tall and they can be easily accessed. The real risk is due to the fact that all the bema and its lower rooms are beyond the crack dividing the church in two parts, the whole crack develops all along the vaults and the vertical walls, and interests the pavement too (fig. 2). Only a

length of half a meter separates the two extremes of the crack on the floor. So any walk done on this side can be considered dangerous for the structure as well for a visitor.

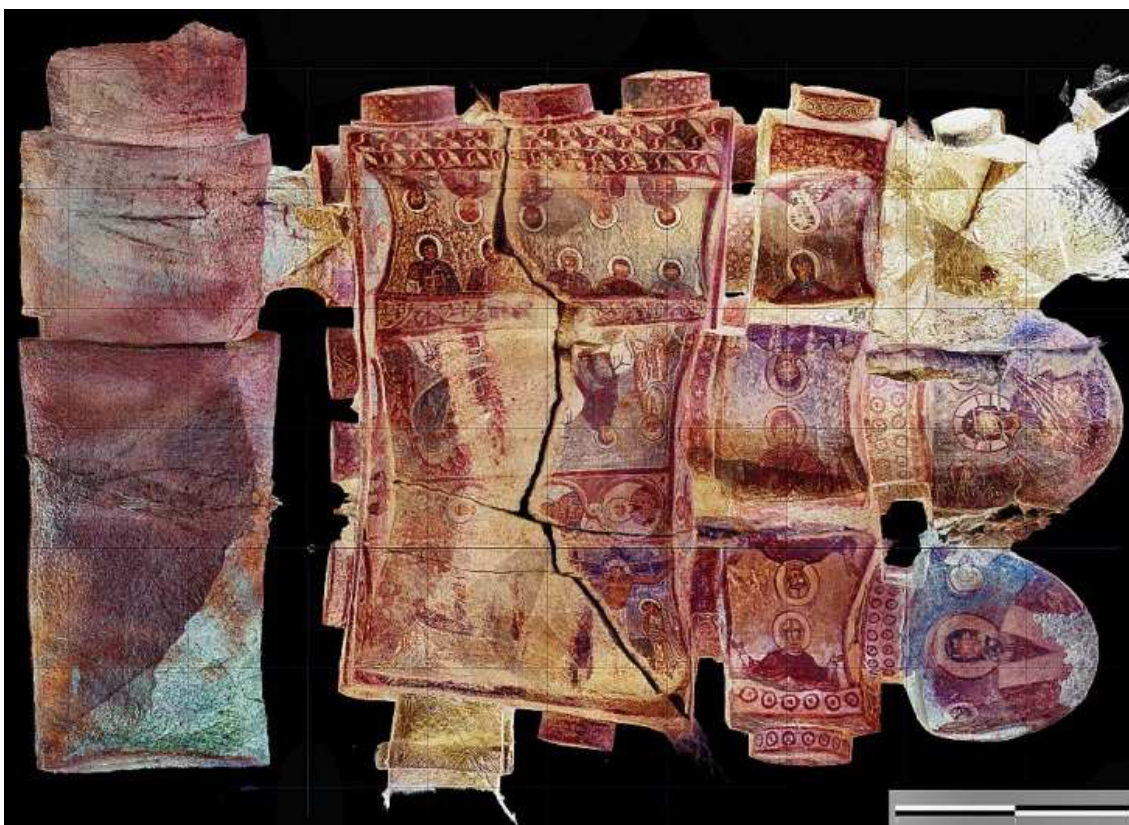
Fig. 3 – Horizontal section toward the vaults of the Meryemana Church (reference scale in meters)
