**EXPERIMENTAL INVESTIGATION ON THE DURABILITY OF FIBRE REINFORCED
CEMENTITIOUS MATERIALS FOR STRENGTHENING OF MASONRY**

Dissertation

Daniela Sinicropi

2015

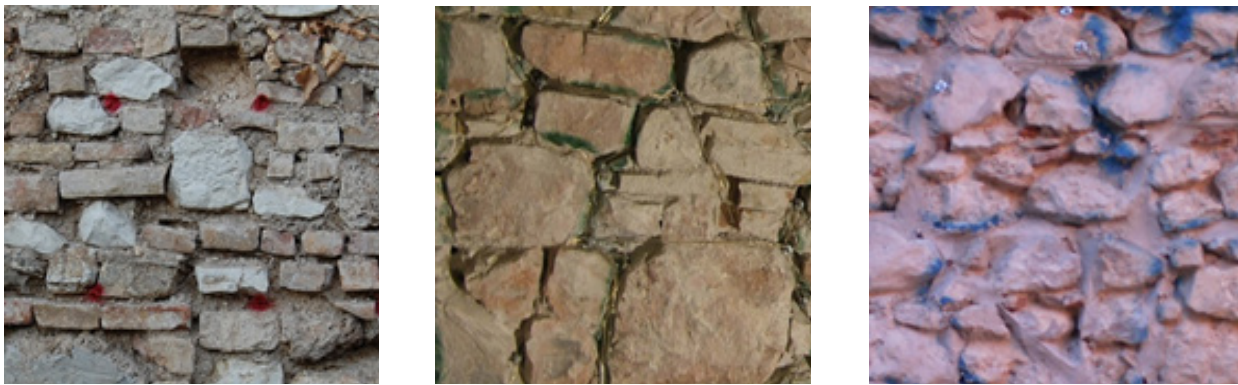
Figures 1.3.5-7. From left to right, masonry from the panels tested in Pale, Foligno and L'Aquila. Image taken from Borri et al. (2010).

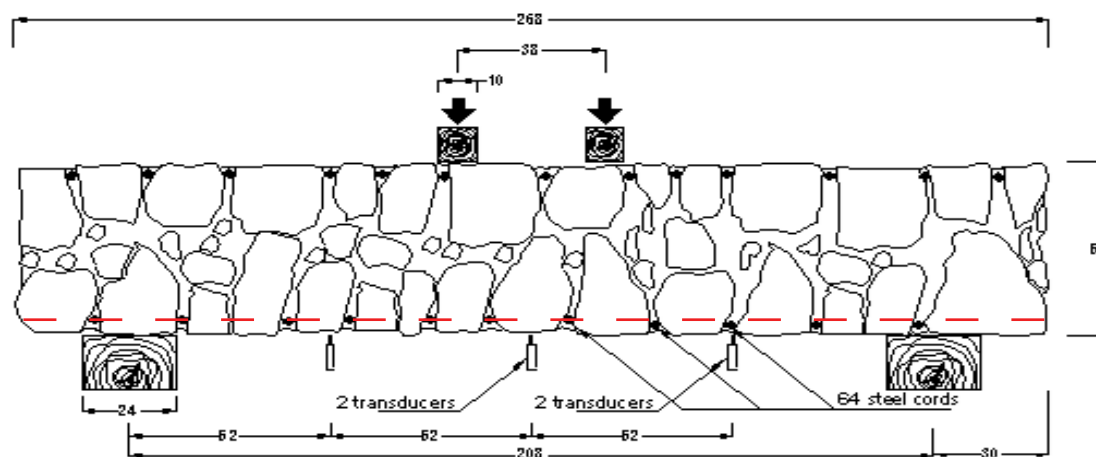
Figure 1.3.11. Set up of Panel 1 for flexural testing. The red line indicates the horizontal steel cords imbedded in the masonry which contrast flexural strength. Image taken from Borri et al. (2010b). Dimensions in cm

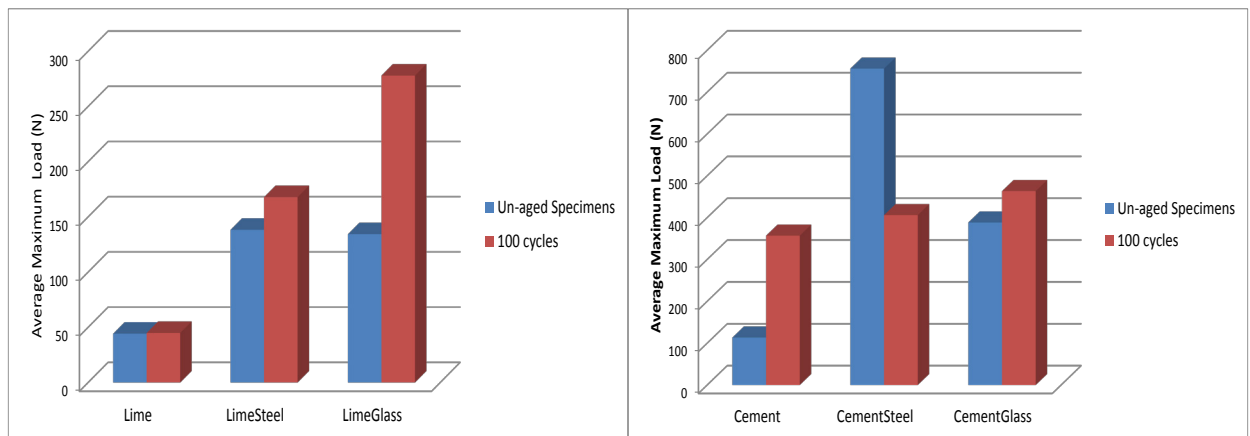
Figures 3.1.8-9. Values for lime and cement mortar specimens when subjected to ageing cycles after a curing period of only 28 days.

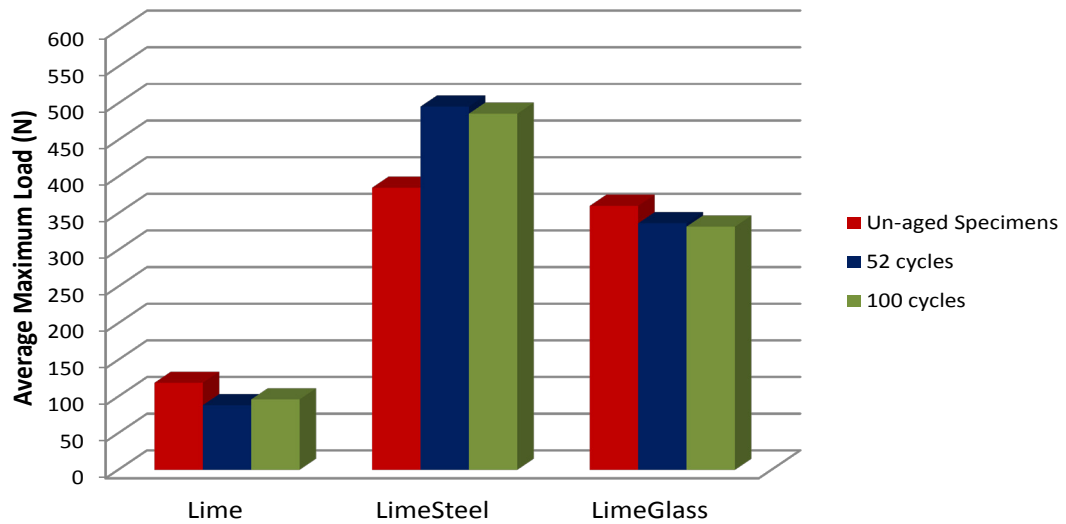
Figure 3.1.12. Average Maximum load of lime mortar specimens, unreinforced, steel reinforced and glass reinforced, subjected to thermal cycles.

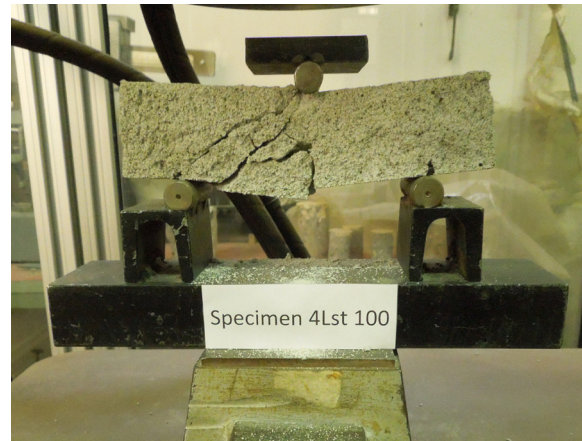
Figures 3.1.13-14. Lime mortar specimens reinforced with steel fibre subjected to 52 and 100 freeze/thaw cycles: mixed failure mechanism.

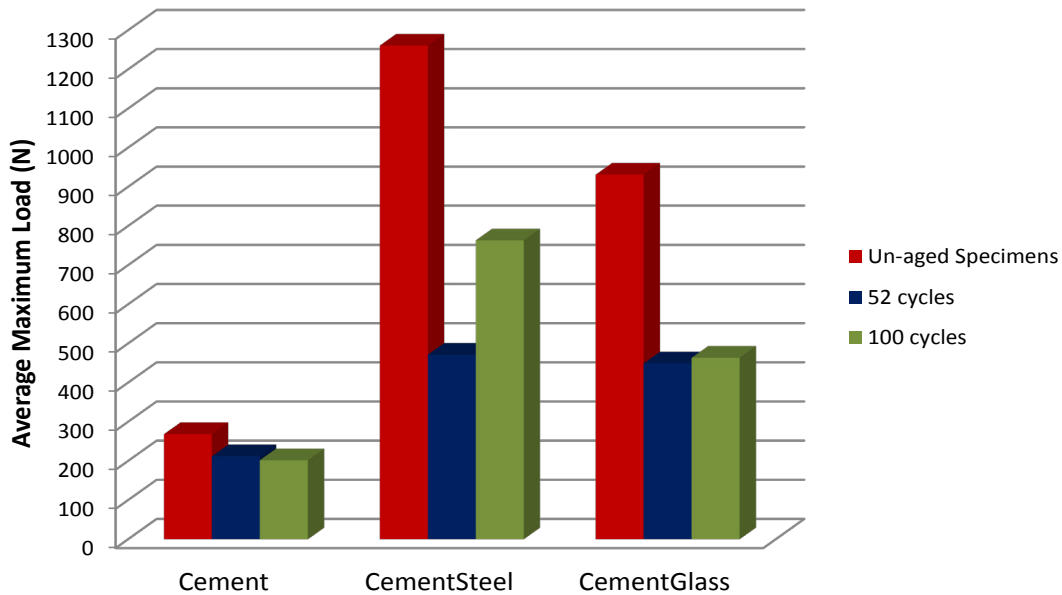
Figure 3.1.15. Average maximum loads for cement mortar specimens, unreinforced, steel reinforced and glass reinforced, subjected to thermal cycles.

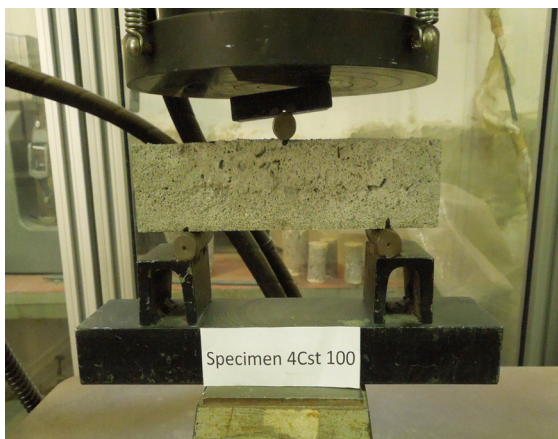
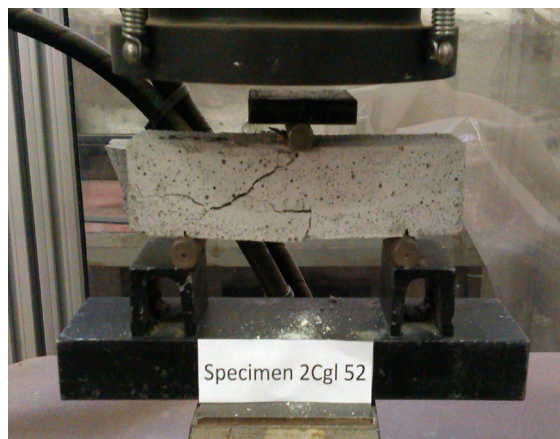
Figures 3.1.16-17. Mixed failure mechanism of steel and glass reinforced cement mortar specimens.

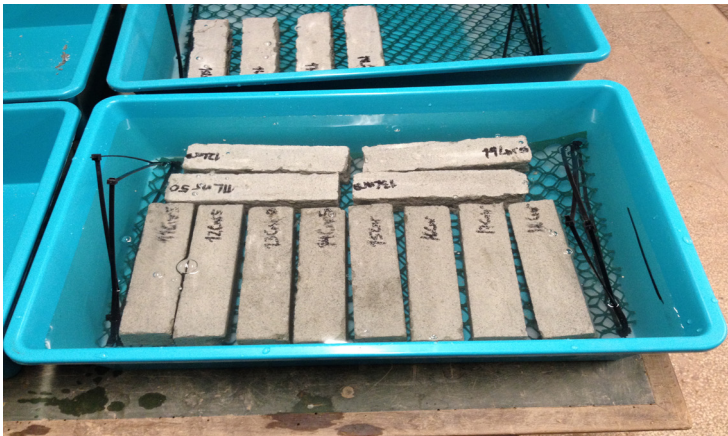
Figure 3.2.1. Mortar specimens during the wet portion of durability cycles in plastic basins filled with 5% sodium chloride solution specimens.

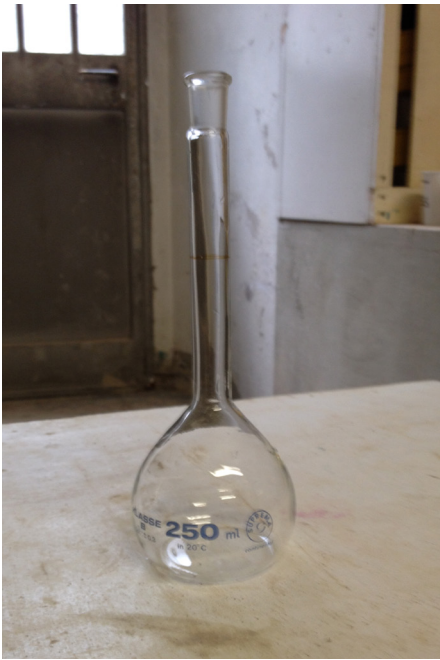
Figure 3.2.3. Flask used for determining weight difference prior to and after wet cycles.

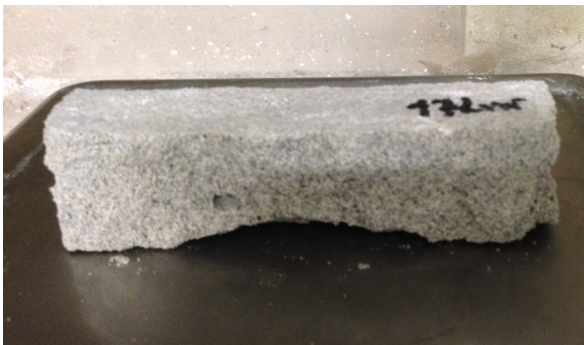
Figure 3.2.4. Evident loss of section after less than 10 cycles in an unreinforced lime specimen.

The loss of section in the cement mortar prisms is much less noticeable, varying from a range of 2% to 5%, whereas the section variation in the MX mortar specimens is virtually non-existent.

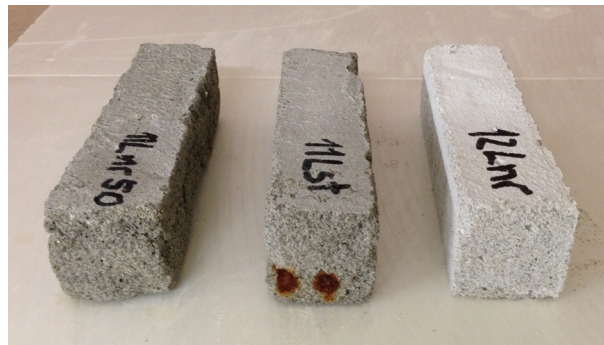
Figure 3.2.5. Discoloration of lime mortar specimens. In the middle specimen the rust of the steel fibres is evident.

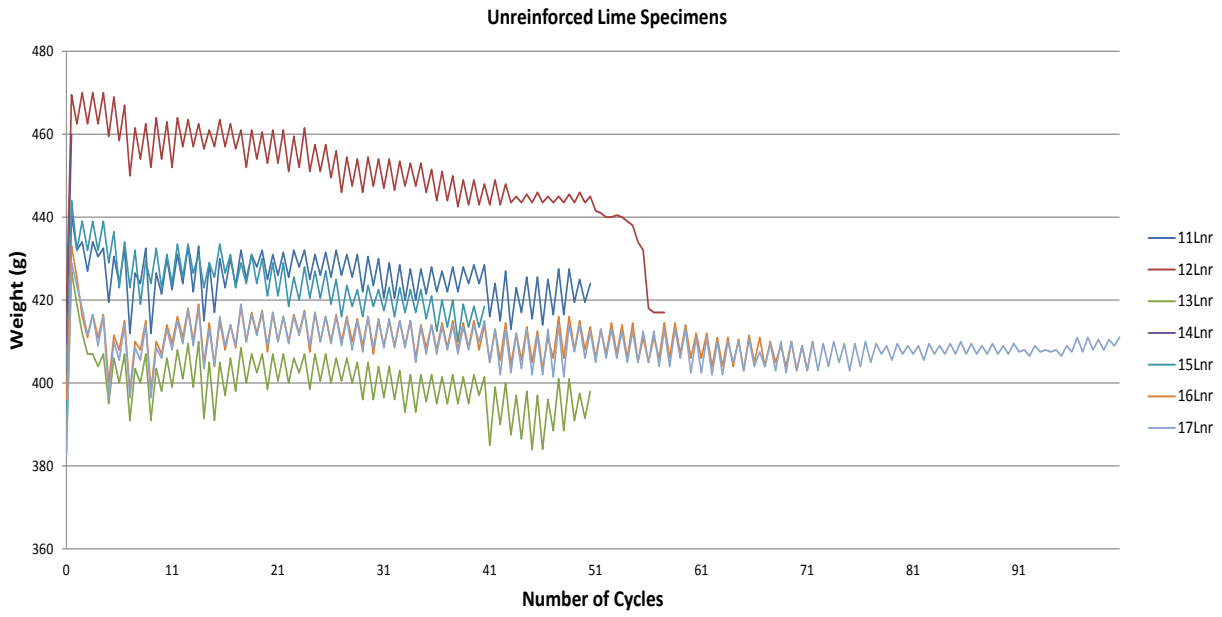
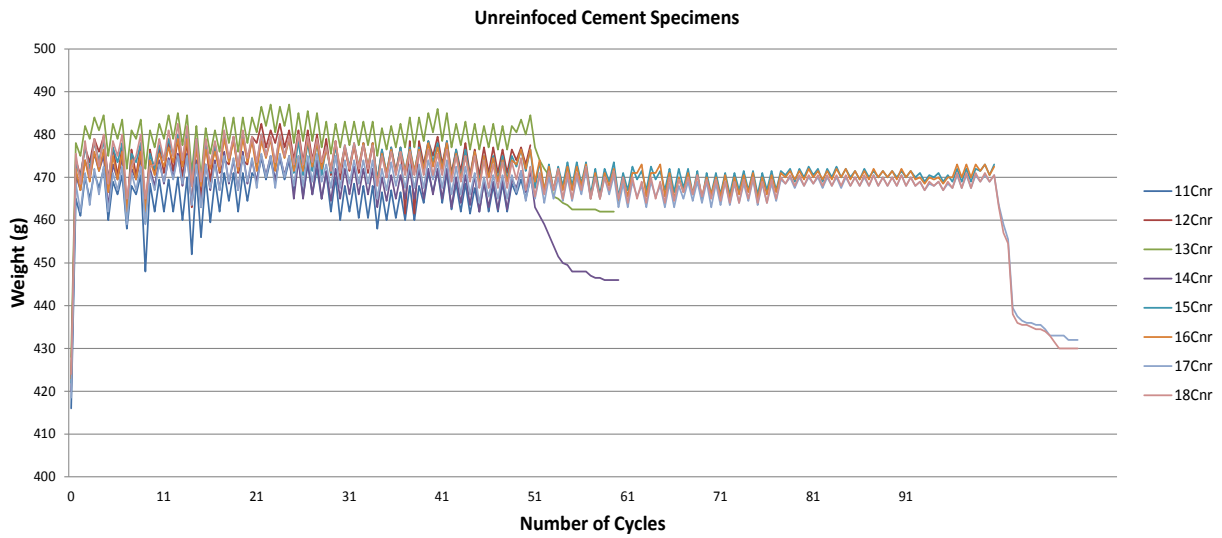
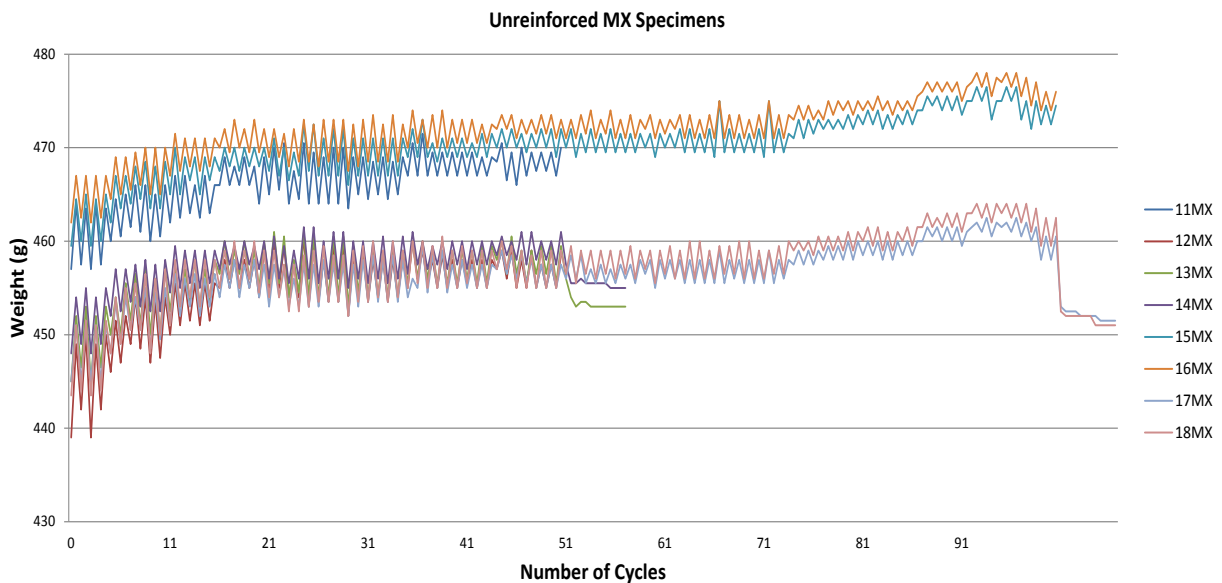
Figures 3.2.6-8. Unreinforced mortar specimens: weight variation.

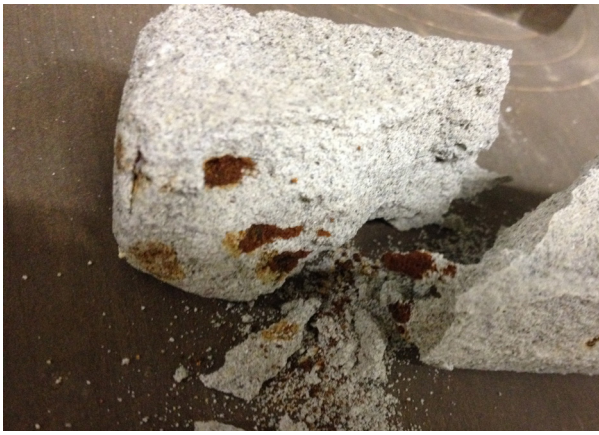
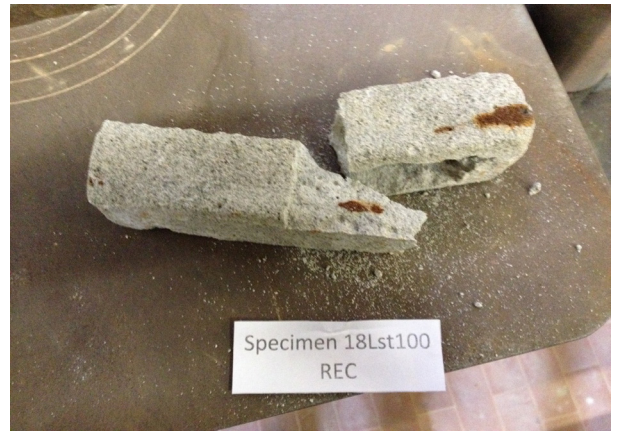
Figures 3.2.9-10. Total erosion of steel fibre in specimens 17Lst100_REC and 18Lst100_REC subjected to 100 wet/dry cycles.

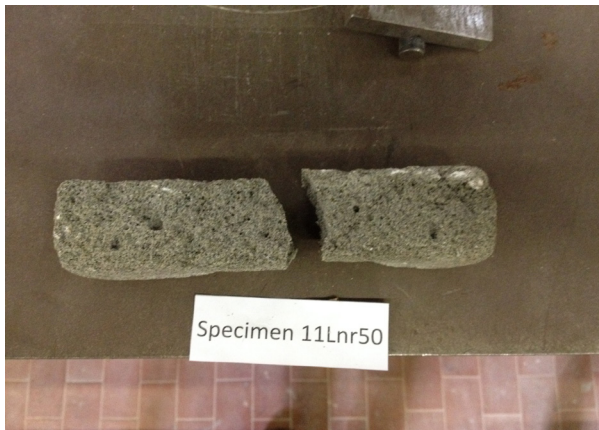
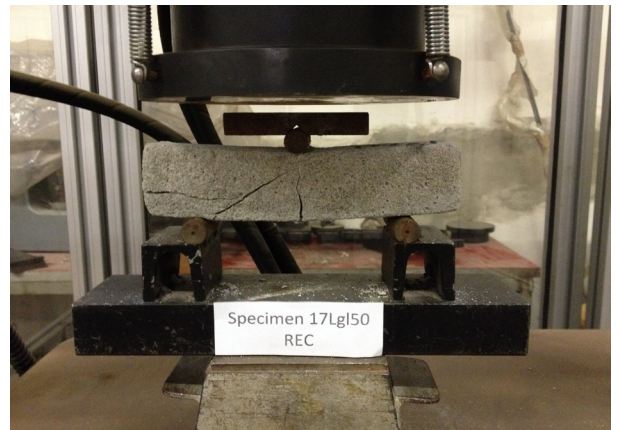
Figures 3.2.11-12. Unreinforced specimens with evident efflorescence and flexural collapse and glass reinforced specimen with mixed collapse mechanism.

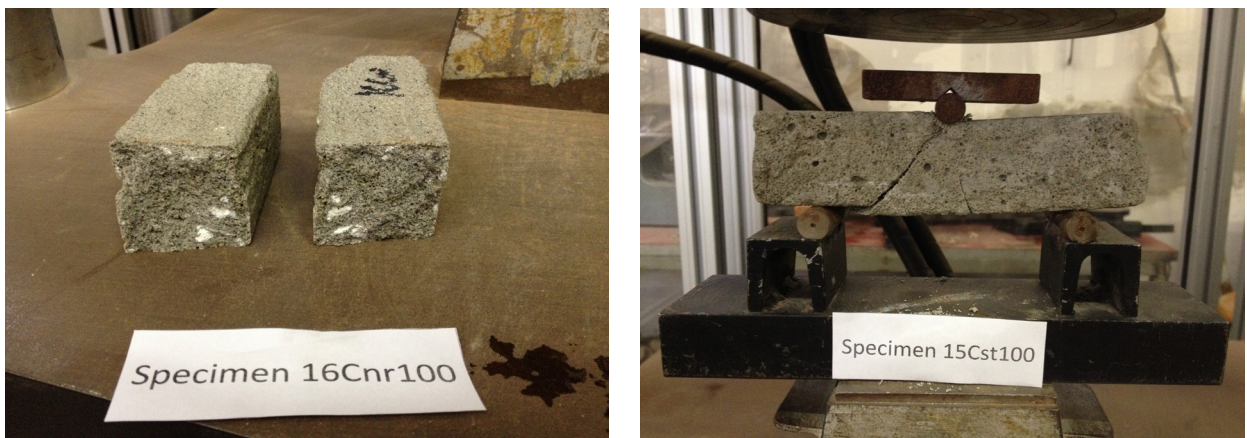
Figures 3.2.16-17. Unreinforced specimen with evident efflorescence and flexural collapse and steel reinforced specimen with mixed collapse mechanism.

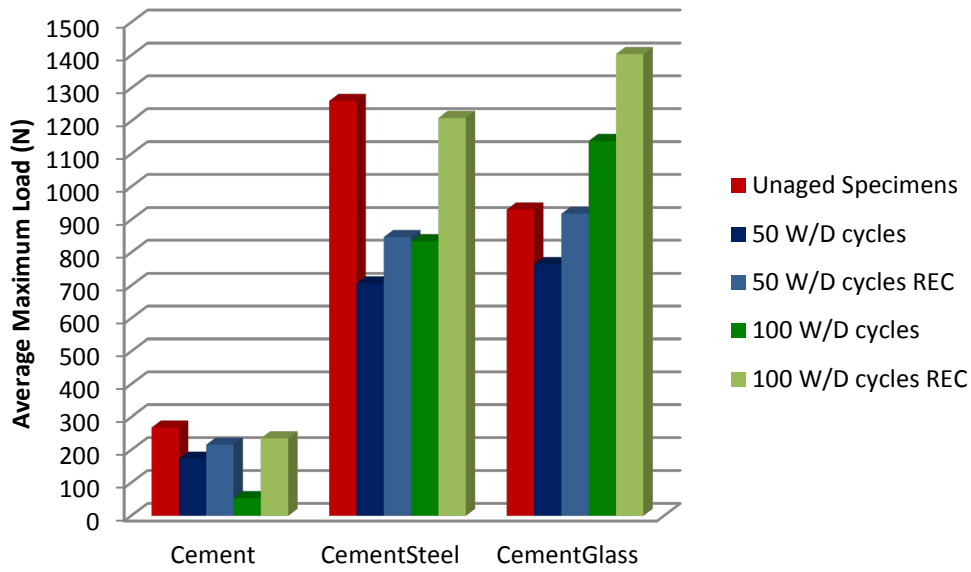
Figure 3.2.18. Average failure loads for cement mortar specimens subjected to none, 50 and 100 wet/dry cycles and relative recovery specimens.

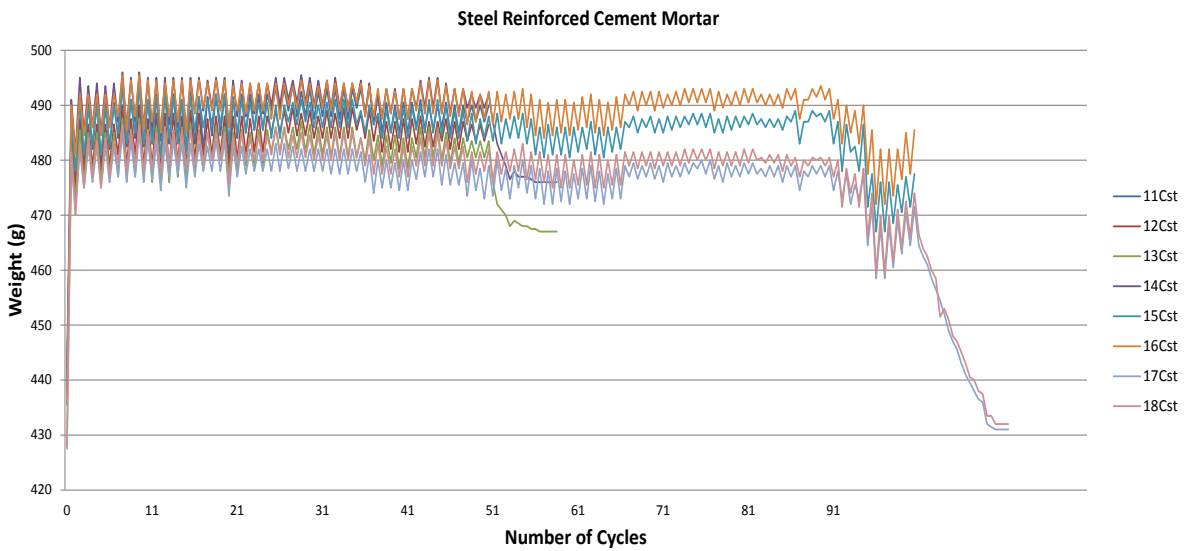
Figures 3.2.19-20. Steel and glass reinforced cement mortar specimens: weight variation.

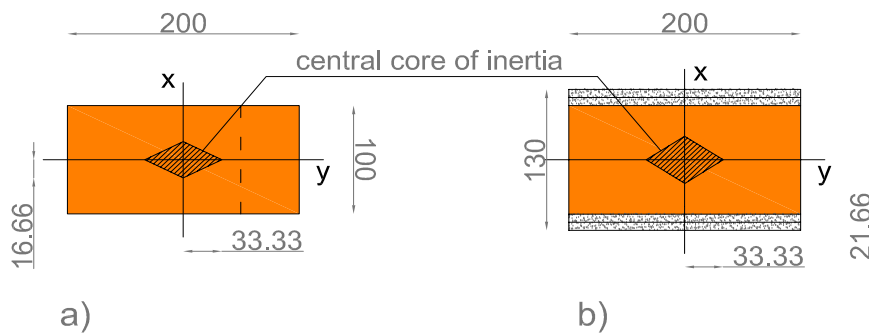
Figure 3.3.6. Graphic scheme of the pilasters (mm), plan and central core of inertia for a) unreinforced specimens and b) reinforced specimens.

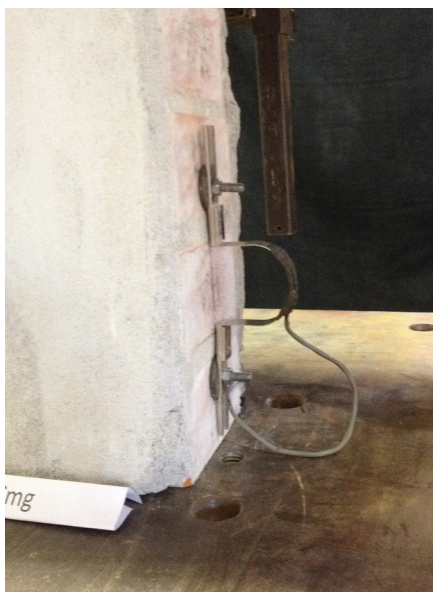
Figure 3.3.10. Mechanical strain gauge.

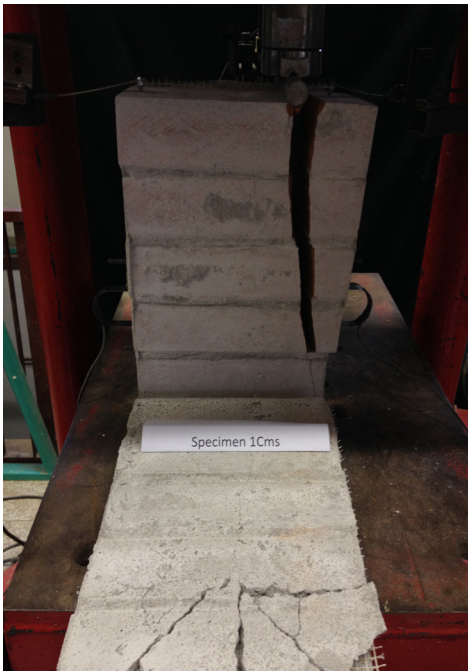
Figure 3.3.11. Steel-fibre Cement-matrix Specimen 1 after testing; the fibre reinforcement has completely detached.

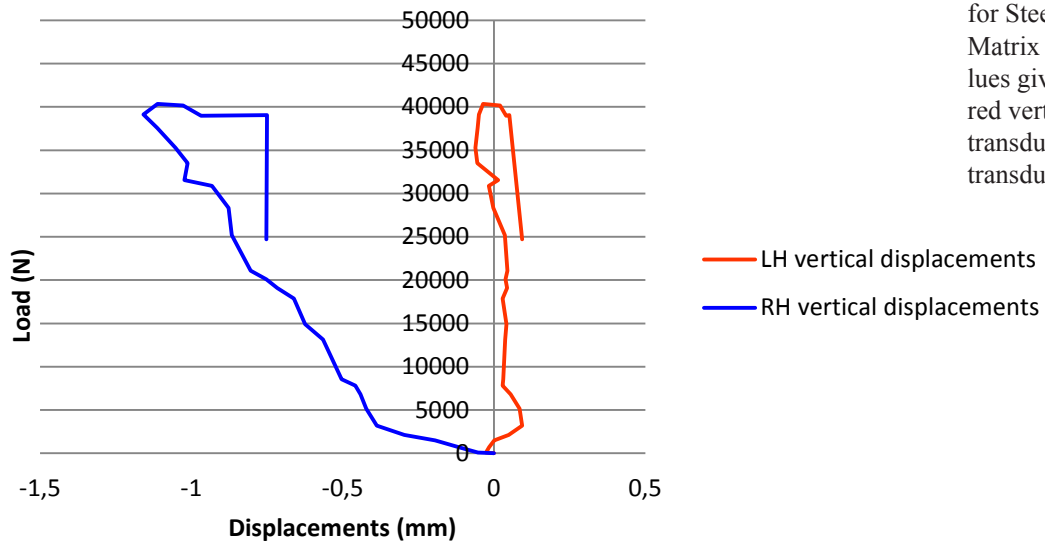
Figures 3.3.25-26. Load - displacement diagrams for Steel Fibre - Lime Matrix Specimen 2; values given by cantilevered vertical displacement transducers and Omega transducers.

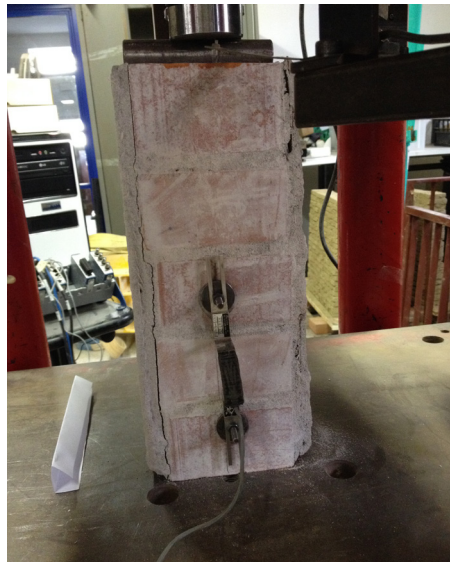
Figures 3.3.28-29. Steel Fibre - Lime Matrix Specimens 1 and 2 prior to fibre detachment.

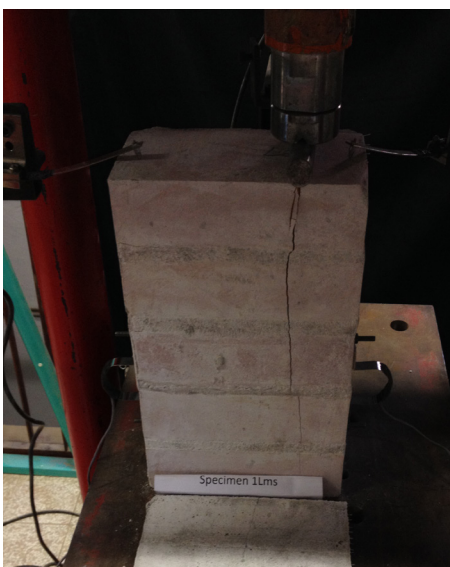
Figures 3.3.30-31. Steel Fibre - Lime Matrix Specimens 1 and 2 after testing.
