Article

Features Analysis of Dry Stone Walls of Tuscany (Italy)

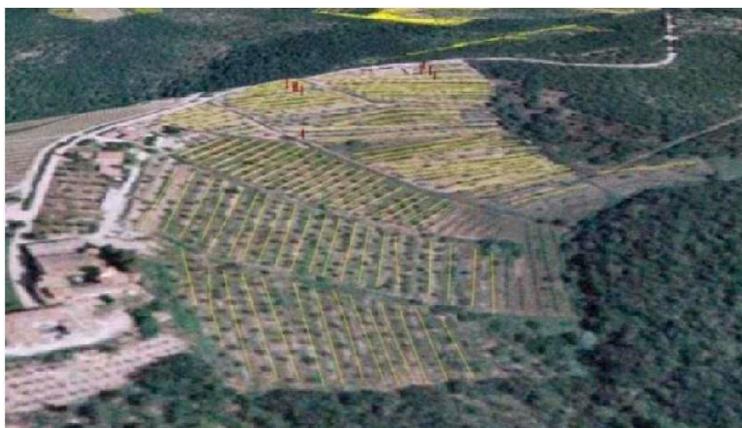
Figure 6. 3D processing with parallel continuous arrangement of the terraces.

The arrangement of the terraces was conceived as a spatial distribution connected with a geometrical or non-geometrical order. In the literature, the geometrical arrangement is defined as: parallel continuous, parallel zigzag and non-parallel. From this study, it emerged that the terraces have a parallel continuous arrangement (86%), sometimes interrupted by ditch or by horizontal or vertical connection elements such as agricultural roads, steps or ramps (Figure 6); a distribution of a non-parallel geometric type was found only in the area (17).

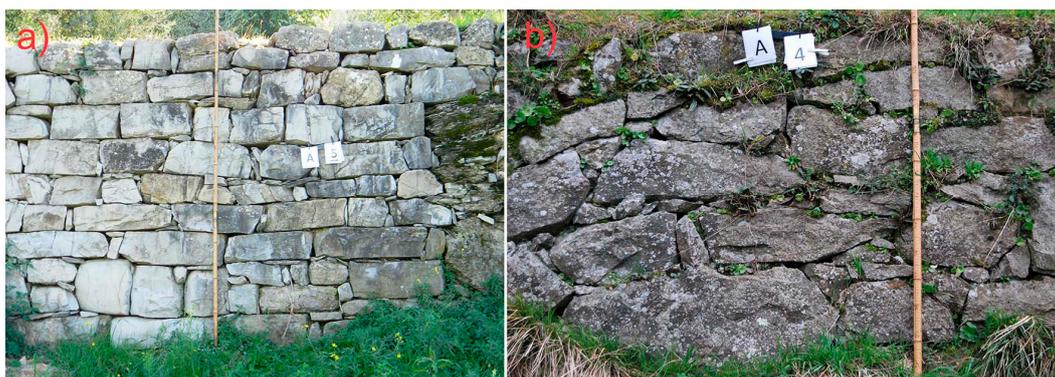
Figure 7. (a) Parallel continuous geometrical type arranged in the form of *Opus polygonale* in area (14); (b) Parallel continuous geometrical type arranged in the form of *Opus incerta* in area (13).

The most common arrangements of the stone material can be referred to the geometries of *Opus polygonale* and *Opus incerta* (Figure 7), with only slightly worked stones arranged in such a way as to be placed as close as possible to each other. Two stone terrace walls displaying *filaretto*, with intensively worked stones, were also identified in the terraced agricultural areas (4) and (6); on the other hand, in the area (18), the dry stone walls are made using rounded pieces of limestone that are hardly worked at all.

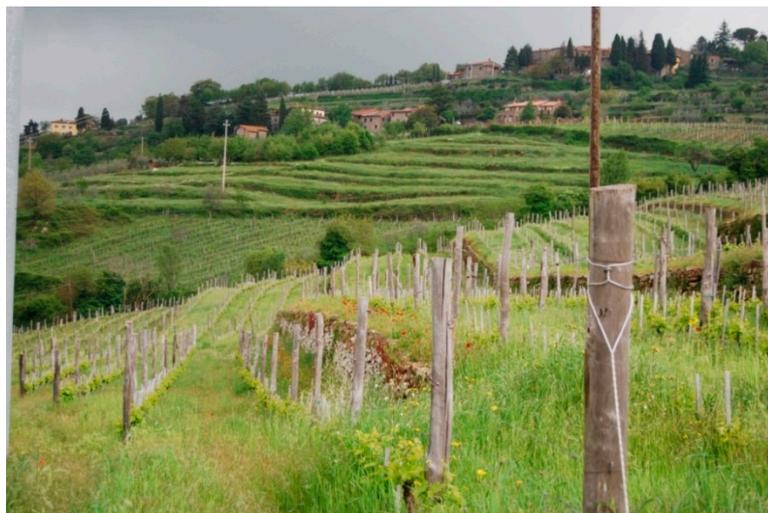
Figure 8. Implantation of new vineyards designed for mechanised viticulture on traditional terraced systems.

Regarding the type of access to the areas, these can be identified as farm tracks arranged sideways or centrally to the terraced system. The continuing existence of country roads allows farm vehicles to access all the areas except for site (6), (10), (11), (13) and (17), which are accessible only by foot. At present, the mechanisation of the terraced areas seems to be an important requisite for the design of new implantations (e.g., the vineyards of area (5)), in order to optimise production without jeopardising the typical elements of the historic agricultural terraced landscape (Figure 8).

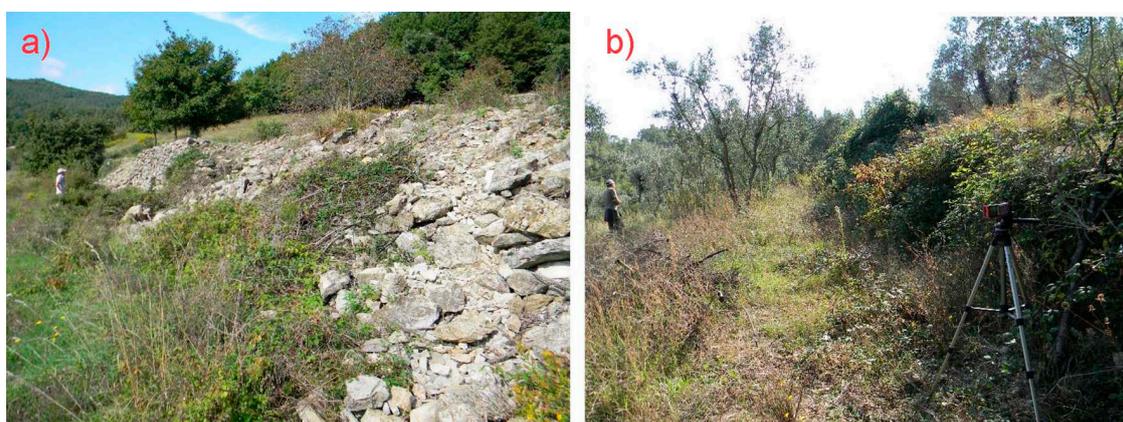
Figure 9. (a) Clear signs of functional abandon of the dry stone walls shown by collapses in area (15); (b) Presence of shrub colonization in area (3).

The overall analysis of the sample areas has allowed to make certain observations regarding the state of conservation of the dry stone walls, recording in all the areas localised structural alterations (small and medium landslides) of the construction system (Figure 9). In such areas the types of instability can be related to phenomena of collapse and/or warping, due to abandonment of the farming activities and consequently to the lack of ordinary maintenance of the dry stone walls. These phenomena have been reported in area (9) and (15), where the wall structures and the components of the hydraulic systems are completely damaged. The insufficient drainage of the retaining dry stone walls can trigger soil saturation and erosion due to the rising up of groundwater table, the uncontrolled runoff (overflow and lateral infiltration of the water), *etc.*

Sometimes, even where the overall structure proves to be in good condition, the presence of infestive shrub vegetation was observed, which has a negative influence on the structural conservation of the dry stone walls increasing the overall instability of the wall itself. Other exogenous causes making dry stone walls vulnerable to erosion can regard to the repeated passage of wild fauna, particularly abundant since the last 10 years in all rural areas, hilly and mountainous, of Tuscany.

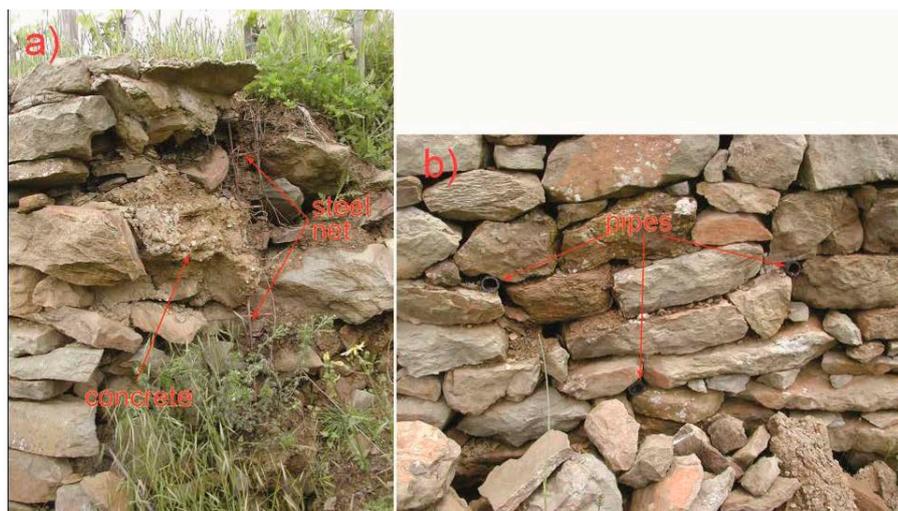
Figure 10. (a) Example of a restoration using electro welded wire and concrete behind the dry stone wall; (b) Since the drainage is obstructed by the concrete, they have been inserted plastic pipes, but the system is very poorly efficient.

In certain situations of particular criticality, operations for the restoration of the dry stone walls were observed, carried out by using binding materials to connect the stones each other and by using electro welded wire mesh upstream of the wall face (Figure 10). In other cases, the use of concrete has regarded the insertion of the plugging elements between the stones to repair specific instabilities of the wall structure. In both cases, the original features of the dry stone walls have been lost, leading to a gradual waterproofing of the terracing. Other technical shortcomings referring to design faults in the hydraulic systems were also observed. It is evident that the incorrect restoration of the walls reduces the drainage capacity of them leading to deformations and collapses.

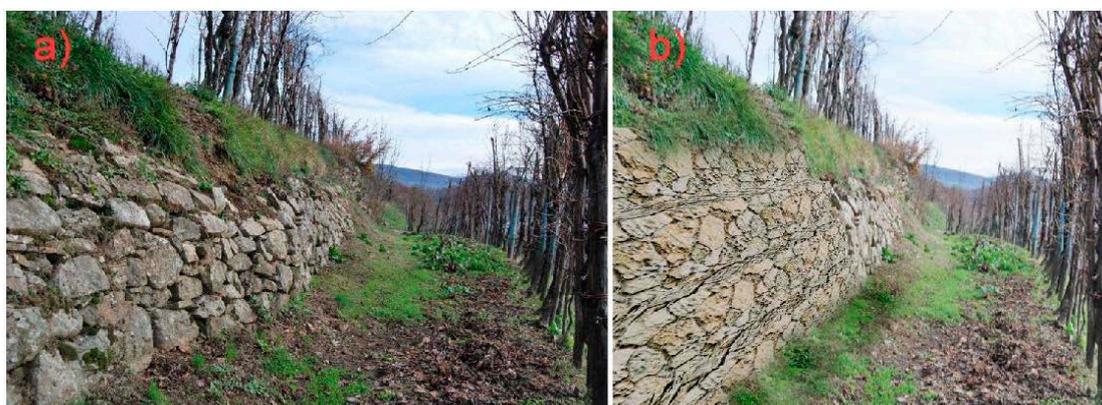
Figure 11. (a) Traditional dry stone wall in sample area (12); (b) Rendering of the same wall made by gabion-wall system.

The feasibility, for example, of soil bio-engineering works, embankments and gabion-walls (Figure 11), could represent alternative structural solutions, environmentally and economically sustainable, which maintain elevated standards of functionality of the terraced landscapes, even altering distinctive characters of each territory.
