The Fourth Italian Workshop on Landslides

Advances in sustainable conservation practices in rupestrian settlements inscribed in the UNESCO's World Heritage List.

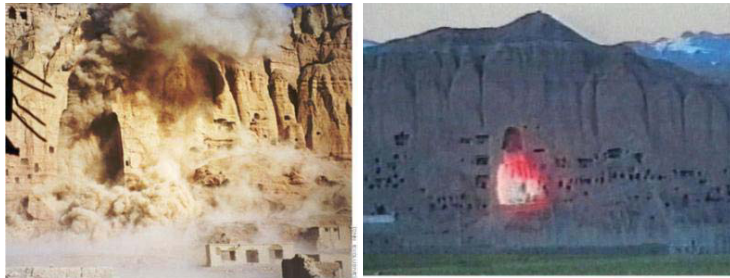
Fig. 2. Explosion and destruction of the Western (left) and Eastern (right) Giant Buddha Statues.

The historical site of Bamiyan is affected by geomorphological deformation processes which were worsened by the blowing up of the Buddhas in March 2001, which destroyed the statues, dating back to the 6th century AD (Fig. 2). Not only was invaluable cultural heritage irremediably lost, but the consequences of the explosions as well as the collapse of the giant statues also added greatly to the geological instability of the area. Traces of rocks which recently slid and fell, are relevant proofs of the deterioration of its stability conditions and most parts of the site now appear prone to collapse in the near future.

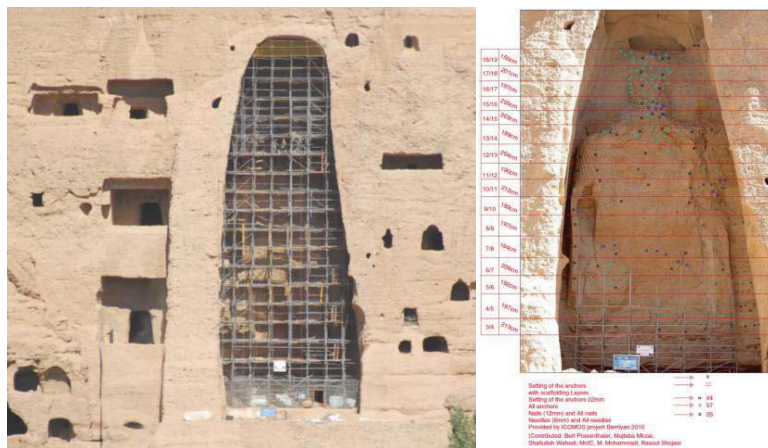
Fig. 4. The scaffolding for the stabilization of back wall shear zone and the position and typology of installed anchors (diam. 22mm, 12mm, 6mm)

Finally, after the stabilization of the external part of the Eastern Buddha niche, in 2009-2012 the inner back wall (shear zone of explosion) was stabilized by means of small anchors and limited grouting also aimed at fixing the still existing original part of the Statue plaster, jointly executed by Engineering Geologists and Conservators (Fig. 4).

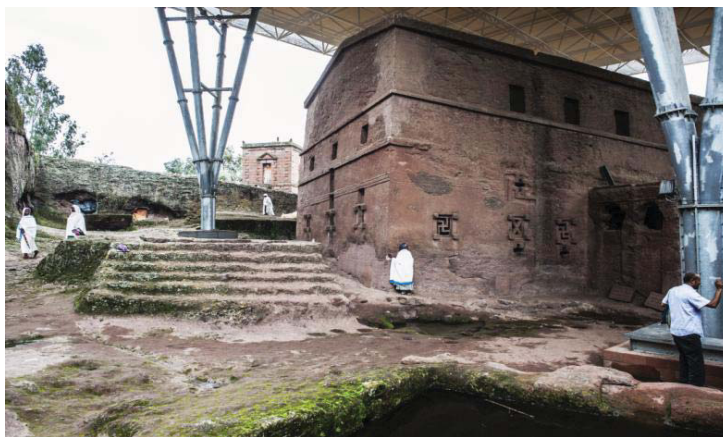
Fig. 5. The modern shelters covering the rock-hewn churches of Lalibela (Ethiopia) (source [www.flickr.com](http://www.flickr.com))

Up to now no proper investigation nor restoration has been implemented. Only new shelters were introduced, but with an impact that was altering the aesthetic value of the site. Thus, the shelters are protecting from water infiltration and can be considered as a temporary reliable measurement before a correct conservation plan can be realized (Fig. 5).

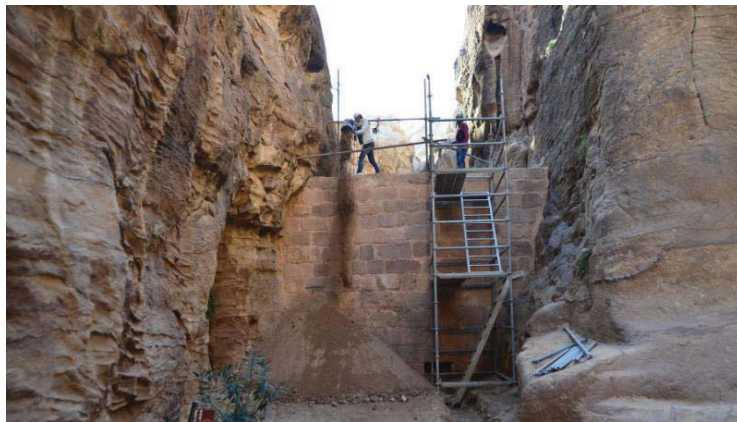
Fig. 6. Manual and proper cleaning of stone dams, to protect the Siq of Petra from flash flood.

Depending on typology and volume, several kinds of mitigation works have been suggested. In any case, such technique cannot be applied without a local investigation on the considered site. In detail, the selection of potential working typologies has to take into account their impact on the peculiarity of the site geo-cultural environment (geomorphology, landslide types, presence of archaeological remains) so that only some specific typologies of consolidation interventions are recommended. Clearly, any intervention has to take into consideration the minimization of the environmental/visual impact of works, the local sustainability and feasibility, and the transfer of know-how to the local system. All these details are included in specific Guidelines<sup>4</sup> for the benefit of Jordanian authorities. Particular attention is given to the traditional techniques and the proper maintenance of such practices (Fig. 6).

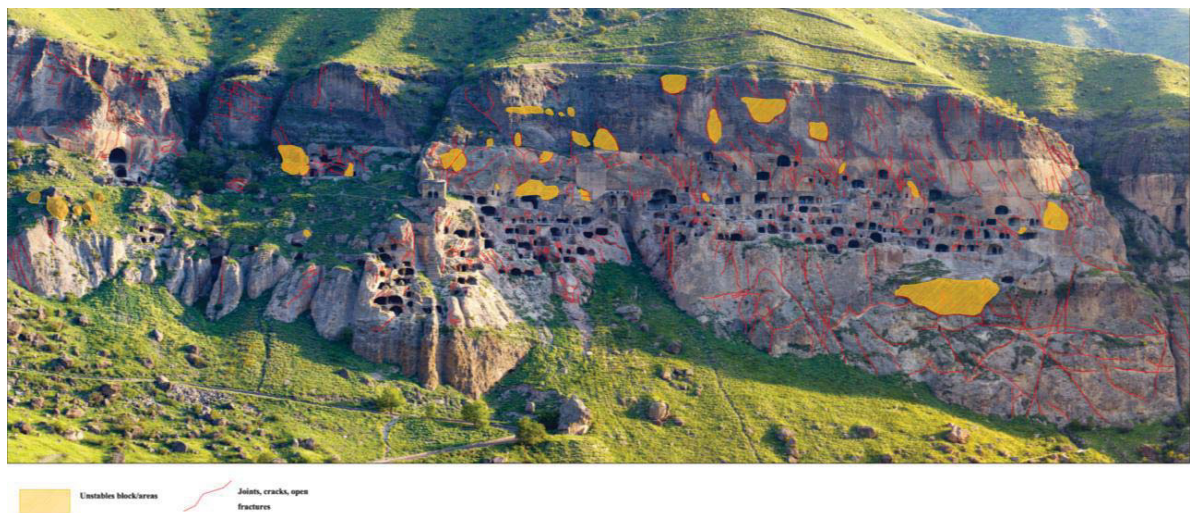
Fig. 7. Joints, cracks and unstable blocks in Vardzia cliff.

All the performed investigations allowed the definition of the most unstable areas. The map is reported in the following Fig. 7.

It was then decided to stabilize one of the potentially unstable blocks, located in the lower-right portion of Fig. 6, the largest among the selected ones. Such block is also interesting because of an archaeological tunnel, connecting the flood plain with the rock-cut city.

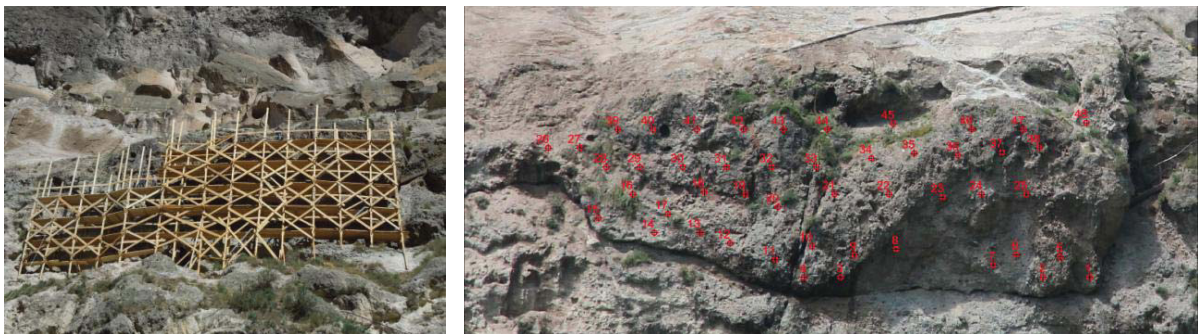
Fig. 8. The wood scaffolding and the map of the 48 installed dowels.

Unfortunately no experienced drilling company was available in Georgia, nor a proper scaffolding for the site. It was then decided to initiate a large capacity building exercise of a local company contracted by the Agency for Cultural Heritage Preservation of Georgia. An Italian engineer with considerable field work experience then accompanied the purchasing of equipment and the field work, including the construction of the scaffolding. The final successful result is shown in the following figure showing the realized wood scaffolding and the 48 installed dowels (Fig. 8).
