The Saadian sugar refinery of Chichaoua (Morocco): constructive and structural investigations for conservation

Abstract

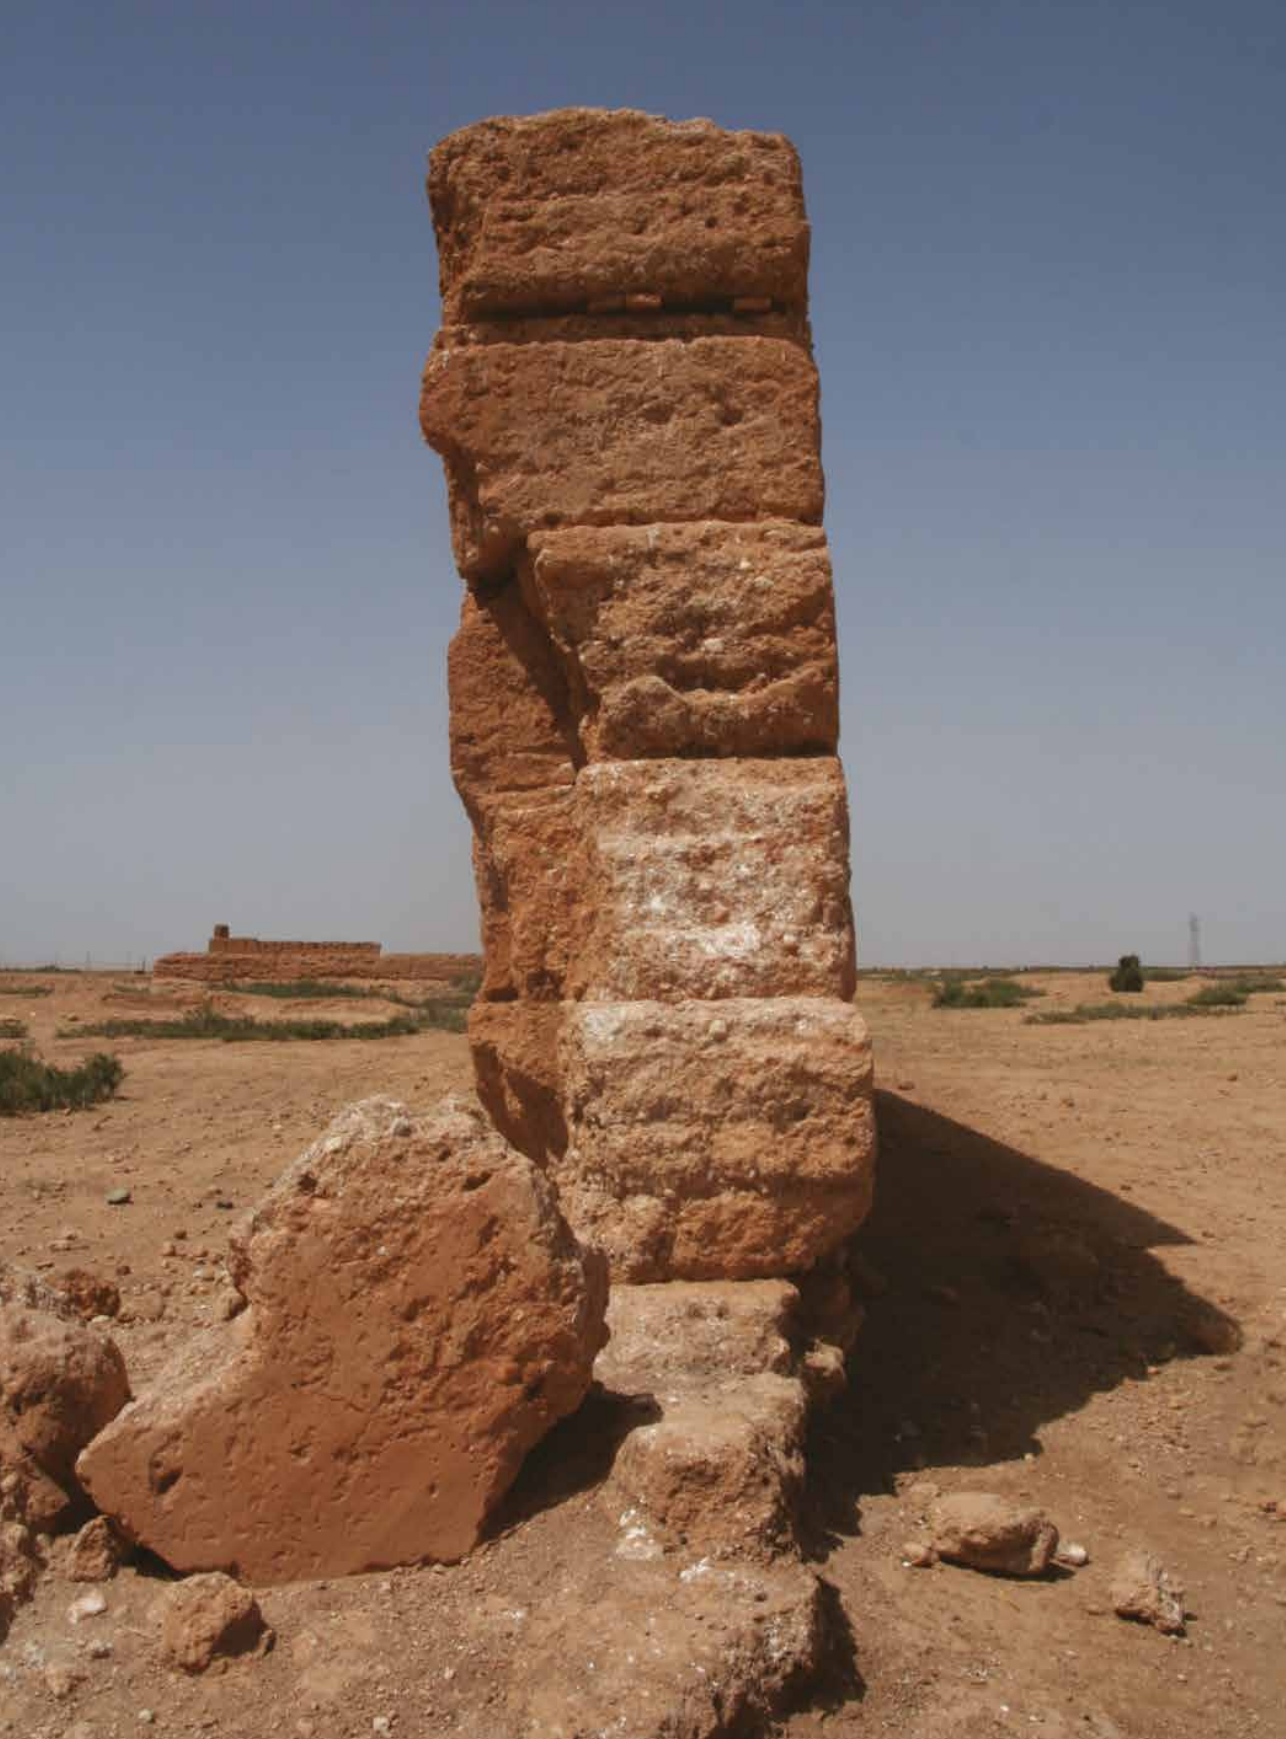
Fig. 12

*Damage mechanisms
in the aqueduct wall:
the leak of verticality*

When the erosion at the base affects only one of the two sides of the wall, a mechanism triggers that causes an inclination toward the excavated side. Since the rammed earth gravity center may be too eccentric with respect to the wall base, the mechanism may evolve till the collapse. When the kinematism starts the wall needs to open some (quite vertical) fractures, required to allow it. It is possible to identify many of such mechanism in the long wall of the aqueduct and in the factory (Fig.12); but the final overturning does not happen immediately because the remaining adjacent portions of wall represent a constraint that hinder configuration changes. Indeed the situation is really dangerous since also a little motion, caused by external forces or by further settlements, may produce a local collapse.

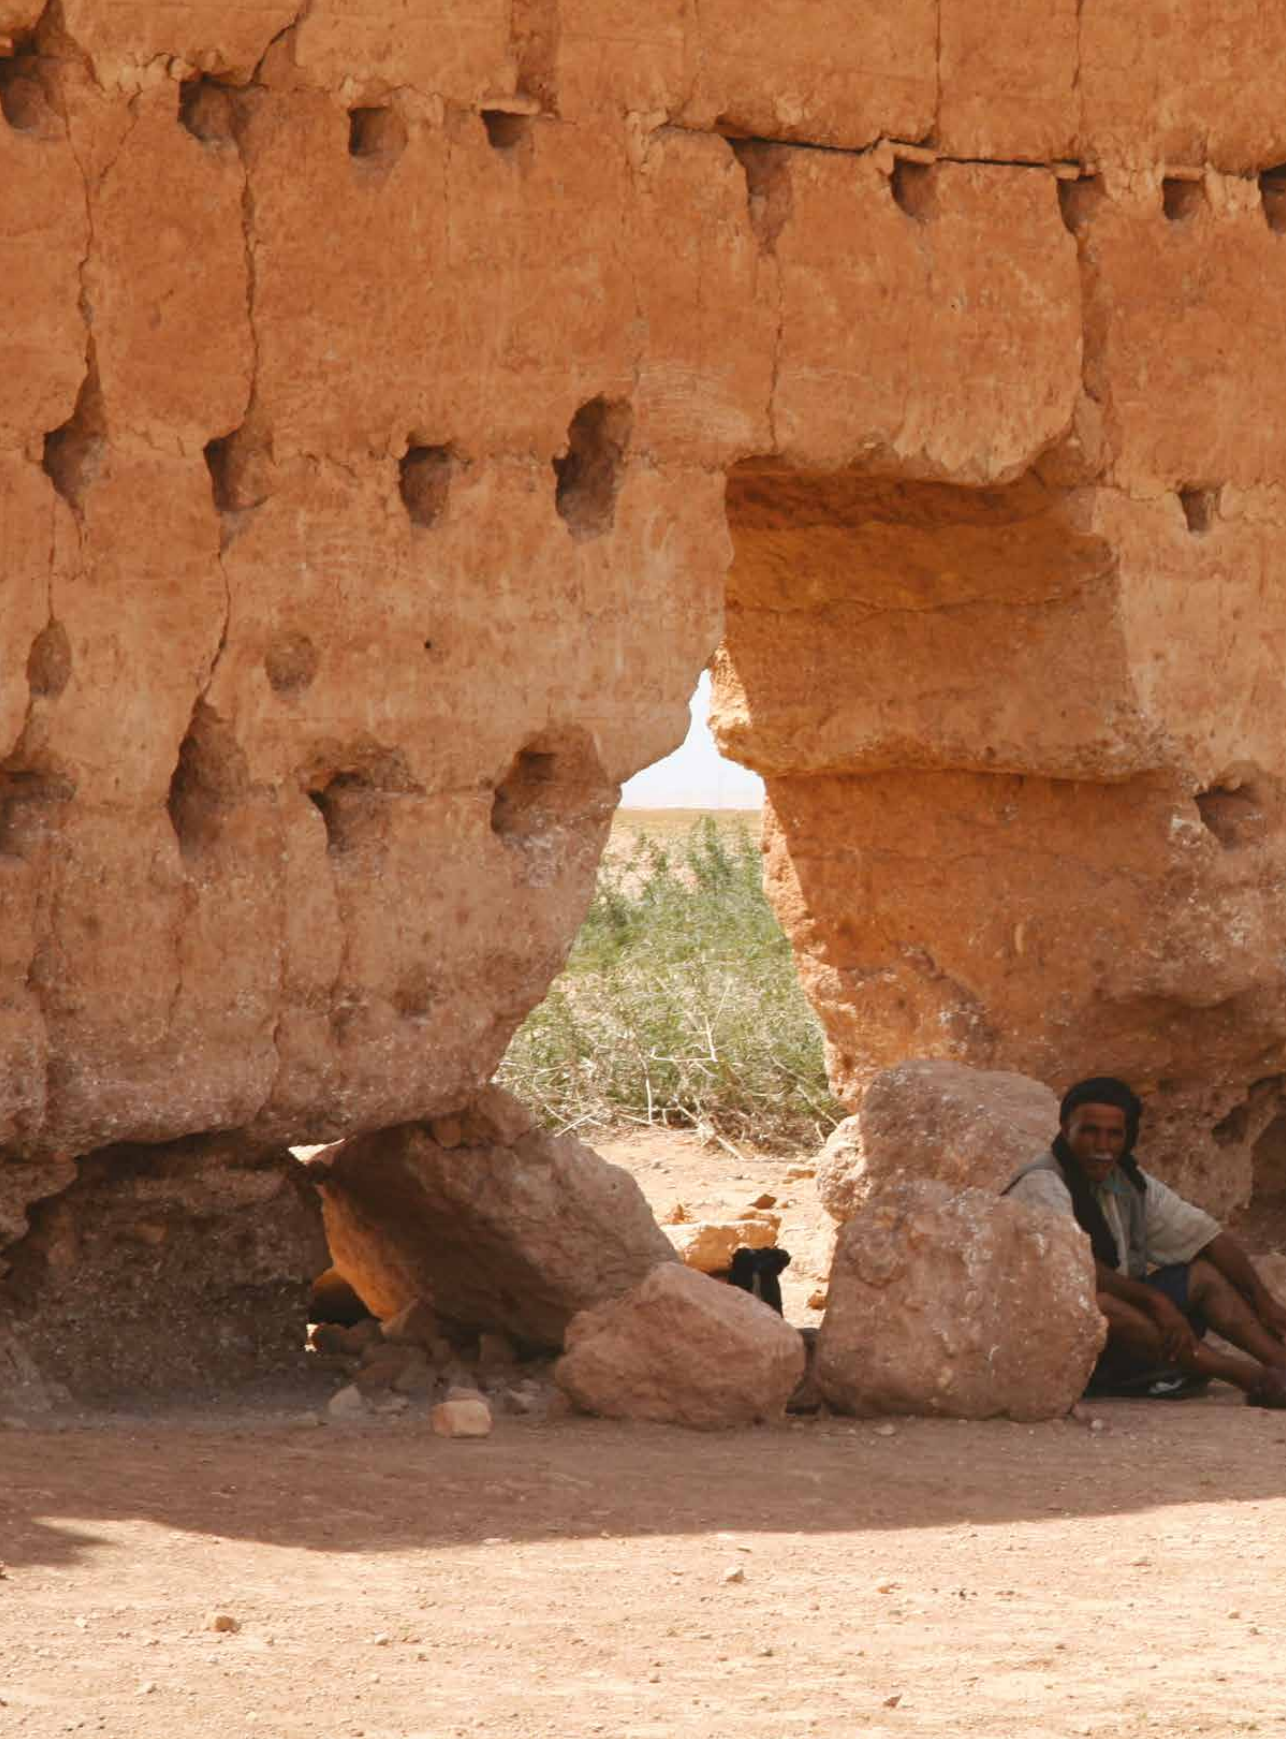
Fig. 1

*Chichaoua sugar
refinery: the aqueduct*

ny aspects: in particular for the quality of the architecture, quality of the materials and for the impact on the landscape. As regards the materials, it must be emphasized that the original *rammed earth* (used to build the aqueduct) reached the characteristics of a lithoid conglomerate. The same aqueduct strongly characterizes the landscape, recalling the impressiveness of the remains of Roman architecture. The suggestion is enhanced by the collapse of a portion: in fact, thanks to the construction technique which utilized large formworks, it is possible to recognize the displacement of the different blocks during the collapse. All these characteristics suggest that this old architecture deserves to be safeguarded and could become a reason of visit in the route from Marrakech to Essaouira (Fig 1).

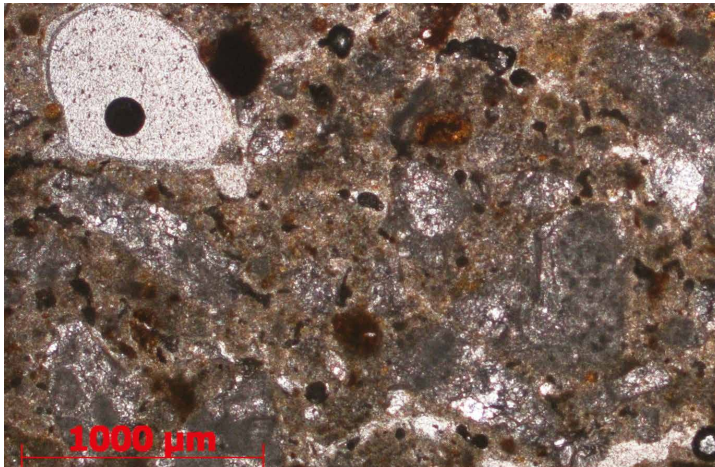
Fig. 7
Thin section under optical microscope: strong presence of micritic calcite clusters and abundant framework of carbonatic gravel in the clay matrix

The observation on thin sections points out that the samples from the aqueduct are characterized by a clay matrix, a strong presence of micritic calcite clusters and an abundant framework made mainly of a carbonatic gravel. These characteristics show that the material can be defined as a lean earth rich in gravel mixed with a large percentage of lime used to facilitate the process of hardening of the earth through carbonation. Calcite, the final product of the reaction, gives to the rammed earth all its particular mechanical and physical properties (Fig.7).

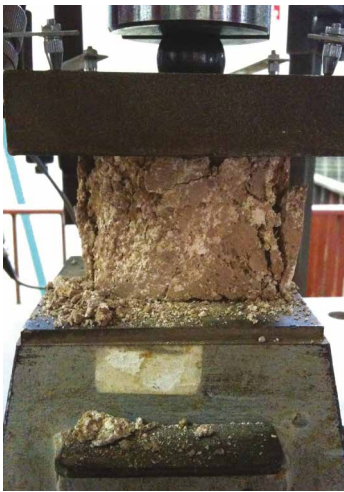
Fig. 8
Compression test

The uniaxial compression test was performed on the material fallen from the aqueduct on 4 samples cut in cubic shape (average size: 5x5x5 cm) (Fig.8). The results show an average compressive strength value equal to 3,5 MPa.

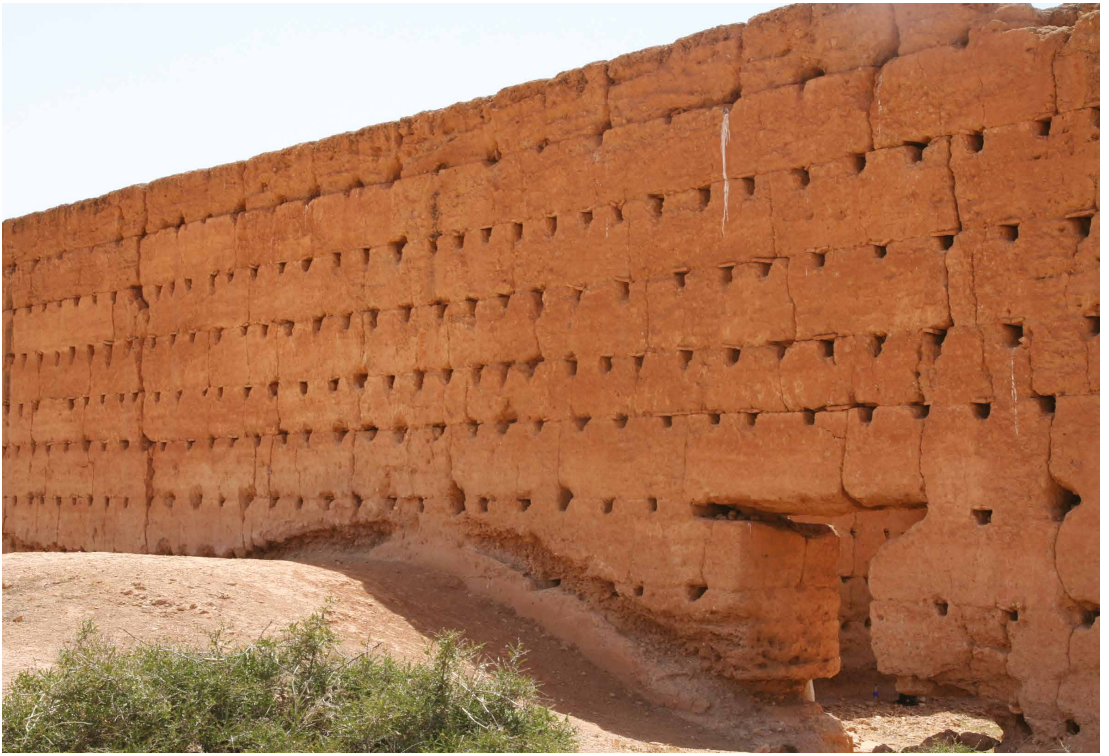
Fig.9
The buried wall bases and foundations

The action of erosion is carried out in particular at the base of the wall. The whole artifact shows an advanced state of decohesion. The foundation and the base should have protected the wall were buried and no longer performed their task (Fig.9). So the rains and the water logging, caused by the irrigation of adjacent fields, have strongly attacked the lower parts of the building (Fig.10). Another important phenomenon of erosion affects the top of the wall; here, in the factory, the protection of the plaster was lost, while the thick layer used for sealing the channel has played a positive role in the aqueduct (Fig.11). The loss of plaster also affects other spread parts of the building where weather, insects and mold attacked surfaces.

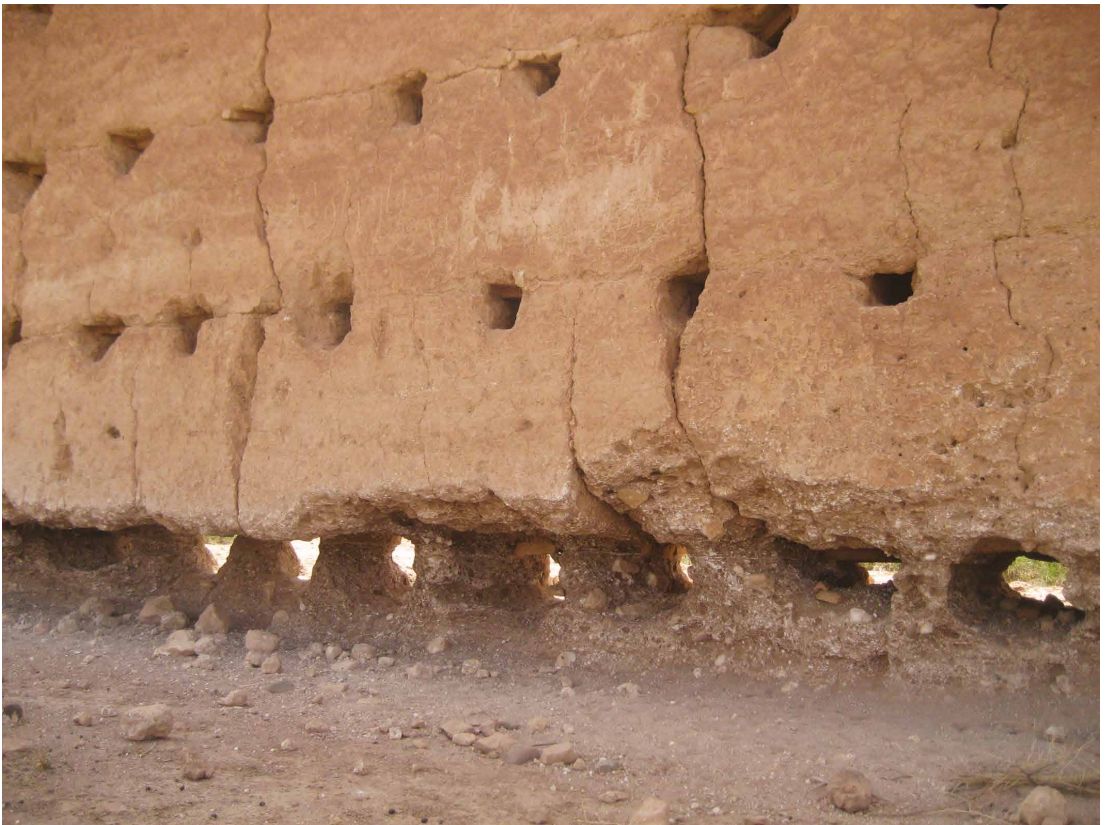
Fig.10
The principal damage mechanisms in the aqueduct wall, due to water erosion: the damage at the base

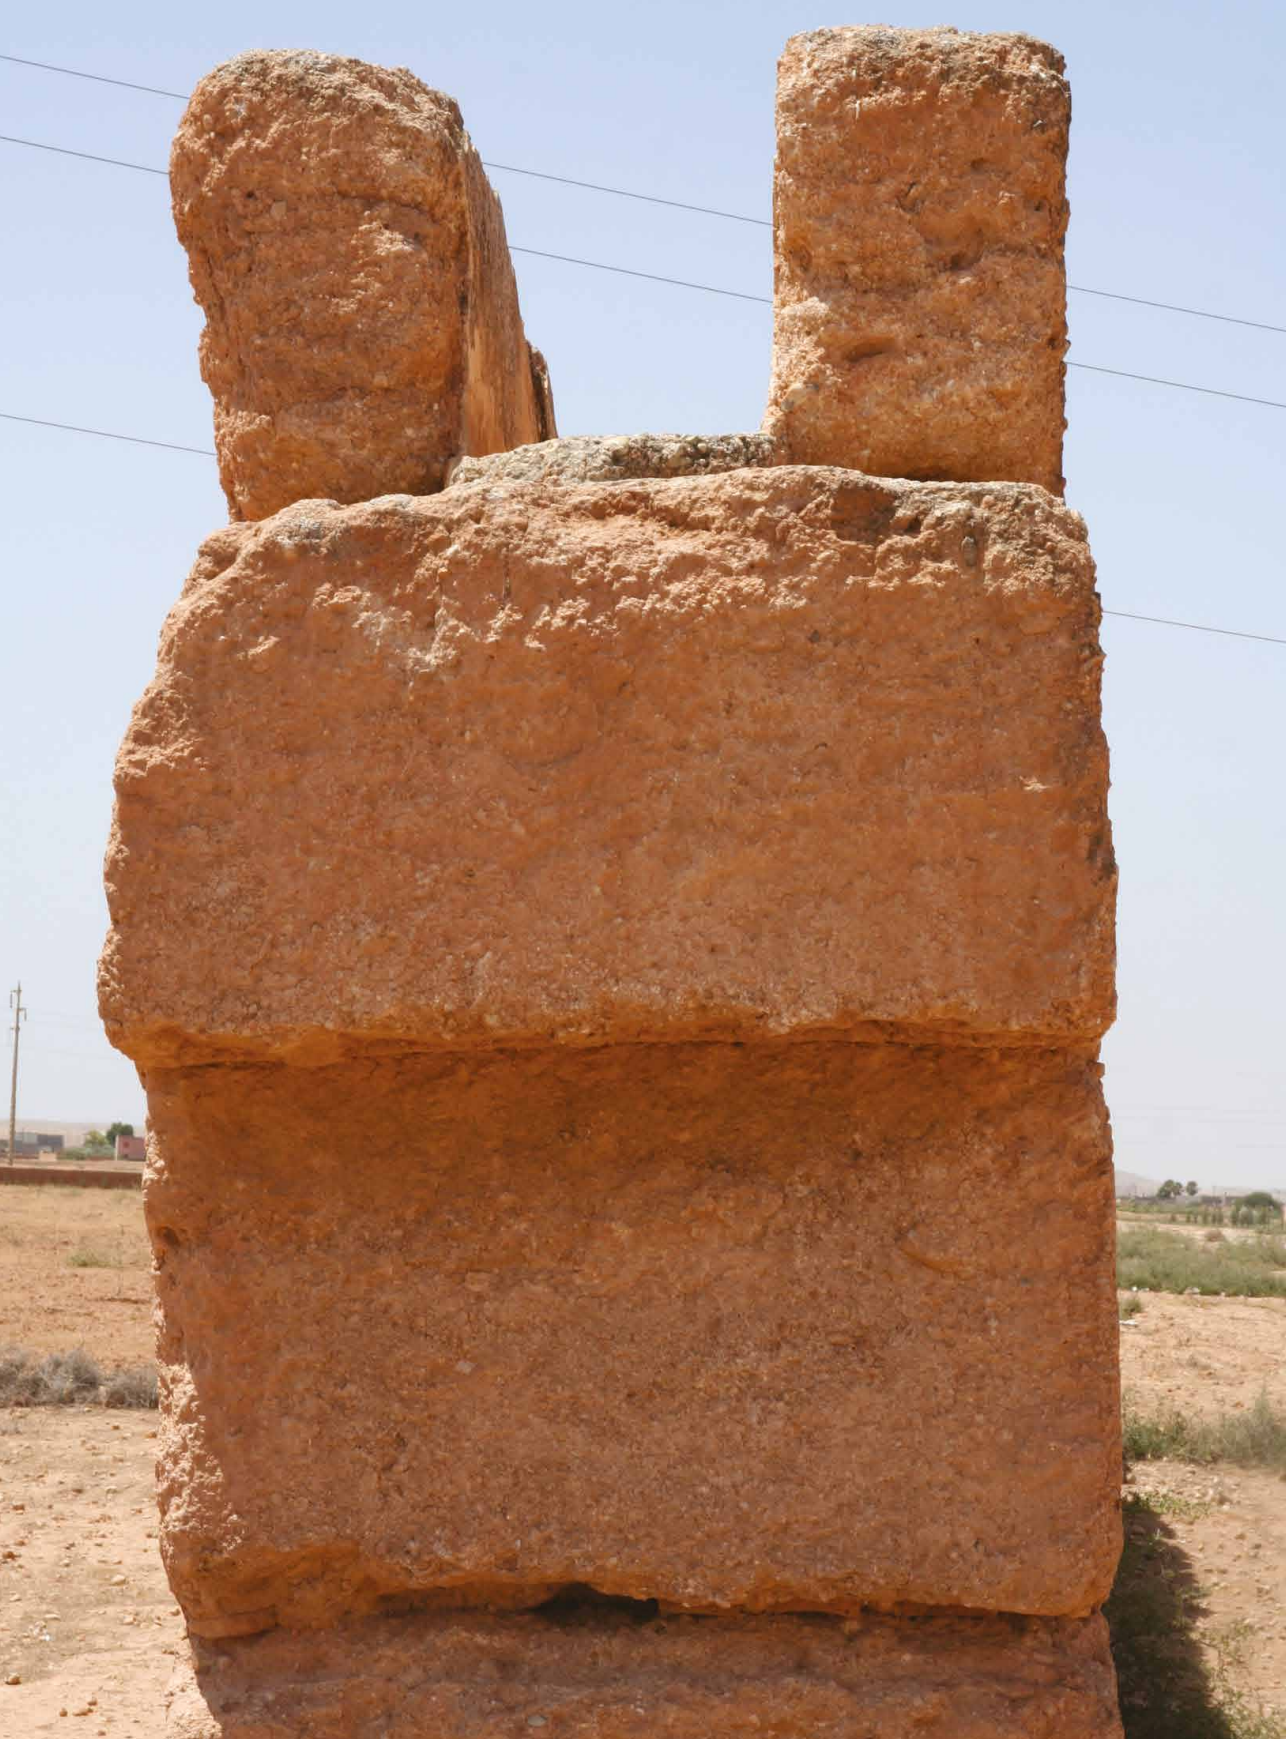
Fig. 11

Water erosion at the top of the wall

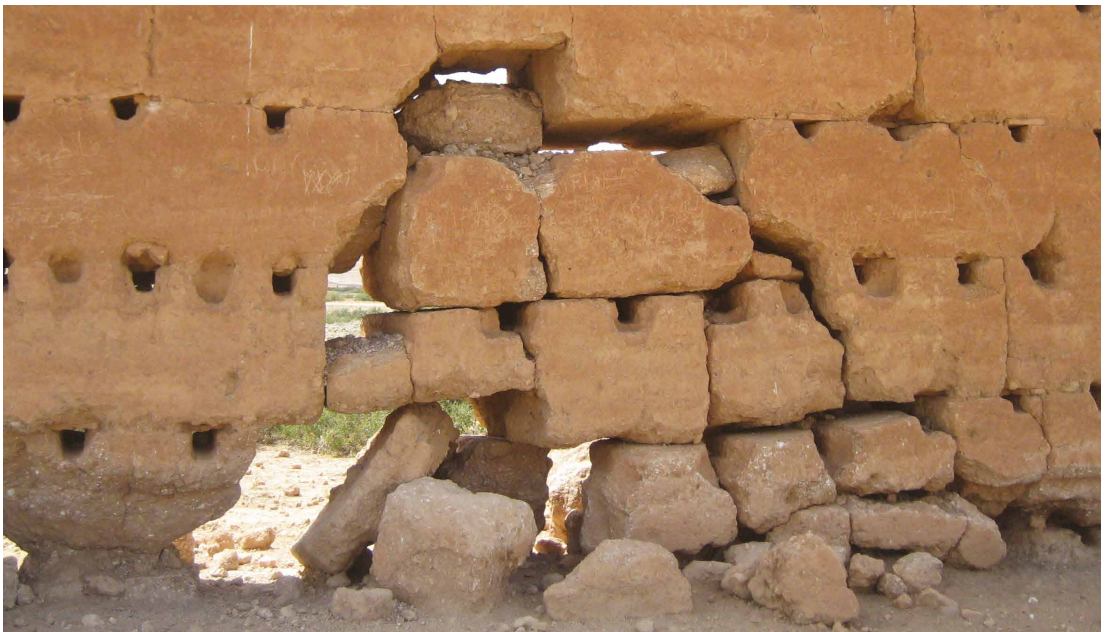
Fig. 13
Damage mechanisms
in the aqueduct wall:
the discharging arch

A different mechanism occurs whenever the erosion involves both sides of the wall. In this case the equilibrium is maintained, but when the first row of blocks breaks up, leaving the upper rows without support, the structure activates in search of a different configuration of stability. The blocks without support rotate, scrubbing on the adjacent ones, around three points, drawing first a V (like a flat arch) that early turns into a sort of arch (after some further settlements).

vement is hindered by the presence of the lateral blocks that constitute a constraint. The different phases in the creation of the “discharging arches” are clearly visible throughout the system of walls (Fig.13).

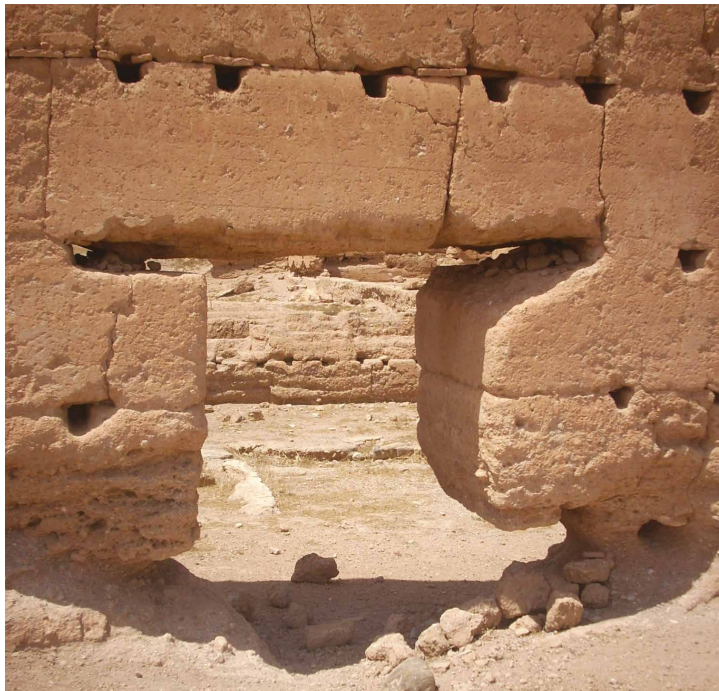
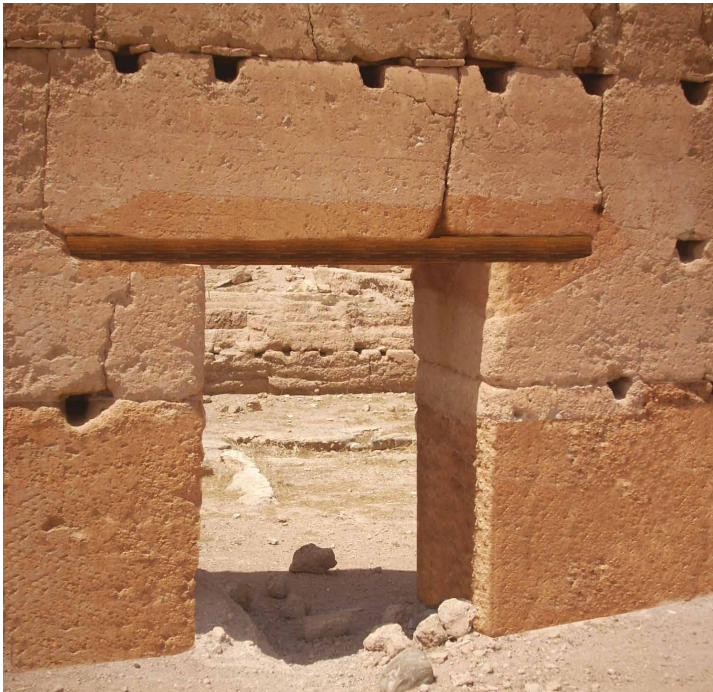
Fig. 14
Virtual example
of consolidation
of an ancient door
(on the right the
insertion of cedar
woods lintels and
the integration
with earth)

An intervention of reconstruction appears very difficult because the employ of a material close to the original one is needed. In this case a material with good strengthening performances is requested because the bases of the walls needs to be consolidated. It will be possible to achieve this purpose by the insertion of a new adobe masonry in the cavities (then hidden by a layer of earthen plaster) or by the application of a new conglomerate (improved with the addition of lime, pozzolana and some aggregates and then jointed by wooden clamps to the preexisting parts). Also some portions of walls must be completed, sometimes, at higher levels to gain security against water.

All these procedures require the adoption of natural materials (like cedarwood for the lintels and so on). Finally the restoration areas will have to be recognizable by a slightly different size of the mixture and of the color. In Fig.14 it is shown a virtual simulation of the intervention on the door, at risk, leading to the factory.
