### **Experimental investigation on cyclic response of RC elements repaired by CFRP external reinforcing systems**

## Experimental investigation on cyclic response of RC elements repaired by CFRP external reinforcing systems

Francesco Capani<sup>a</sup>, Angelo D'Ambrisi<sup>a</sup>, Mario De Stefano<sup>a</sup>, Francesco Focacci<sup>b,\*</sup>, Raimondo Luciano<sup>c</sup>, Raffaele Nudo<sup>a</sup>, Rosa Penna<sup>d</sup>

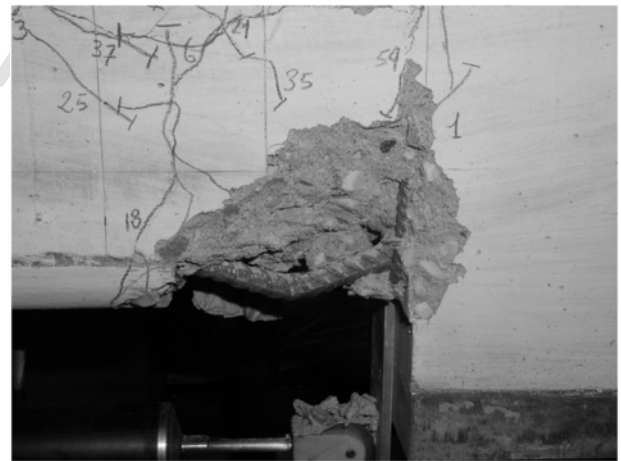
Fig. 11. Specimen REF100: buckling of a longitudinal bar at a critical region.

As expected, the unstrengthened specimen REF100 ( $n = 16.7\%$ ) exhibited a greater strength and a lower deformation capacity than the specimen REF50. Hysteresis loops were less stable with considerable strength degradation, especially at high deformation levels (Fig. 9). Failure was reached at beginning of the 17th cycle due to the overall instability of the specimen caused, in turn, by the excessive concrete degradation and buckling of longitudinal bars at critical regions (Fig. 11).
